# **SANDIA REPORT**

SAND2006-6551

## **Laser Engineered Net Shaping™ (LENS®) for the Repair and Modification of NWC Metal Components**

David D. Gill, John E. Smugeresky, Clinton J. Atwood

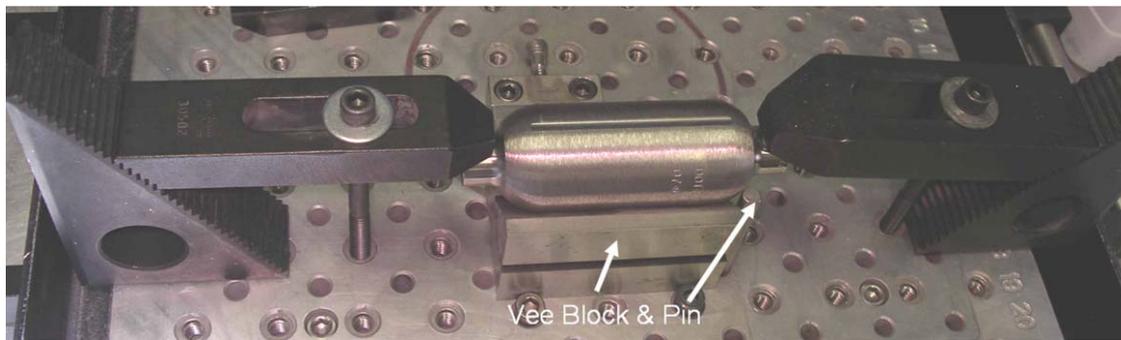
Figure 7. Mounting Fixture in LENS Machine Holding Bottle for Repair

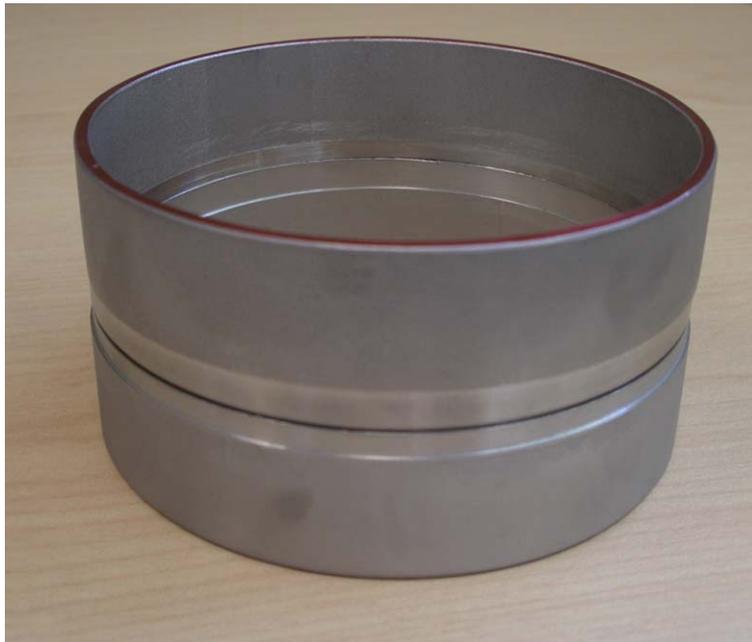
**Figure 14. The Assembled Step Joint Rings**

The LENS process parameters are given in Table 3 along with a comparison with process development parameters determined on large 304L blocks. The LENS depositing of the step joint rings showed that improved fixturing might be an area of potential improvement. First, the fixturing was done by pinning the ring between 2 bolt heads and a clamping bolt. This method provided too much opportunity to further deform a ring that we already not round. In the future, it would be much better to do these rings with a 3 or 4 jaw chuck that would not only center and positing the ring, but also might help to make it round. The LENS material deposited on top of the ring would then help to hold the ring in a circular geometry. It might also be helpful to mask the lower portions of the ring so that any laser fall off would not cause spatter to adhere to the walls of the rings. A final process improvement would be to randomize the start position of the LENS passes. In this testing, the laser started and stopped at the same X-Y location for each ring deposited. This area then had the seam as well as small irregularities because of the finite time for the laser to develop a melt pool after the shutter opens. The randomization of start location would cause more uniform properties around the ring.

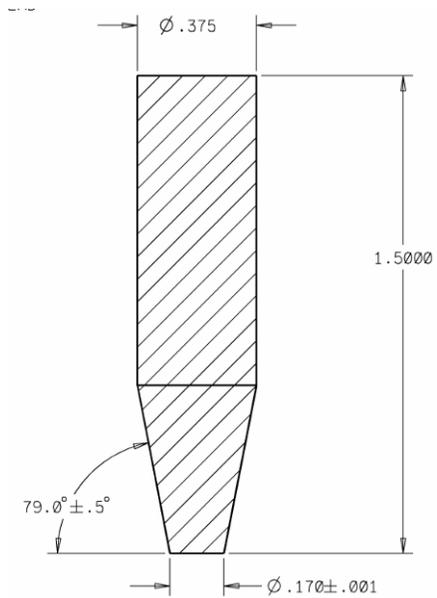
The first repair to the W87 housing was the filling of holes. The holes are in bosses that are attached to thin walls on the side of the can. Before LENS repair, the holes were machined using a form tool, shown in Figure 16, which left a steeply angled sidewall to the holes. The form tool was designed to have the maximum possible diameter at the top edge (determined by the size of the boss) and the flattest angle possible to present a face for the LENS process to build upon. Because holes with sidewall angles this steep had not been LENS repaired before, a block was drilled with many holes and the form tool was then used on these holes. Process parameter testing indicated the parameters that would be most successful for filling the hole, so an attempt was made to fill one of the holes in the W87 housing using these parameters. The result was a very hot build that discolored all of the area around the boss. The process parameter block and discolored boss are shown in the top row of Figure 17. Though the geometry of the hole was exactly the same as had been used in the process parameter development, the surrounding geometry was not the same which caused the heat conduction pathways to be different as well. To make the process development and actual part builds match, one of the two items had to be modified to provide similar heat conduction to the other. It was determined that creating process development bosses on thin walls would be prohibitively expensive and time consuming, so the real part was made to mimic the process development block with the addition of a heat sink. The aluminum heat sink allowed the heat to conduct away from the boss so that the LENS deposit did not discolor the surrounding geometry. The heat sink and resulting hole filling are shown in the bottom row of Figure 17. In addition to the heat sink block, it was necessary to add a plate underneath the hole for the LENS material to use in creating a melt pool. The plate was clamped in place for the build and was relatively easy to remove either by drilling the hole at which point the plate usually separated by itself or by milling the plate off the hole. This exercise was a valuable lesson in the filling of holes and showed the ability to LENS deposit in the holes. Additional process development would be necessary to make this repair completely successful as the bottom of the holes had incomplete adhesion. A more extensive process development might determine that the process would benefit from total rebuilding of the bosses rather than just hole filling. However, hole filling was of more interest to first users than boss replacement.

**Figure 16. This Form Tool Was Used to Bored the Bolt Holes Before LENS Depositing. Even this Steep Angle Gave Sufficient Surface for Adequate LENS Adhesion**

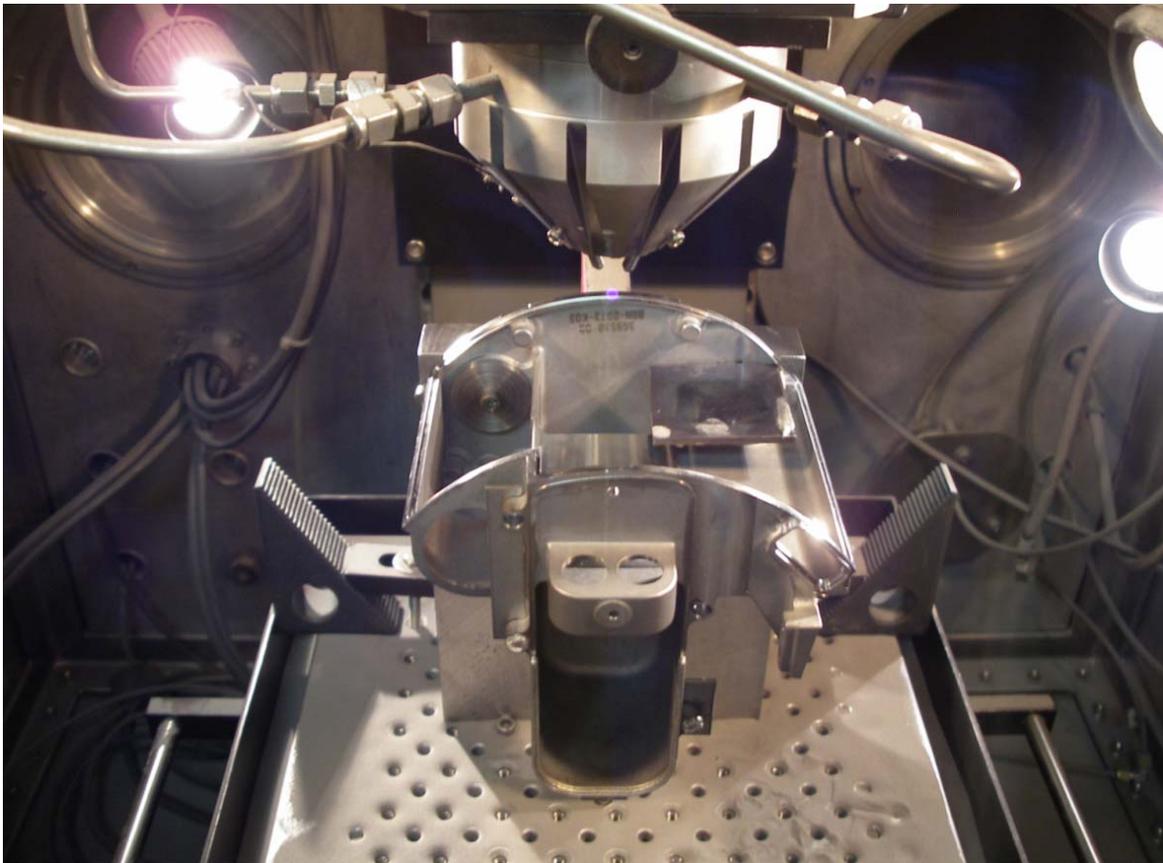
The W87 repair also required that the cover weld flange, a curved feature, be repaired by building up the weld lip to allow machining and rewelding. Some sections of the lip are straight and some have compound curves. A fixture for the part was designed and manufactured by KCP to allow accurate location of the part in the LENS machine as shown in Figure 19. Because of the 2½ dimensional nature of the LENS machine at the time of this repair, it was necessary to repair this part with the part sitting as shown. The laser was traversed in a conformal path along

the weld flange sides, up and over the arcs, and around the compound curve near the fixture. With the newly installed elevation and azimuth rotary axes in the LENS machine, this part would be repaired differently with the part rotating under the laser to keep the incident beam normal to the flange face. The face required multiple layers with 0.020" nominal layer thickness. The face was a challenge to fill because it tended to be thick at the outer edges and sometimes knife-edge thin at the inside edges, thus giving different heat conduction paths. In one location the face was completely missing as is shown in Figure 18. The LENS team attempted build up the face in this location, but was somewhat unsuccessful due to the angle of the incoming laser, a difficulty that would no longer be an issue. Overall, however, the flange was satisfactorily repaired. There was some possible lack of adhesion discovered in the weld flange during the machining stage. In these areas, it is surmised that the LENS deposits for the large arc did not sufficiently overlap the straight passes on the edges of the flange. A process improvement would be to offset the passes on alternating layers to assure full adhesion layer to layer and to eliminate any possibility of voids between hatch lines.

**Figure 19. The W87 Firing Set Housing in the LENS Machine for Repair of the Cover Weld Flange.**

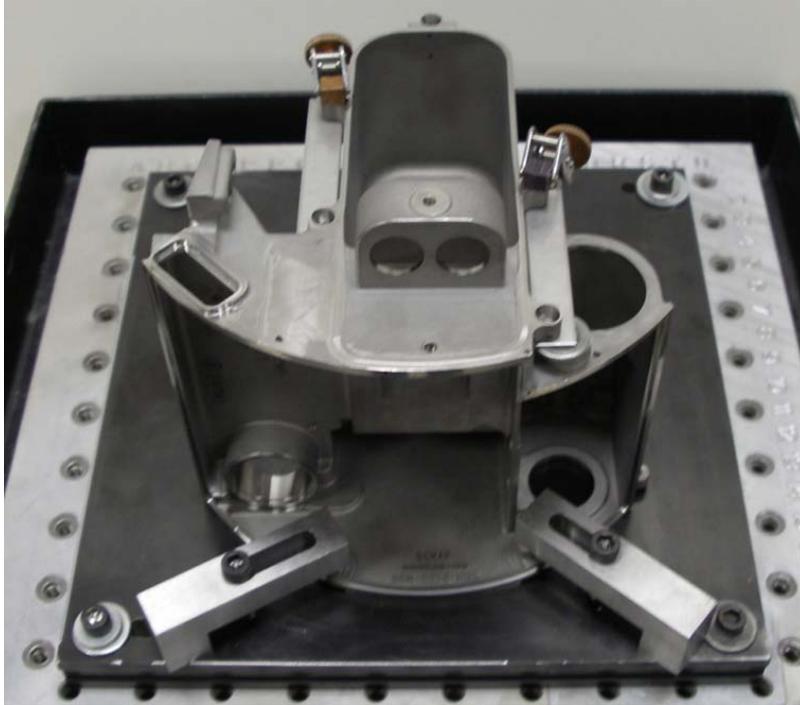
The final repaired feature was the can lip which was repaired by placing two side-by-side LENS passes around the periphery of the can as shown in Figure 15. Again, KCP created a fixture for precise location of the housing as shown in Figure 20. Because of the axis limitations of the LENS machine at the time of the repair, a tall feature at one end of the lip (left side of Figure 21) prevented the entire can lip from being repaired. The feature would not prevent the repair on the current LENS axis system with tilt capability. This repair was easy to align and quick to repair. During testing, it was discovered that there was incomplete bonding between the parallel LENS passes. This incomplete bonding could be easily avoided by programming an overlapping LENS pass in between the two parallel passes.

**Figure 20. The Fixture for Repair of the Can Weld Lip and the Bolt Holes on the W87 Firing Set Housing.**
