Washington Phase II Fish Diversion Screen Evaluations in the Yakima and Touchet River Basins

Annual Report 2005 - 2006

February 2006

DOE/BP-00000652-31

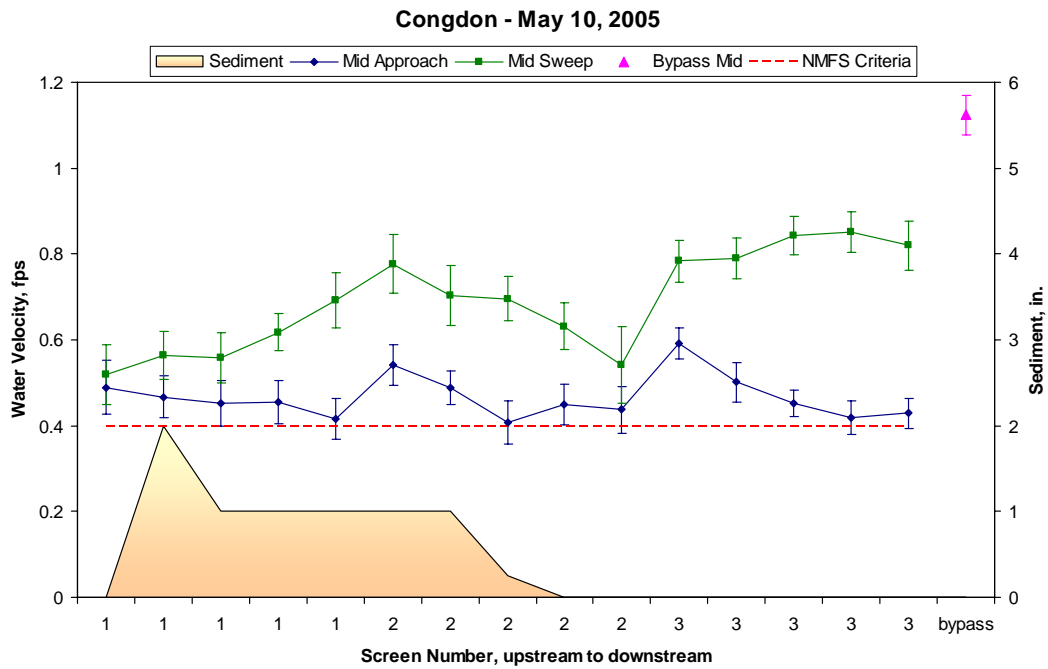
The Congdon facility was evaluated on May 10, June 30, and September 15, 2005. Approach velocities did not meet the NMFS criterion of 0.4 fps in May (Figure 11). June and September approach velocities met this criterion in 93% and 47% of the measurements, respectively (Figures 12 and 13). Ray Gilmour (WDFW) was notified on May 10 concerning the high approach velocities. He said there was probably nothing to be done because the site was operating within the specifications. In 2006, we would like to look at design flows for the diversion and bypass as well as the operating procedures for the screens at this site, and work together with WDFW personnel to see whether changes to stoplog position or other facility settings can be made to keep the site within criteria.

Figure 11. Congdon water velocities and sediment accumulation, May 2005. Error bars represent turbulence.

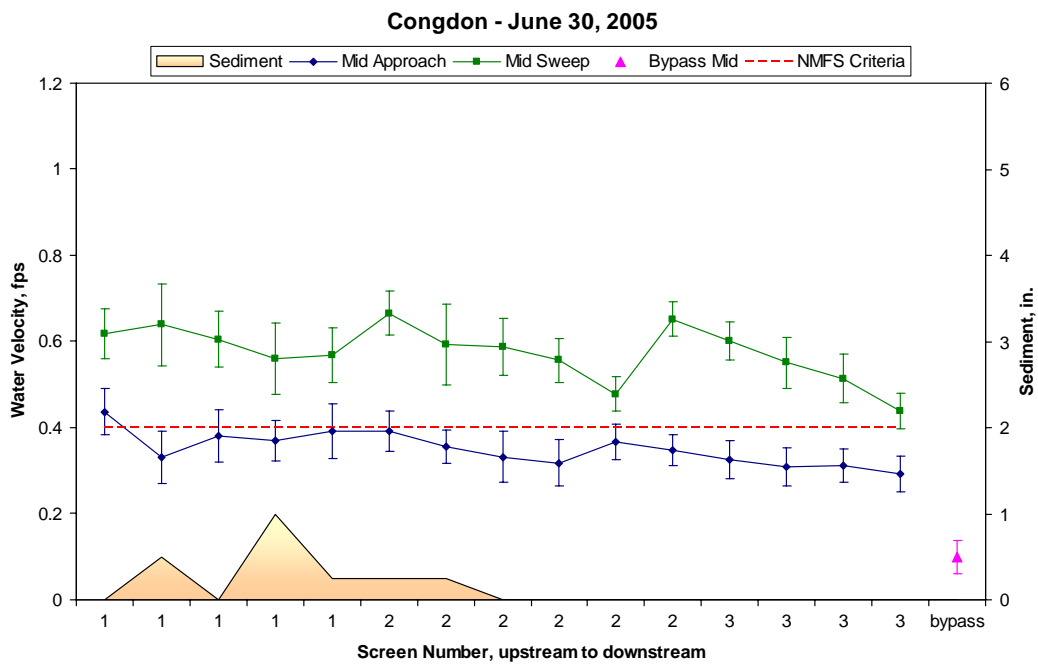
Sweep velocities always were higher than approach velocities, and bypass velocity was generally higher than the sweep velocity except in June, when the ditch rider raised the weir while we were there. This resulted in only 2.5 in. of water over the weir and decreased the amount of water moving through the bypass. Otherwise, flow over the weir and through the bypass was generally adequate. According to the logbook, there were at least a couple occasions in July and August when there was no bypass flow and the WDFW had to reset the weir to allow bypass flows again. Submergence met the criterion for drum screens at 85, 75, and 80% in May, June, and September, respectively. Seals and screens were in good condition during all visits. Several predator-sized northern pikeminnow were waiting at the outfall for anything coming through the bypass.

Figure 12. Congdon water velocities and sediment accumulation, June 2005. Error bars represent turbulence.

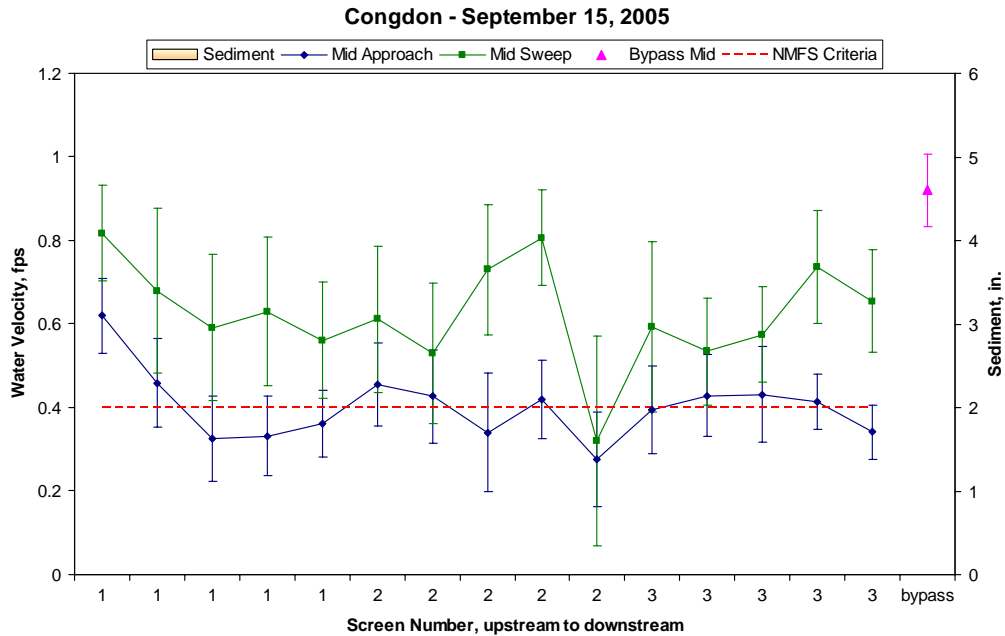
Figure 13. Congdon water velocities and sediment accumulation, September 2005. Error bars represent turbulence.

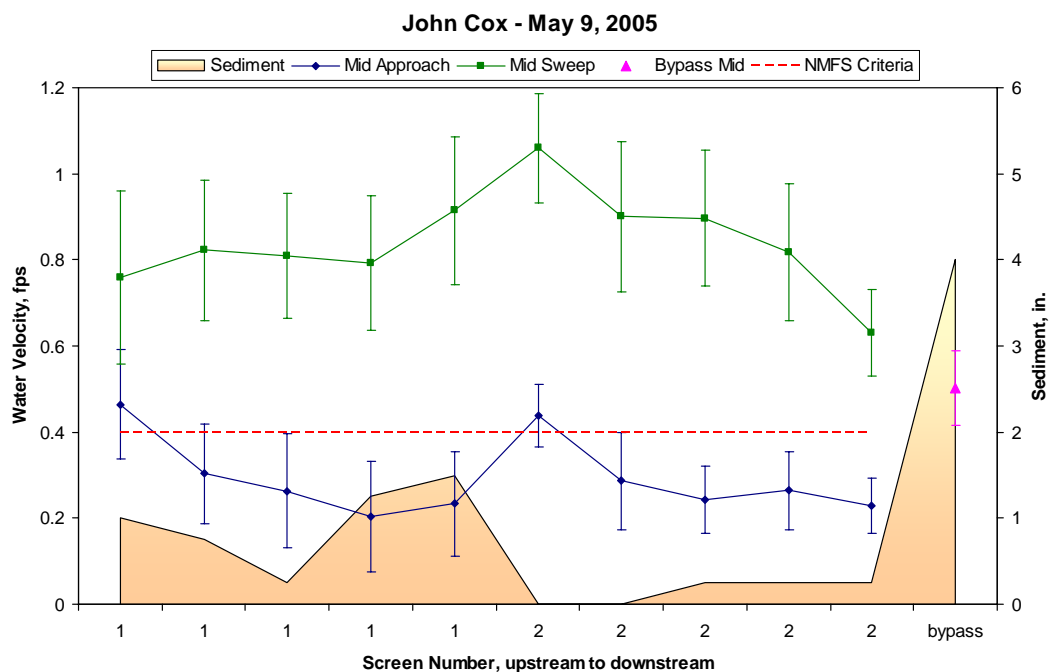
The John Cox site was operational during only one visit in 2005, on May 9. Submergence was at 75% on that date. Approach velocities exceeded the NMFS criterion in the first measuring point along each screen, probably due to eddies around the cement framework (Figure 20). Sweep was greater than approach velocities but did not increase toward the bypass and, in fact, was greater than the bypass flow.

Figure 20. John Cox water velocities and sediment accumulation, May 2005. Error bars represent turbulence.

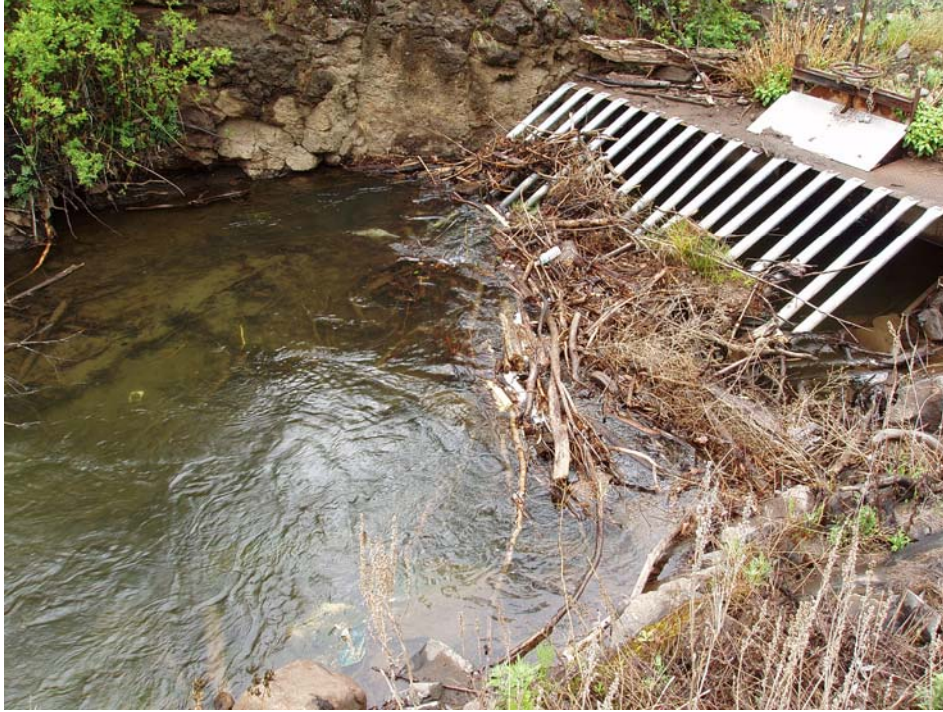
In May, the bypass ramp was up several inches, and the area underneath was jammed full of sticks and debris. The bypass was still able to pass fish. The trash rack was also mostly blocked with sticks and debris, which had been there so long that grass was growing on the top of the pile (Figure 21). The pile covered much of the trash rack and may pose a problem for fish passage. Debris on the trash rack has been a problem here for several years. The irrigation district is supposed to maintain it but does not do so as often as needed. Underwater video showed a small stick wedged between the downstream screen and seal. The USBR personnel were notified on May 9 about the excessive approach values, the stick in the seal, and the debris underneath the open ramp. They were going to correct the problems within a few days. We were not notified of the corrections, but the problems had been fixed by the time of our visit on June 21, when the site had been shut down for the season. Cheeks between the frame and cement structure were caulked in September for the first time, so they will be ready for the 2006 season.

Figure 21. John Cox trash rack, laden with debris

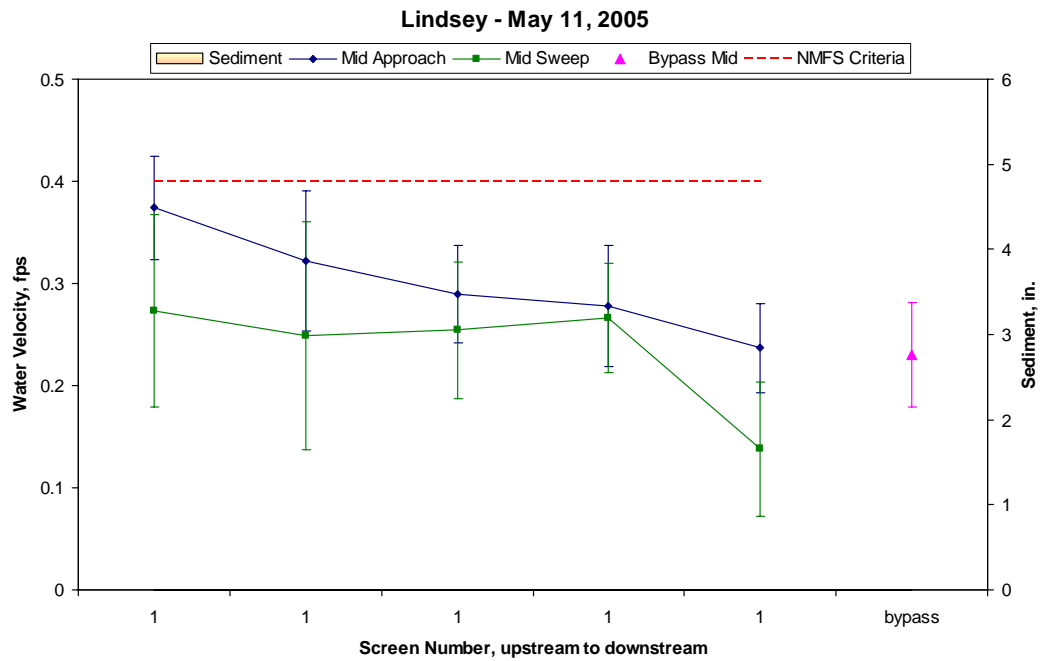
The Lindsey site was evaluated on May 11, June 23, and September 19, 2005. During all surveys, 100% of approach velocity values were below the NMFS criterion of 0.4 fps (Figures 25 through 27). Sweep velocities were greater than approach velocities in June and September but were lower in May, and sweep did not increase toward the bypass during any of our evaluations. Bypass velocity was greater than the sweep velocity in May but not during the June and September surveys.

Figure 25. Lindsey water velocities and sediment accumulation, May 2005. Error bars represent turbulence.

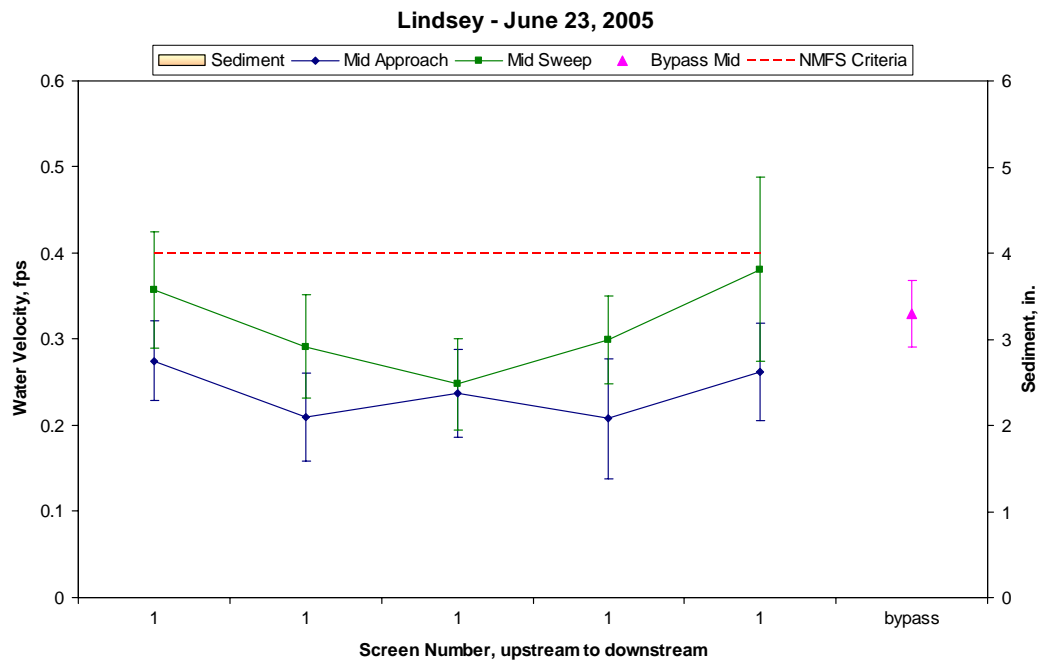
Figure 26. Lindsey water velocities and sediment accumulation, June 2005. Error bars represent turbulence.

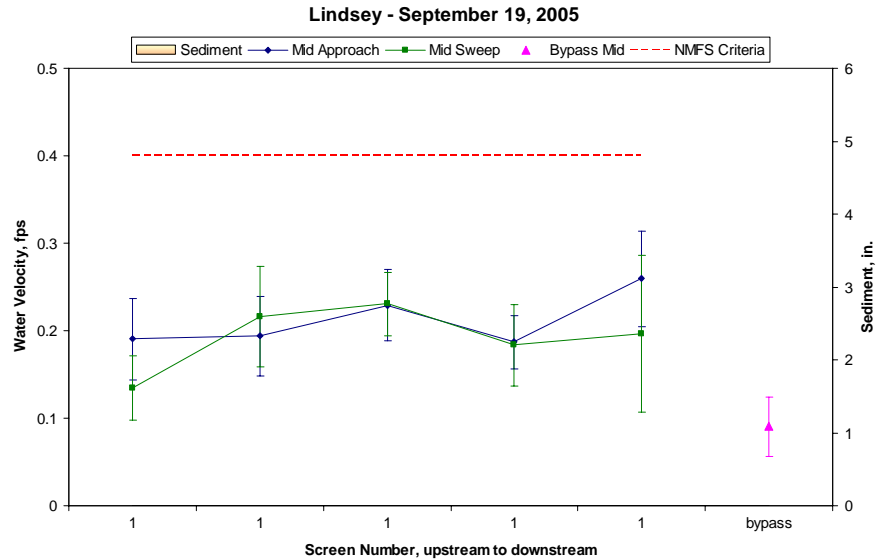
Figure 27. Lindsey water velocities and sediment accumulation, September 2005. Error bars represent turbulence.

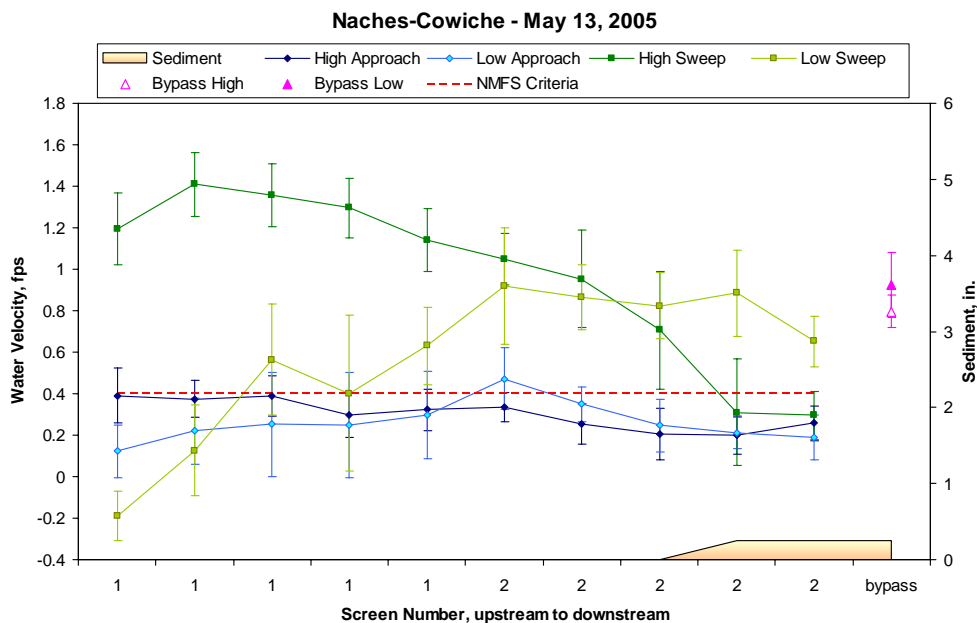
The Naches-Cowiche site was evaluated on May 13, June 30, and September 15, 2005. During each of those visits, average sweep was greater than average approach velocities (Figures 28 through 30). Average bypass velocities were greater than average sweep in May and September but not in June, and average sweep did not increase toward the bypass during any survey. Approach values were within the NMFS criterion 95% of the time at each survey. Bypass flow seemed to move freely over the weir and through the bypass. Because the outfall is in the middle of the river, it can be inspected only when the river is low. The ecology blocks placed around the outfall in 2004 seem to help prevent rocks from blocking the outfall.

Figure 28. Naches-Cowiche water velocities and sediment accumulation, May 2005. Error bars represent turbulence.

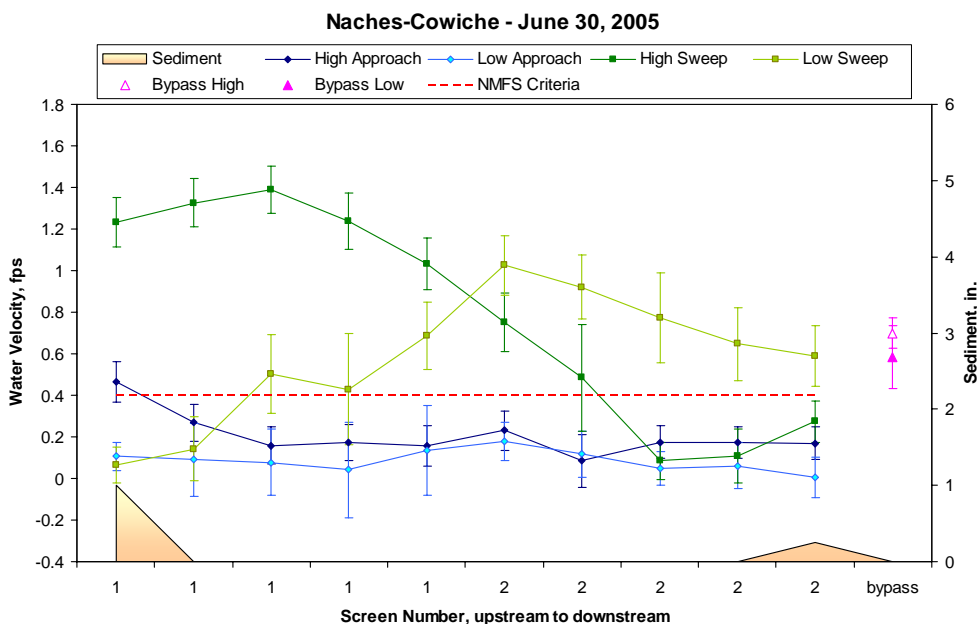
Figure 29. Naches-Cowiche water velocities and sediment accumulation, June 2005. Error bars represent turbulence.

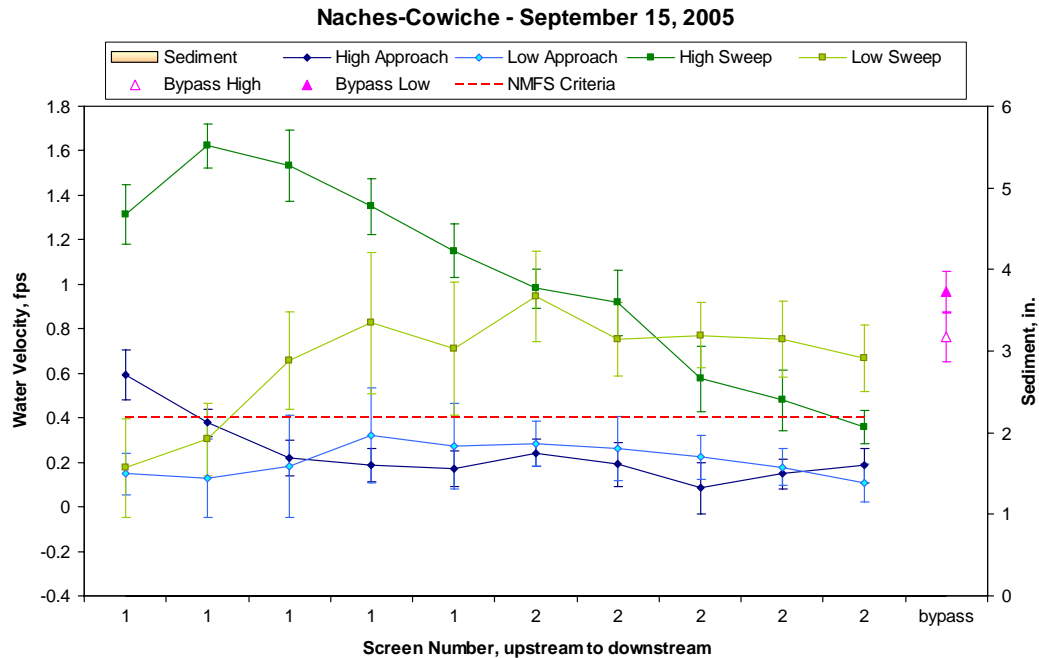
Figure 30. Naches-Cowiche water velocities and sediment accumulation, September 2005. Error bars represent turbulence.

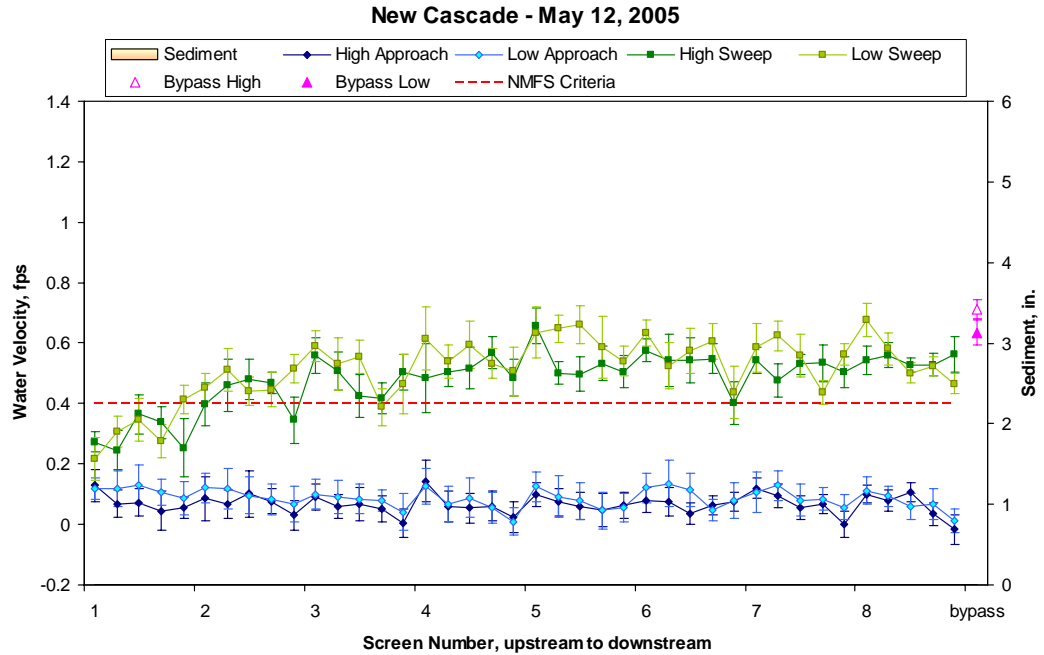
We evaluated the New Cascade site on May 12, June 29, and September 14, 2005. Approach velocities met the NMFS criterion 100, 95, and 100% of the time in May through September (Figures 31 through 33). Sweep velocities always were greater than approach velocities. Bypass velocities always were greater than sweep, which did not increase toward the bypass during any of our surveys.

Figure 31. New Cascade water velocities and sediment accumulation, May 2005. Error bars represent turbulence.

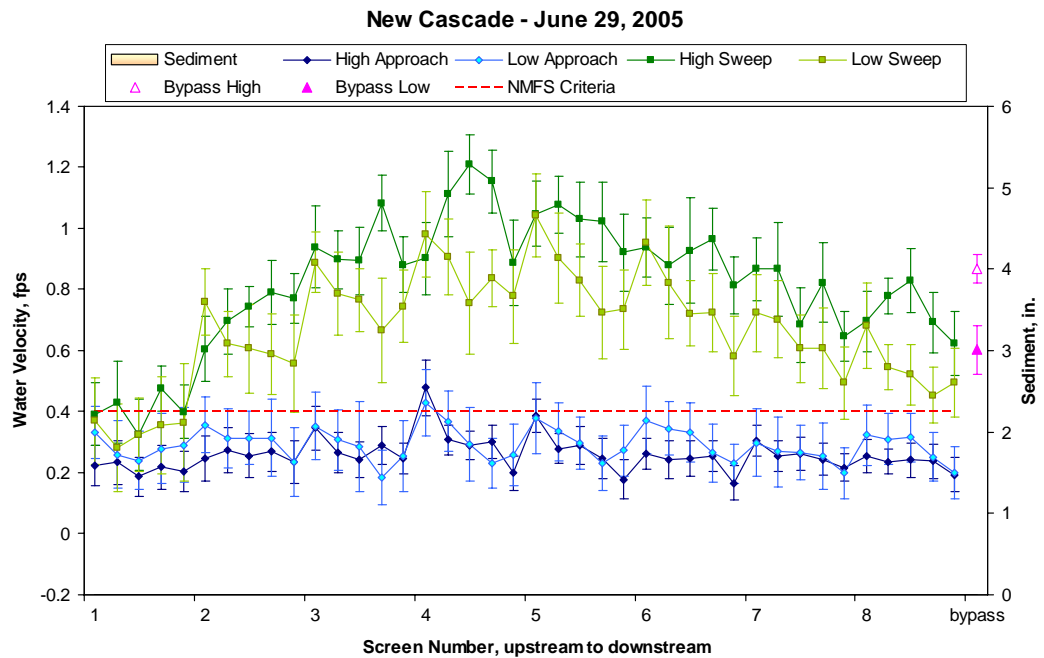
Figure 32. New Cascade water velocities and sediment accumulation, June 2005. Error bars represent turbulence.

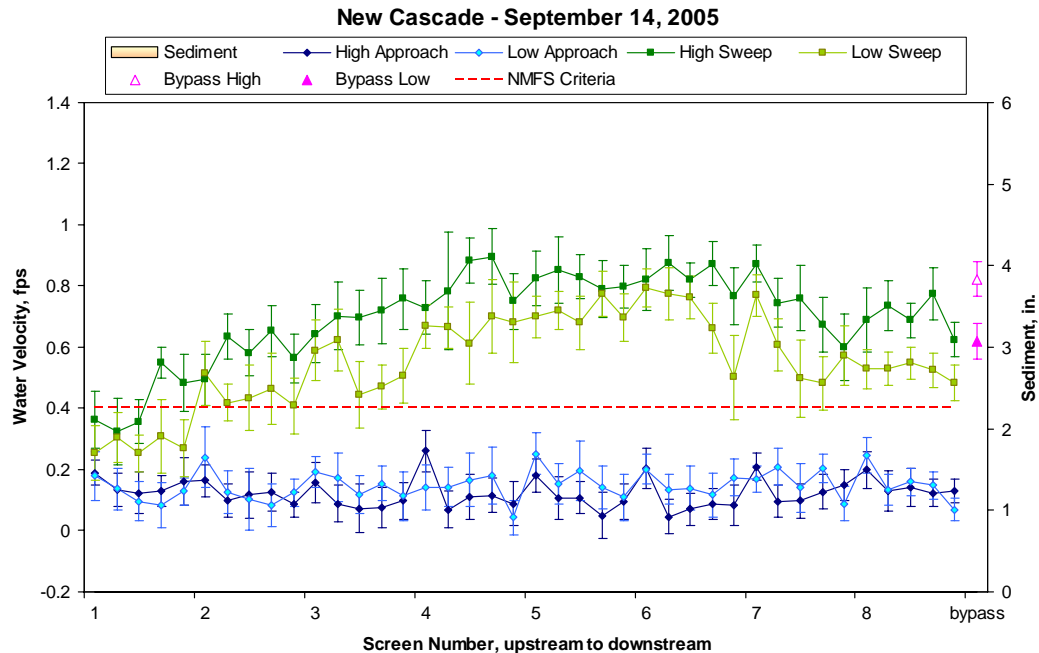
Figure 33. New Cascade water velocities and sediment accumulation, September 2005. Error bars represent turbulence.

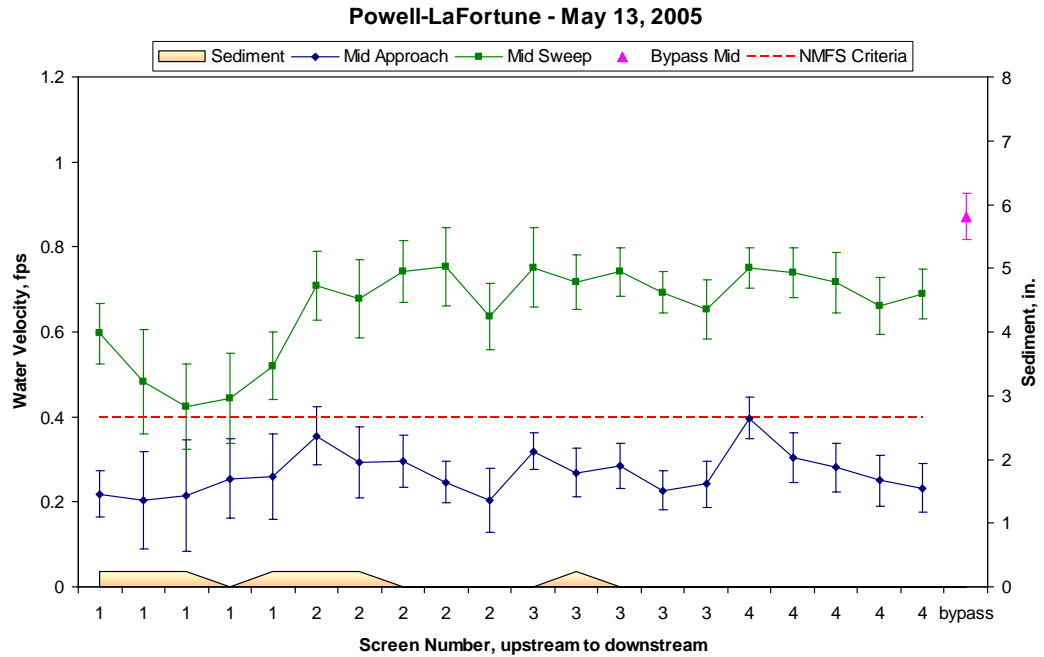
Powell-LaFortune was visited multiple times in 2005, including May 13, June 28 and 30, July 14, and September 15. Velocity measurements were made in May, on June 28, and again in September. All approach measurements met the NMFS criterion, and sweep was always higher than approach velocities (Figures 34 through 36). Sweep did not increase toward the bypass during any of our evaluations and was higher than bypass velocities in June and September.

Figure 34. Powell-LaFortune water velocities and sediment accumulation, May 2005. Error bars represent turbulence.

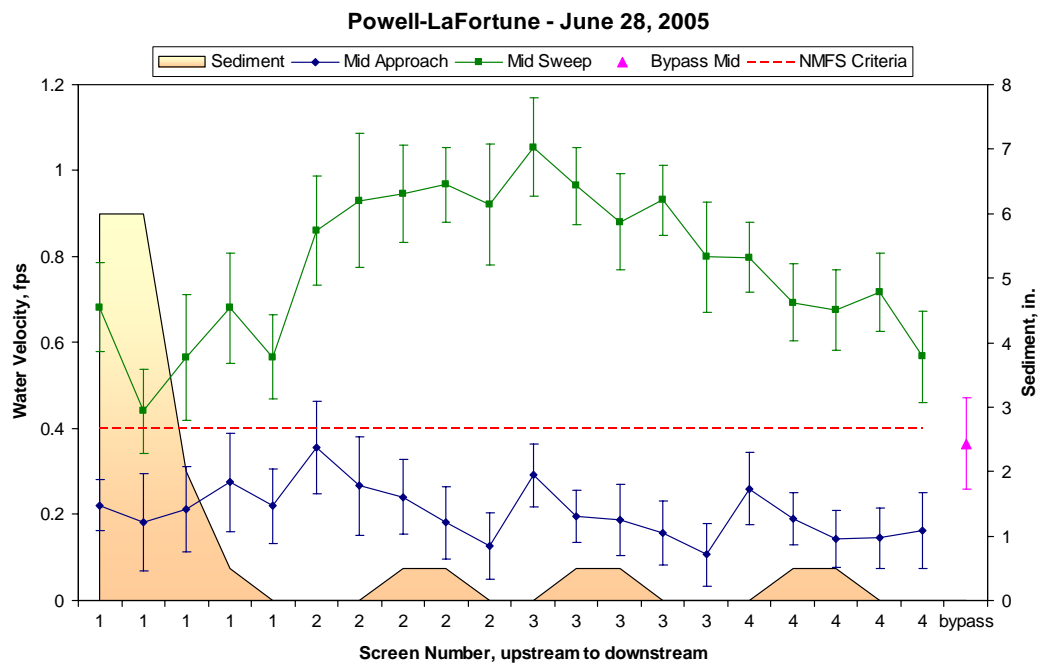
Figure 35. Powell-LaFortune water velocities and sediment accumulation, June 2005. Error bars represent turbulence.

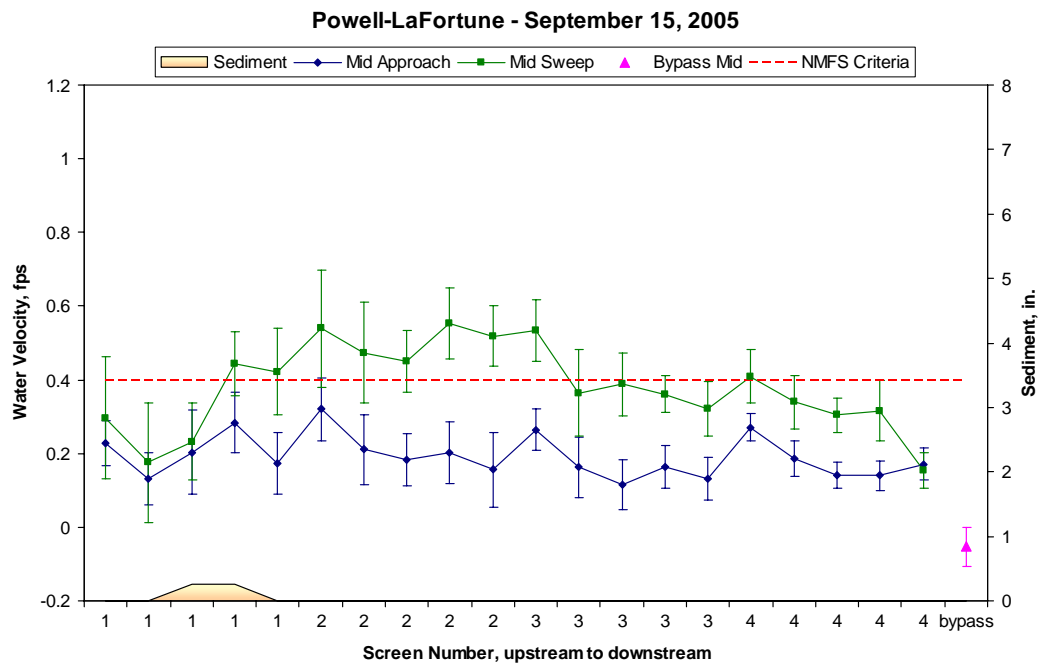
Figure 36. Powell-LaFortune water velocities and sediment accumulation, September 2005. Error bars represent turbulence.

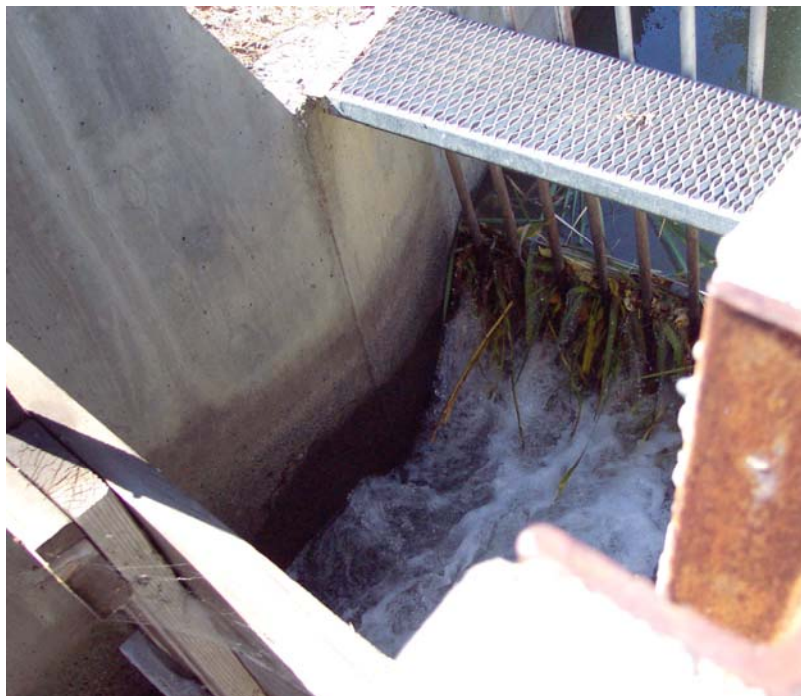
Debris removal at the upstream trash rack has been a problem since the site was put into operation. A lot of vegetation as well as debris and garbage are caught there. The vertical bars of the trash rack are closely spaced. It may be possible to redesign the trash rack to let some of the vegetation and smaller debris pass through, to be caught on the facility trash rack. We recommend considering alternative trash rack designs and working with the irrigation company personnel to improve debris removal.

Figure 37. Upper trash rack at Powell-LaFortune partly blocked with debris. Approximately 12 in. of head loss are visible.

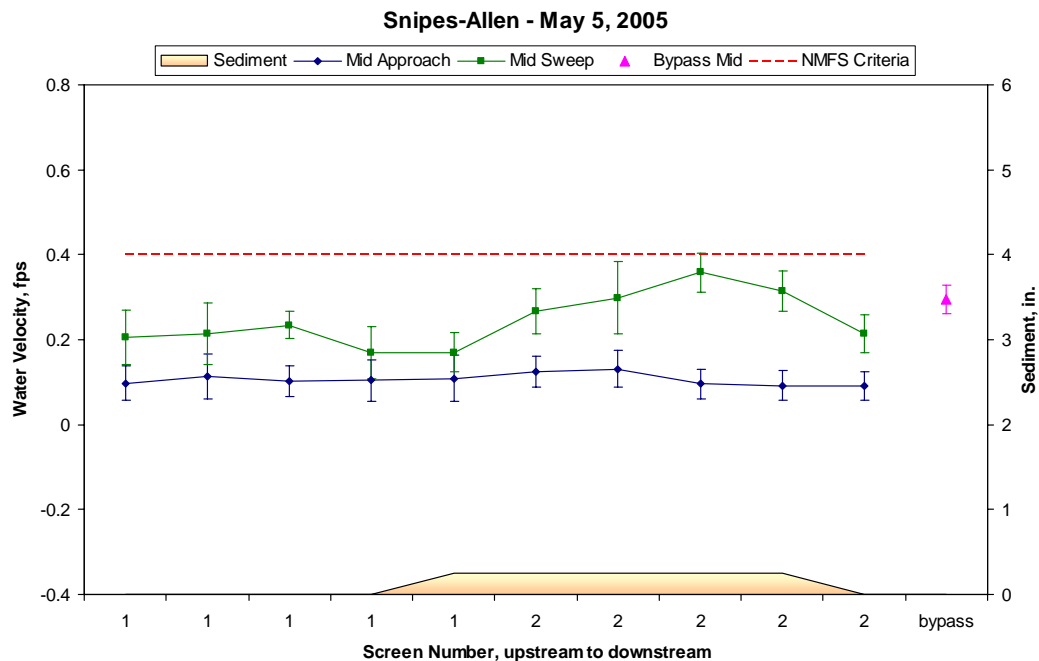
The Snipes-Allen site was inspected on May 5, June 21, and September 20, 2005. All approach velocities were below 0.4 fps, and bypass velocities always were higher than the average sweep velocities, meeting NMFS criteria (Figures 38 through 40). Sweep velocities increased toward the bypass in June and September (slightly) but not in May. Sweep was greater than approach in May and September, but approach was higher in June until the middle of the second screen.

Figure 38. Snipes-Allen water velocities and sediment accumulation, May 2005. Error bars represent turbulence.

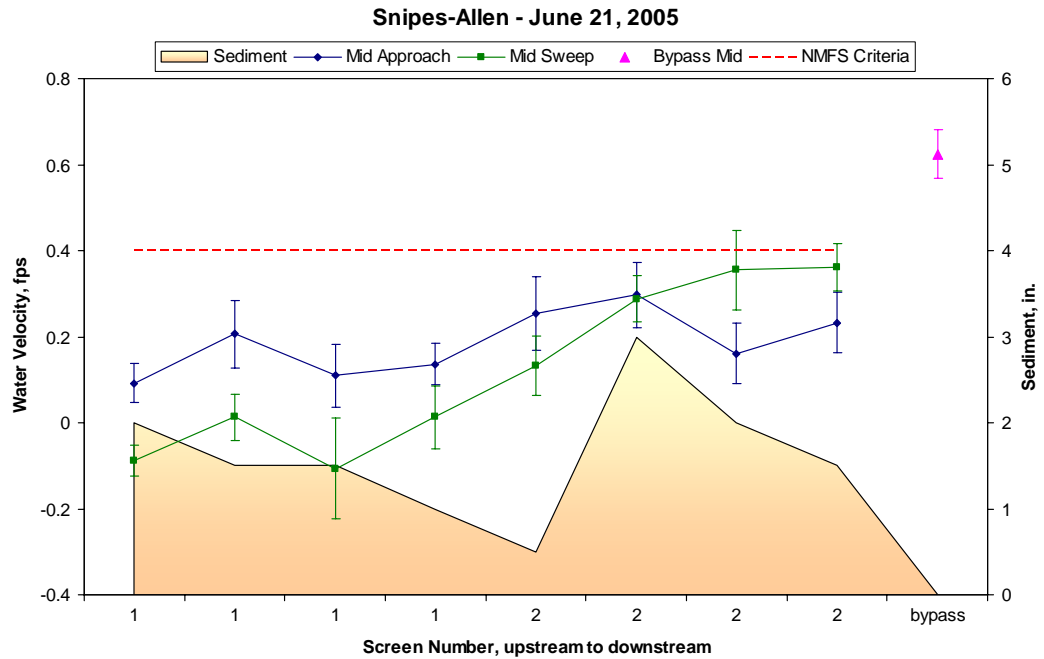
Figure 39. Snipes-Allen water velocities and sediment accumulation, June 2005. Error bars represent turbulence.

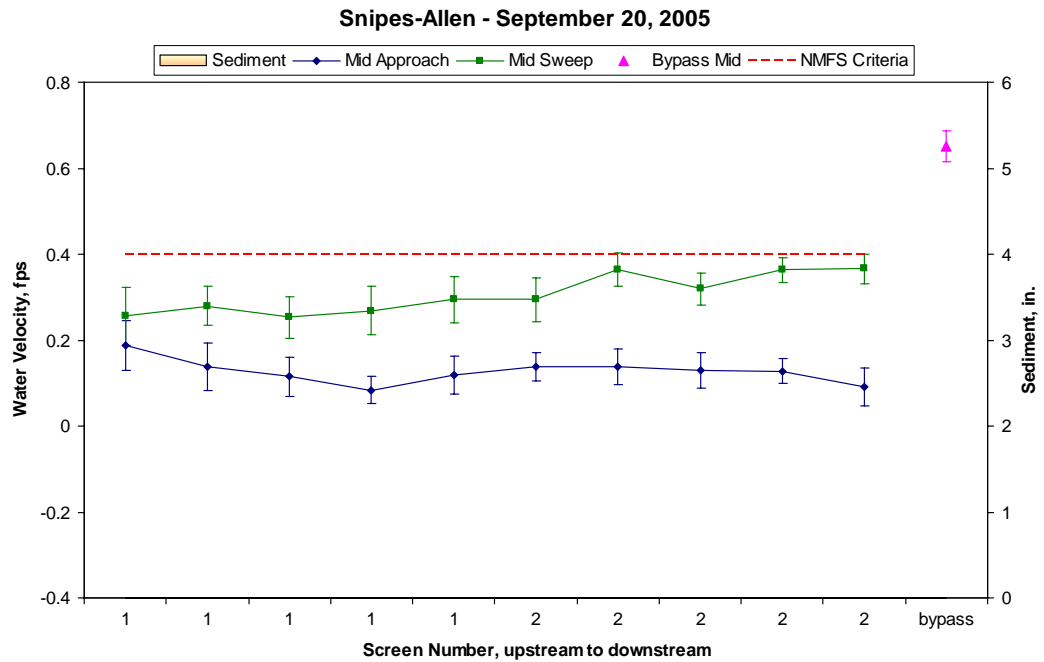
Figure 40. Snipes-Allen water velocities and sediment accumulation, September 2005. Error bars represent turbulence.

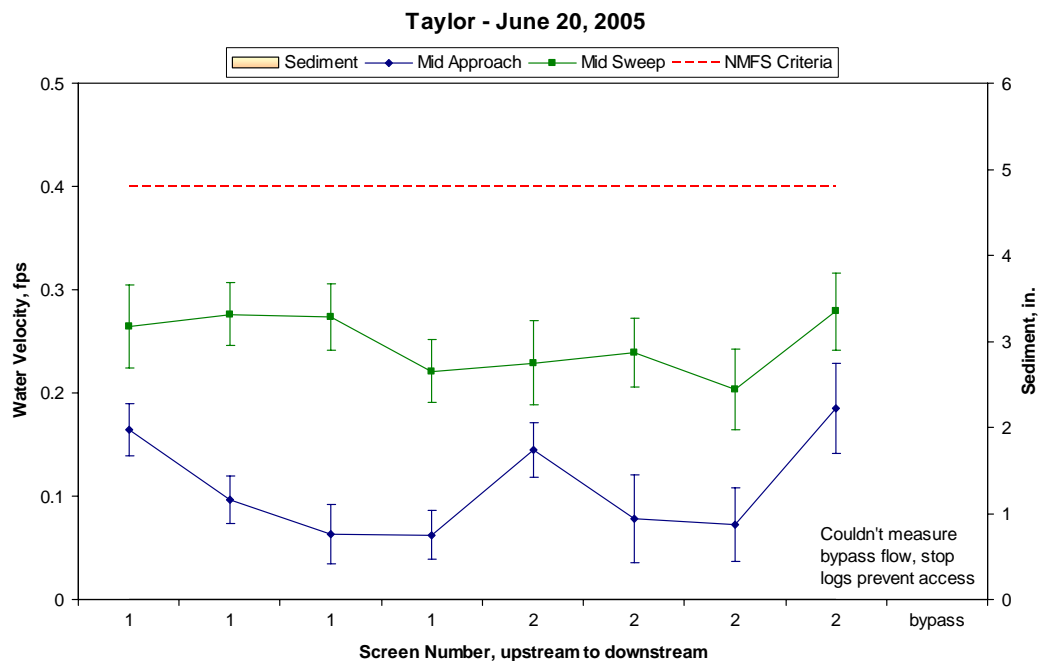
Velocity measurements were not made in May due to low water levels and little flow. Sweep was almost always less than the approach values, although in September, 2 of the 10 sweep values were greater than the approach (Figures 42 and 43). Submergence did not meet the NMFS criterion during any of our visits, although the logbook indicates there were periods in late April and early May when the gravel dams were new and submergence was good. In May, several small dead and dying fish were observed in the forebay. The dying fish were not salmonids and appeared to be diseased.

Figure 42. Taylor water velocities and sediment accumulation, June 2005. Error bars represent turbulence.

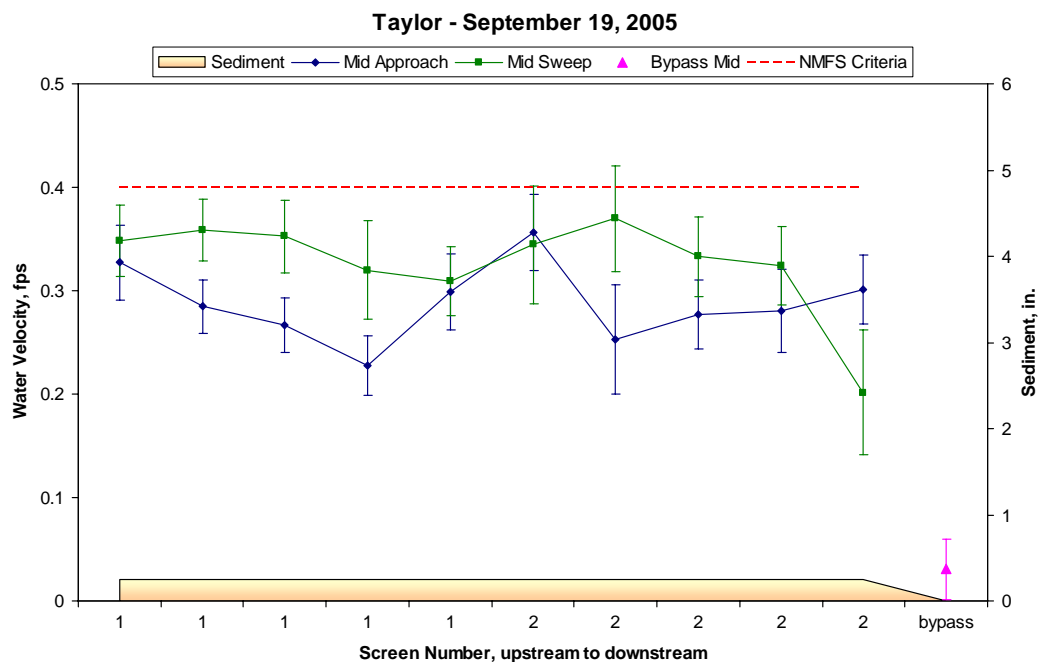
Figure 43. Taylor water velocities and sediment accumulation, September 2005. Error bars represent turbulence.

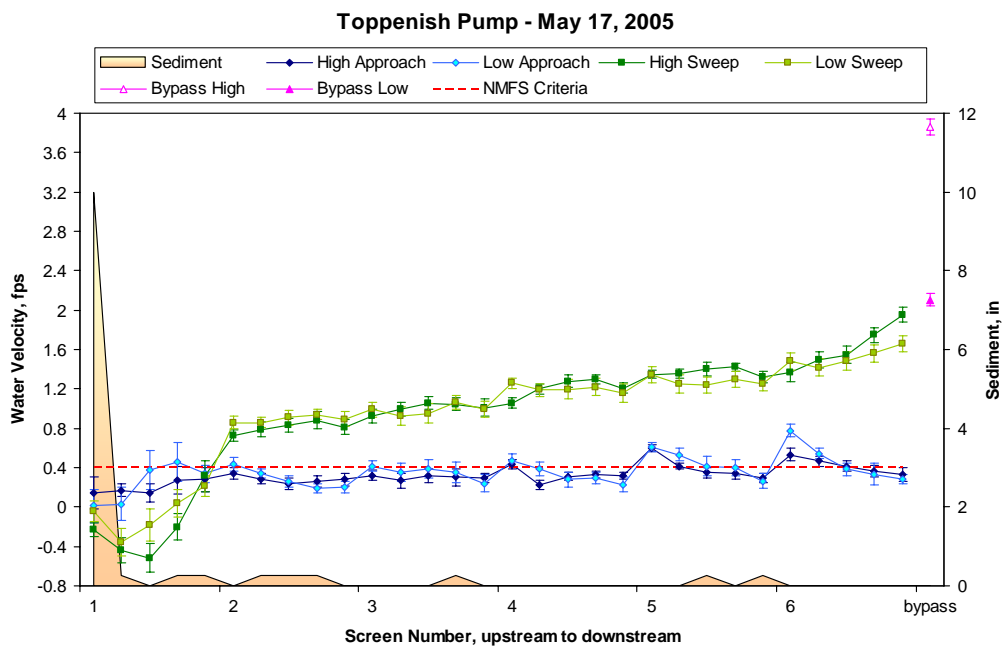
We visited the Toppenish Pump fish screen facility on May 17, June 24, and September 13, 2005. Velocity measurements showed sweep increased toward the bypass in May and September, although not in June (Figures 44 through 46). Bypass velocities always were greater than average sweep velocities. Sweep velocities were also greater than approach velocities except at the upstream end of the site. A large eddy at the upstream end of the facility causes approach values to be significantly higher than sweep for part or all of the first drum. The eddy also drops substantial debris in front of the first screen.

Figure 44. Toppenish Pump water velocities and sediment accumulation, May 2005. Error bars represent turbulence.

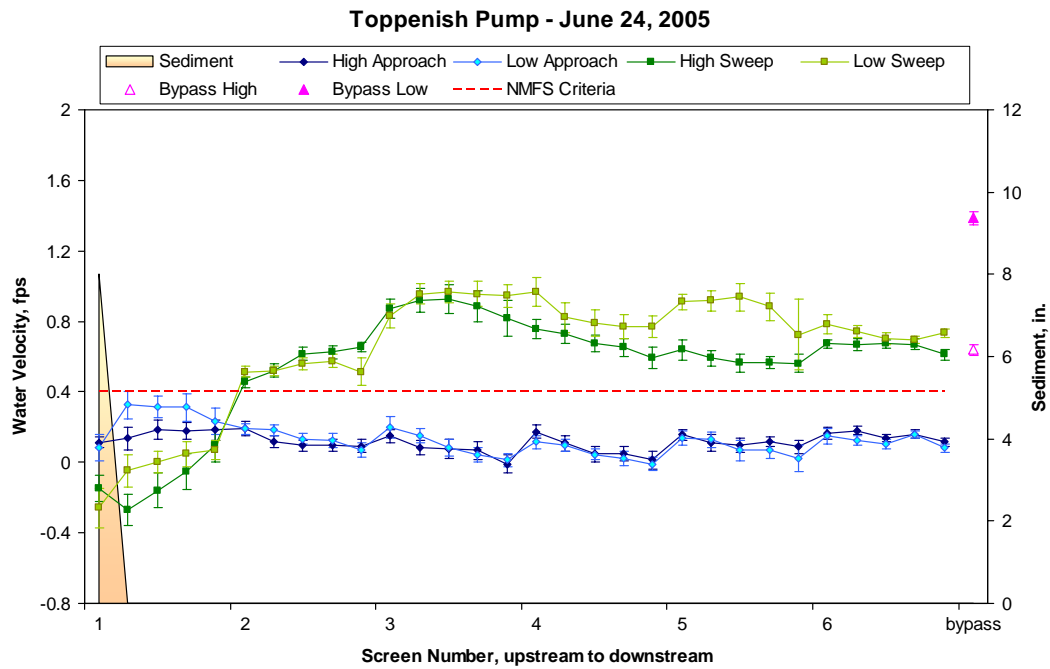
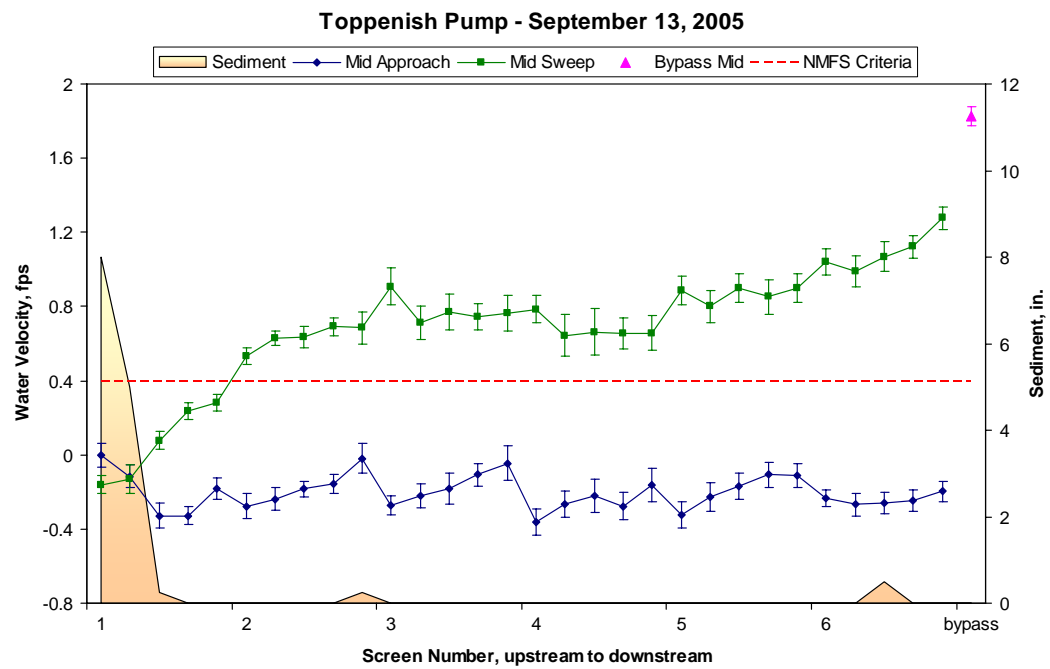
Submergence met the NMFS criterion in May and June (83% and 76%) but was slightly lower (62%) than the criterion of 65% in September. Screen condition was good, with moderate to heavy algae and periphyton buildup in places, an indication that the bottom seals may not fit tightly against the screens anymore. A small outward bow in the upstream seal of screen 5 was noticed; otherwise, side seals were in good condition. Cheeks have not been caulked here, and some of the gaps between the cement and drum frame are 1/2 in. wide. We would recommend caulking these gaps to prevent impingement of juvenile fish.

Figure 45. Toppenish Pump water velocities and sediment accumulation, June 2005. Error bars represent turbulence.

Figure 46. Toppenish Pump water velocities and sediment accumulation, September 2005. Error bars represent turbulence.

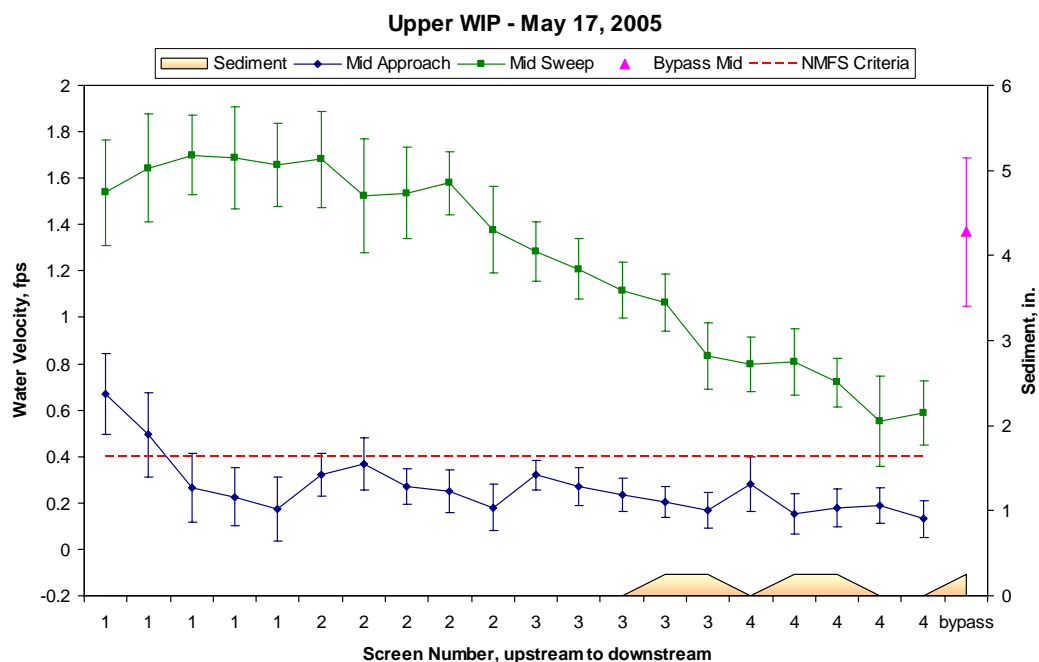
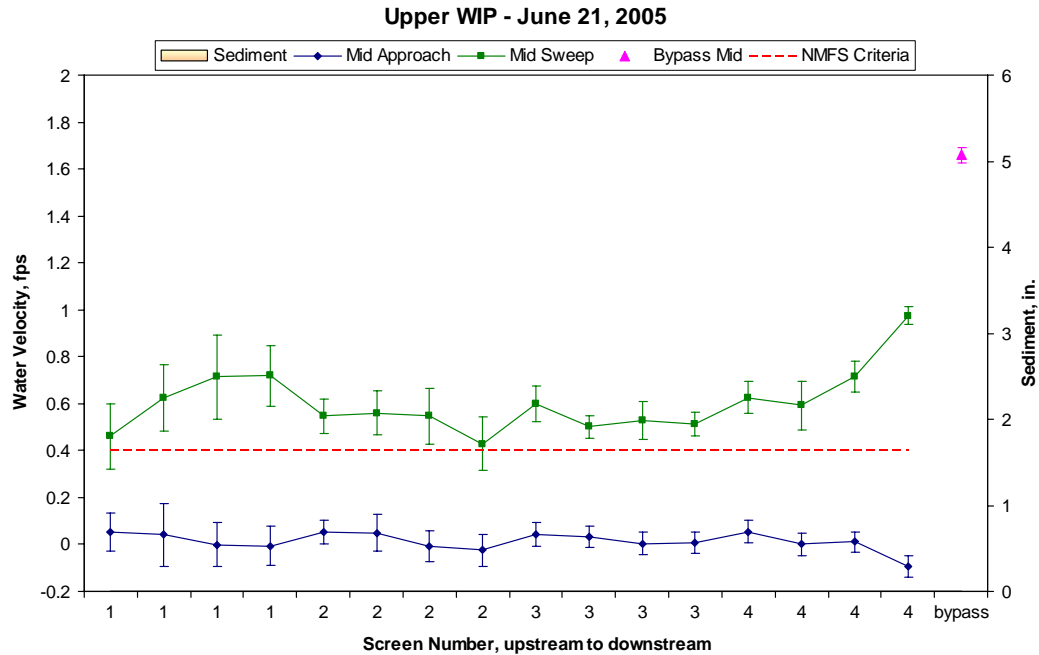
The Upper Wapato Irrigation Project (WIP) site was evaluated on May 17, June 21, and September 22, 2005. The site was shut down for the season before our visit in September. As can be seen in Figures 47 and 48, sweep velocities always were greater than approach values, and bypass velocity always was greater than sweep velocities. In May, sweep decreased toward the bypass. In June, however, the sweep increased slightly toward the bypass. Bypass flow was adequate, and the water depth at the outfall was greater than 1 ft during our surveys.

Because of anticipated low river flows, the ramp and weir were removed from the bypass, and checkboards were used instead at the entrance to the bypass, with water flowing over, under, and between the boards. Submergence was at 55% in May and 65% in June. Screens were in good condition. In June, an outward bow was noticed in the downstream side seal of the second screen, and the seal was replaced by the USBR in August.

Figure 47. Upper WIP water velocities and sediment accumulation, May 2005. Error bars represent turbulence.

Figure 48. Upper WIP water velocities and sediment accumulation, June 2005. Error bars represent turbulence.
