Washington Phase II Fish Diversion Screen Evaluations in the Yakima and Touchet River Basins

Annual Report 2005 - 2006

February 2006

DOE/BP-00000652-31

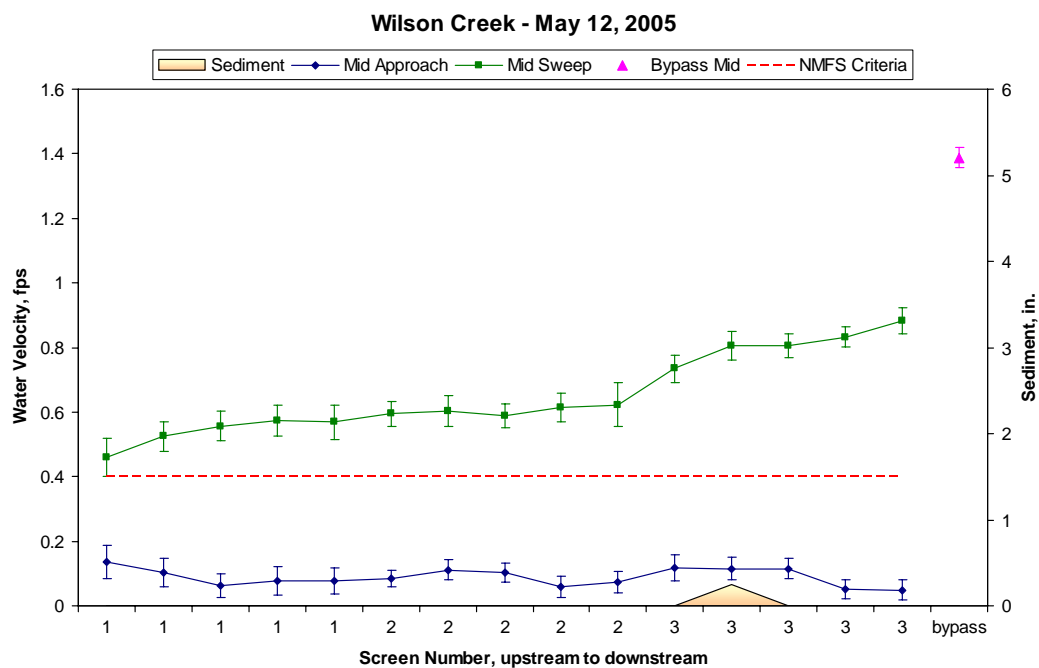
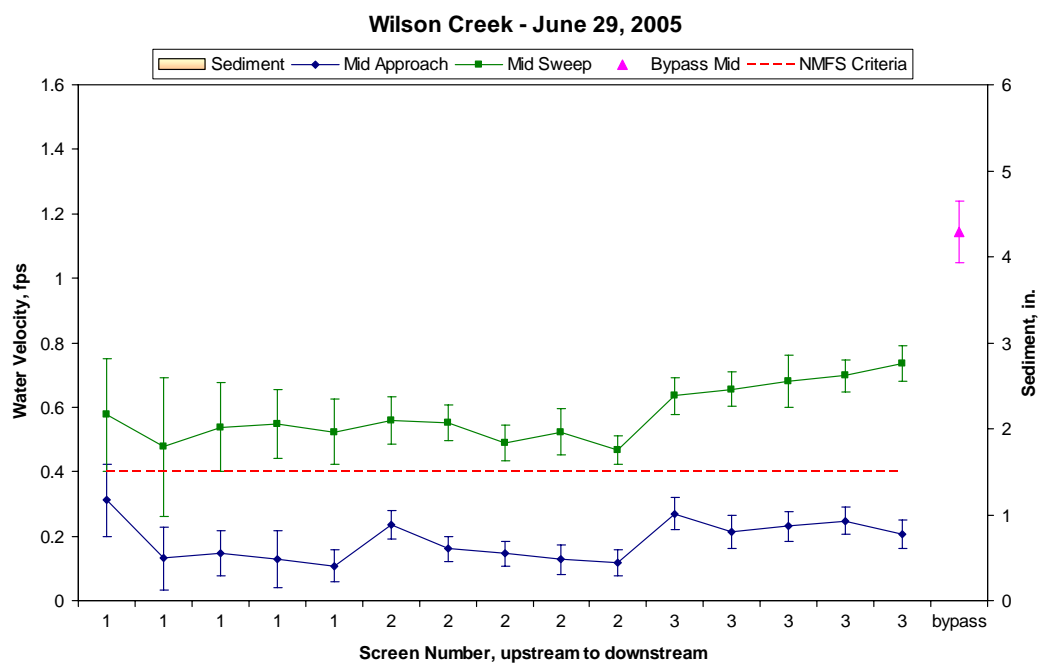
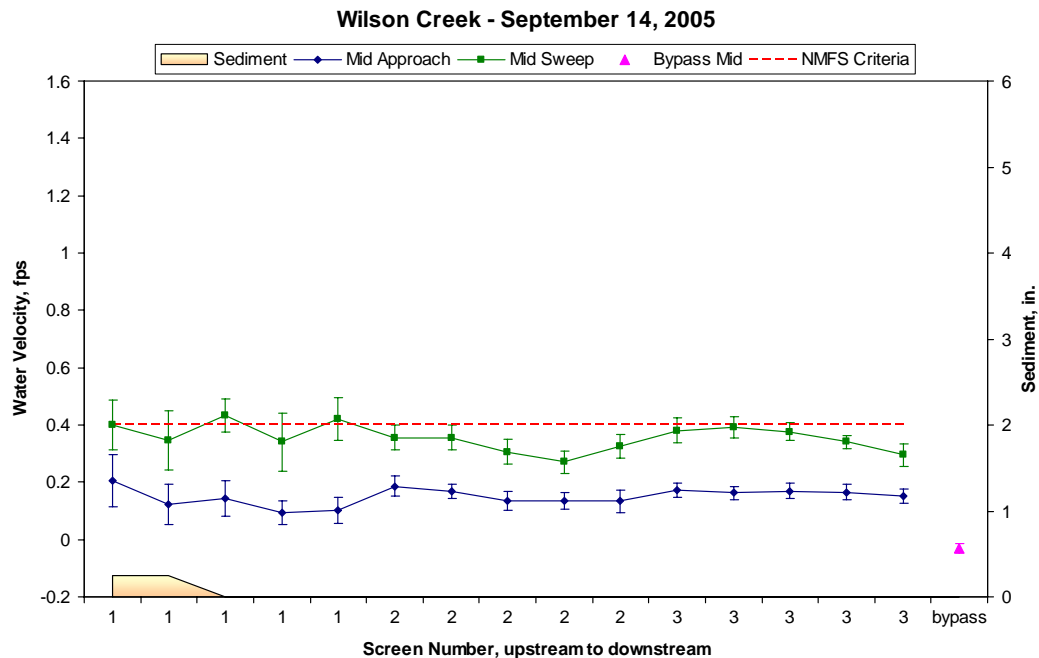
The Wilson Creek fish screen site was evaluated on May 12, June 29, and September 14, 2005. In May and June, sweep velocities were greater than approach velocities, increased slightly toward the bypass, and were less than the bypass velocities (Figure 49). Approach velocities and submergence met NMFS criteria during both surveys. In September, however, all flow through the head channel was moving through the screens, with no flow through the bypass, fish ladder, or checkdam. This led to a negative value for the bypass flow as water eddied into the bypass entrance and back out again. Submergence was only 55% in September. We contacted WDFW staff about the low water at this site, which they thought was just low water levels in general and could not be changed.

Screen and seal condition was good during all surveys. Caulking along the cheeks was still functional but is starting to deteriorate in places. Bypass conditions were conducive to the safe passage of fish in May and June. There was much less plant debris accumulation in the forebay this year compared to previous years.

Figure 49. Wilson Creek water velocities and sediment accumulation, May 2005. Error bars represent turbulence.

Figure 50. Wilson Creek water velocities and sediment accumulation, June 2005. Error bars represent turbulence.

Figure 51. Wilson Creek water velocities and sediment accumulation, September 2005. Error bars represent turbulence.

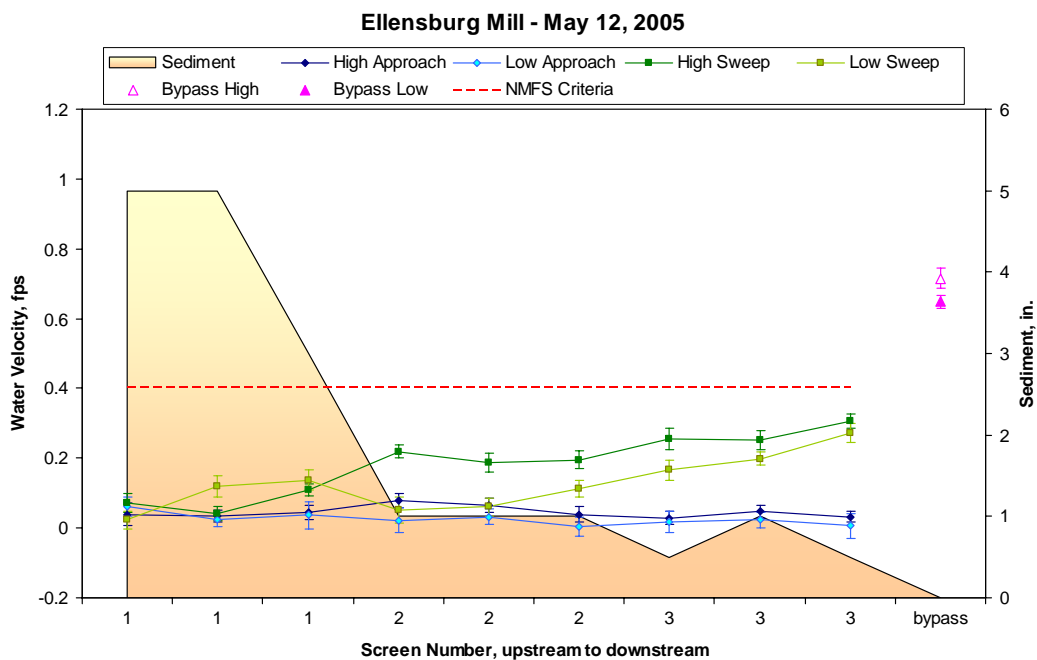
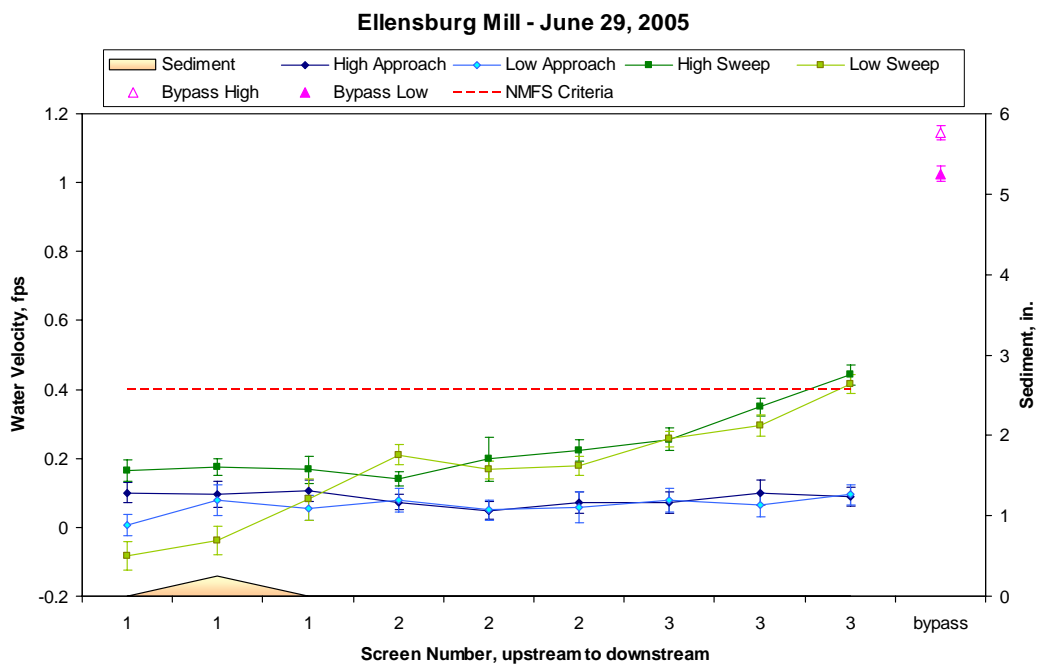
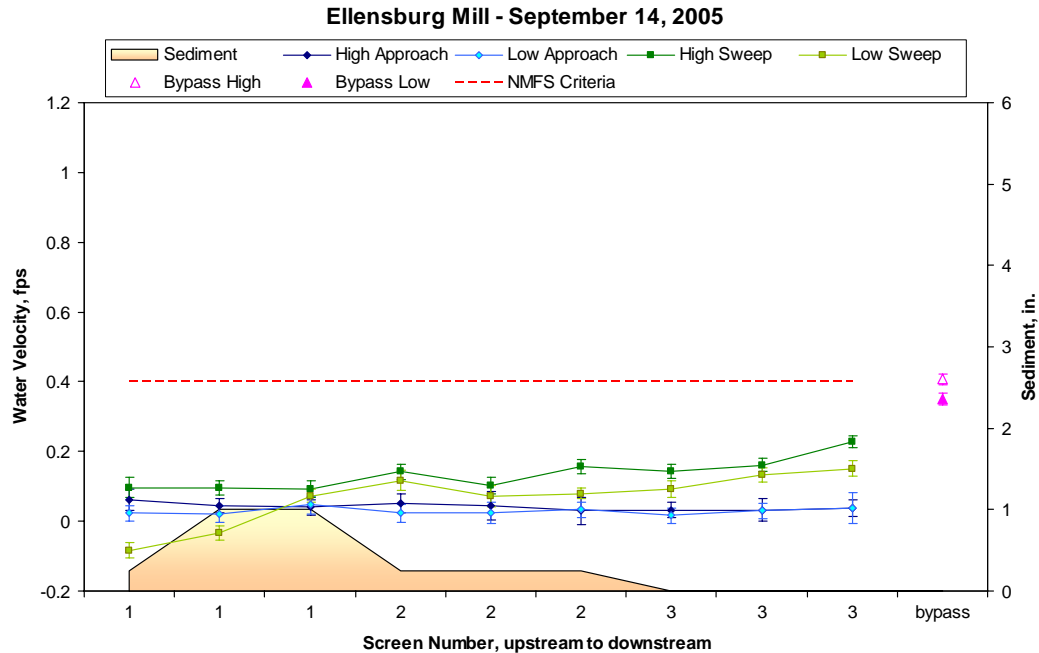
The Ellensburg Mill site was inspected on May 12, June 29, and September 14, 2005. Approach velocities were fairly low, as is usual for this site, and easily below the NMFS criterion during each of our inspections (Figures 52, 53, and 54). Sweep was generally greater than approach except the lower measurements at screen 1, which were lower than approach velocities. Sweep velocities increased toward the bypass, and bypass velocities were always greater than the sweep velocities.

Boards were set across the bottom of the entrance to the forebay, just downstream of the trash rack, in an effort to reduce the amount of sediment entering the forebay. Sediment in front of the first screen was relatively high in May but may have been there before the boards were put in place. The WDFW cleared the silt out of the forebay on June 16, and the site was still very clean on June 29. In fact, June was one of the first times we could see all the fish, primarily chiselmouth, congregating in the forebay before spawning. More than 20 whitefish or dace were seen in the forebay in May, and 50 or more yellow perch were seen in September.

Figure 52. Ellensburg Mill water velocities and sediment accumulation, May 2005. Error bars represent turbulence.

Figure 53. Ellensburg Mill water velocities and sediment accumulation, June 2005. Error bars represent turbulence.

Figure 54. Ellensburg Mill water velocities and sediment accumulation, September 2005. Error bars represent turbulence.

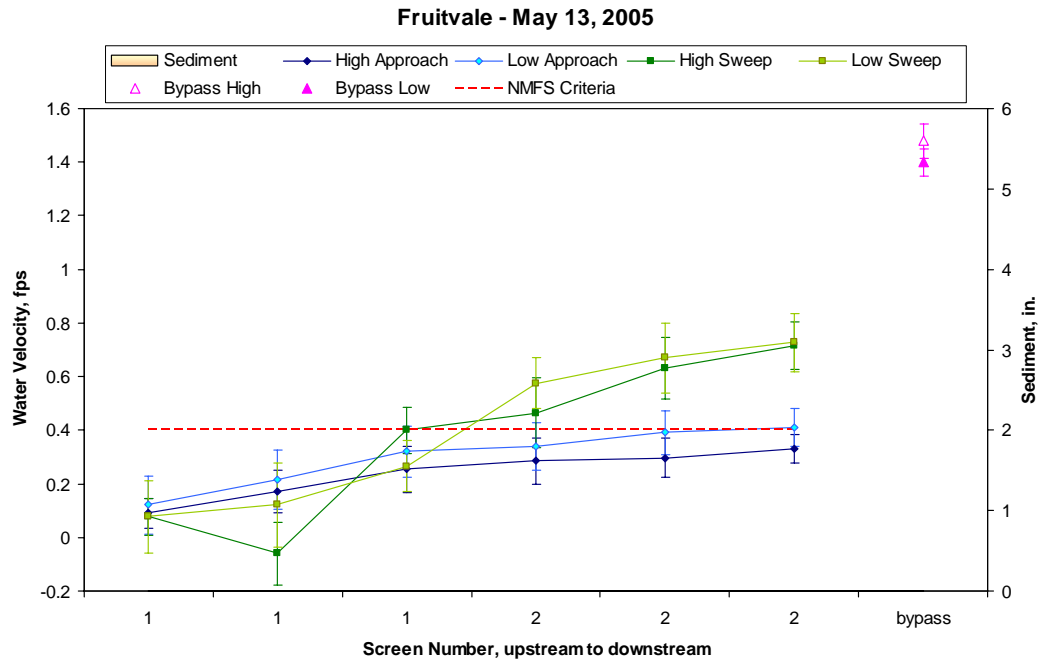
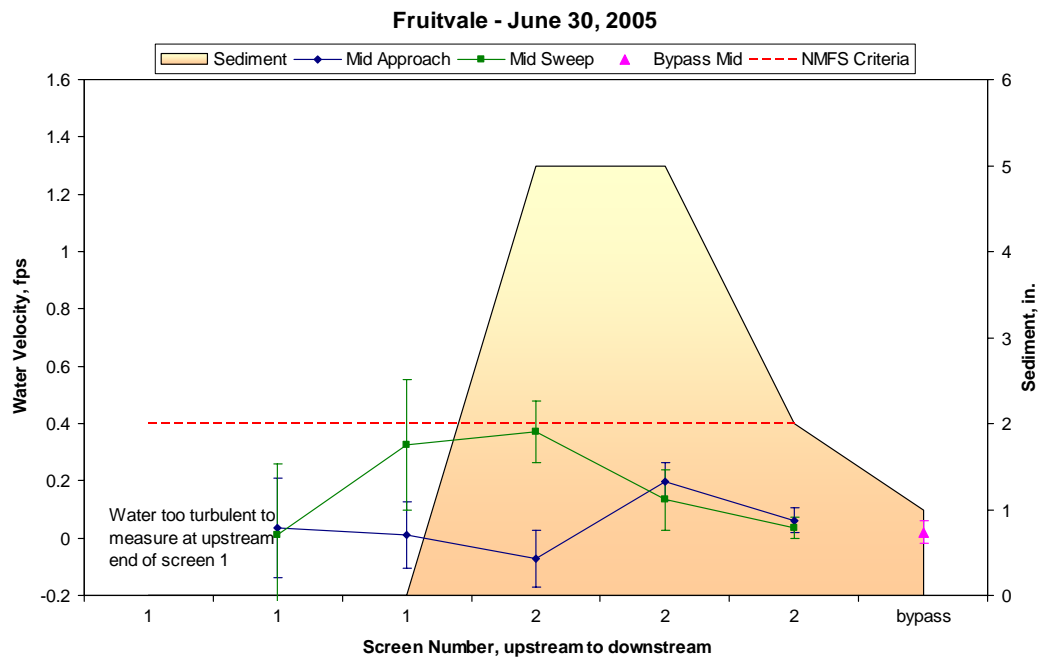
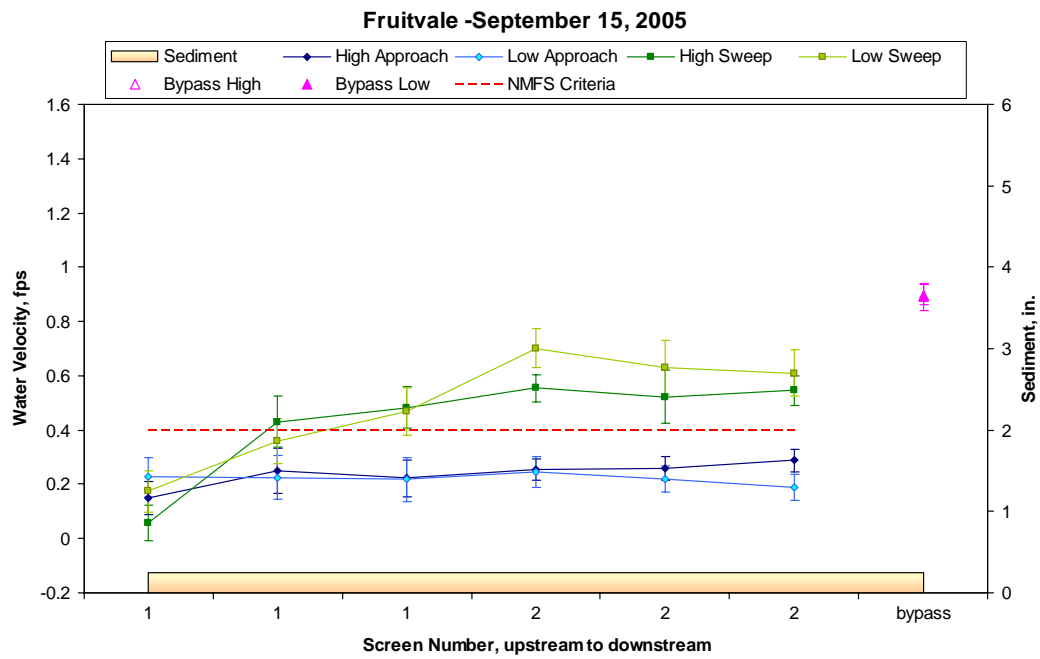
The Fruitvale site was inspected on May 13, June 30, and September 15, 2005. Approach velocities met the NMFS criterion 92, 100, and 100% of the time in May, June, and September, respectively (Figures 55, 56, and 57). Sweep values were less than approach values at the upstream end of the first screen during each inspection as well as at the downstream end of the second screen in May. Bypass velocities were higher than sweep in May and September, but there was no bypass flow in June. Sweep increased toward the bypass in May and September as well, but not in June.

Figure 55. Fruitvale water velocities and sediment accumulation, May 2005. Error bars represent turbulence.

Figure 56. Fruitvale water velocities and sediment accumulation, June 2005. Error bars represent turbulence.

Figure 57. Fruitvale water velocities and sediment accumulation, September 2005. Error bars represent turbulence.

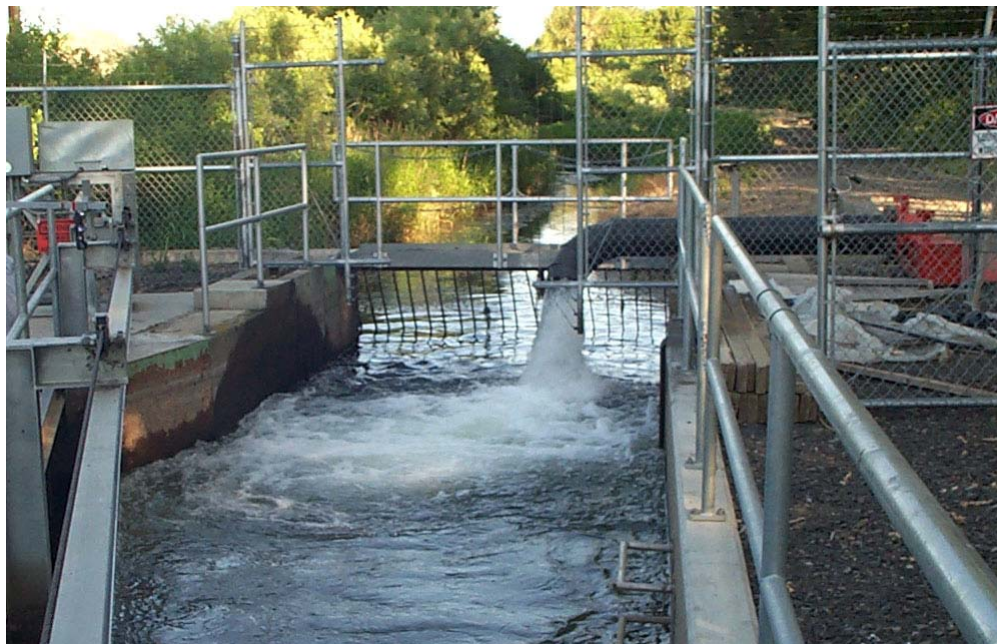
In June, river levels were low, the main channel had shifted away from the diversion dam, and the City of Yakima was not allowed to push its dam any further out into the river. The city installed a large pump in the aftbay at the nearby Old Union screen site and pumped water into the forebay at Fruitvale (Figure 58). This brought submergence up to 55%, but that was not enough submergence to allow bypass flow. Flow in the forebay was very turbulent, especially at the upstream end (Figure 56). We notified the WDFW of the lack of bypass flow and the fact that juvenile salmonids were found in the forebay. This led to a biological evaluation of the site and its operations to determine whether there was danger to juvenile fish. Fishery biologists indicated the channel leading to Fruitvale is good salmonid rearing habitat and that fish would be safe in that channel as long as no threats were caused by debris buildup at the screens themselves. The WDFW opened the flushgate periodically to allow fish in the forebay to move out. At some point in late August or early September, the pump was removed from Old Union aftbay. Normal operation of Fruitvale had resumed by the time we visited the site on September 15.

Figure 58. Water being piped in from the Old Union screen site into the Fruitvale forebay. View upstream from bypass.

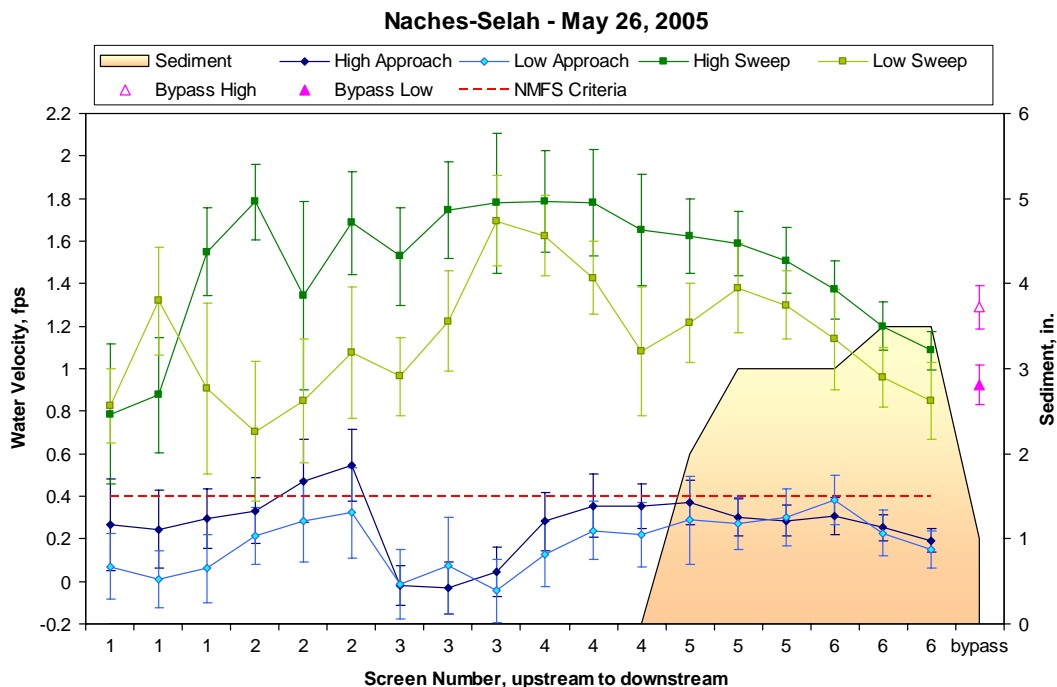
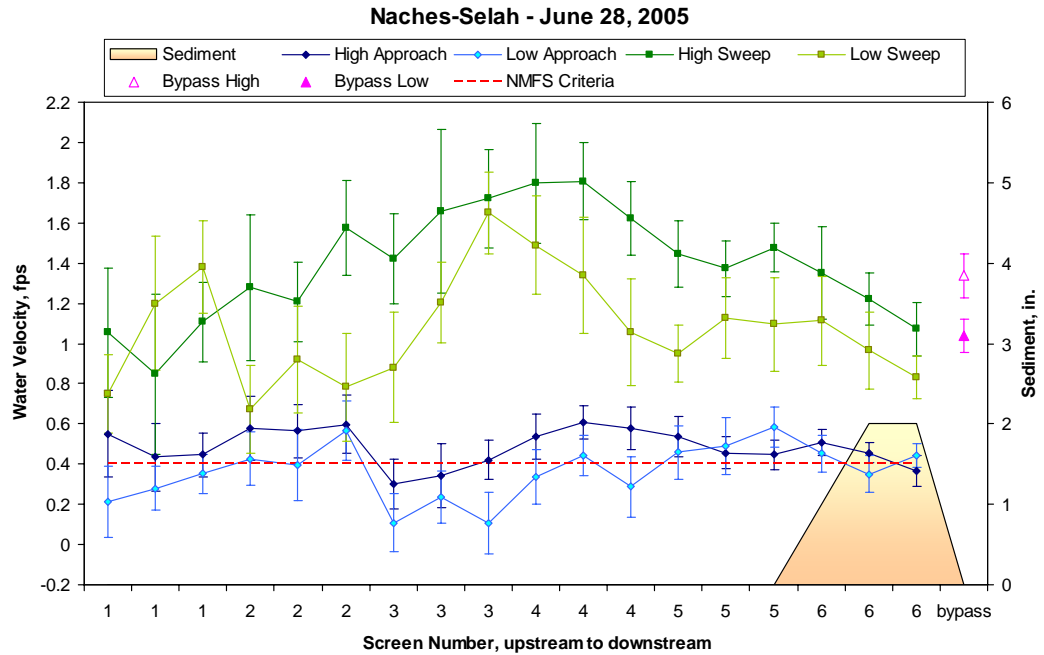
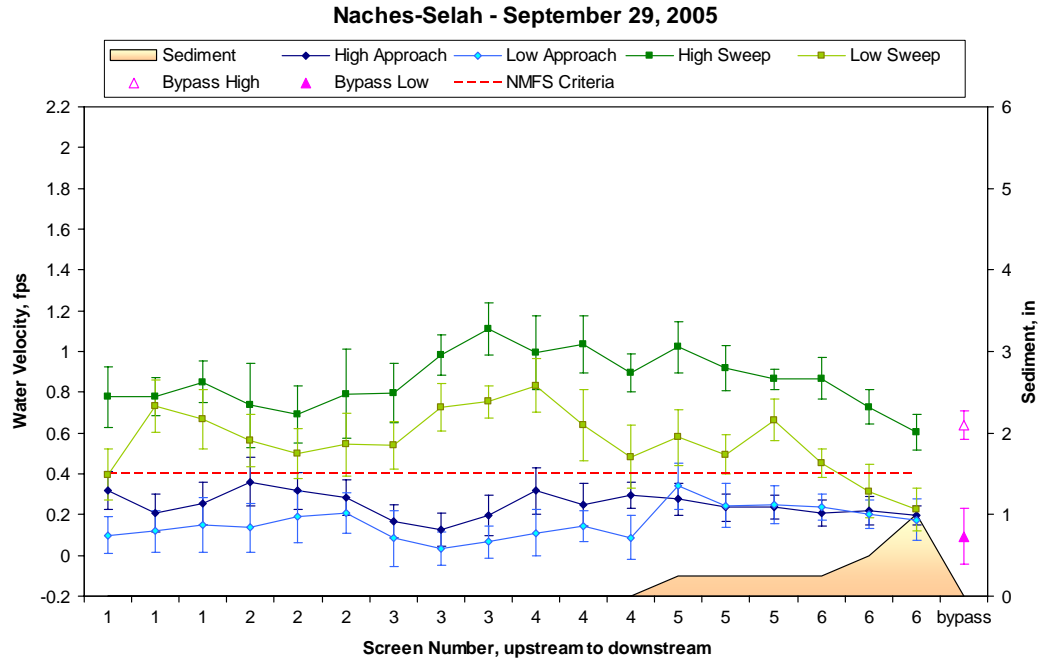
The Naches-Selah site was evaluated on May 26, June 28, and September 29, 2005. Sweep velocities always were higher than approach velocities but did not increase toward the bypass (Figures 59, 60, and 61). Bypass velocities were always less than the average sweep. Approaches met the NMFS criterion 94, 36, and 100% of the time in May, June, and September, respectively. Submergence and depth of water over the weir were essentially the same in May and June, and canal flows were slightly higher in May (124.7 cfs versus 123.1 cfs). However, the approach values were markedly different between these two evaluations. The only difference we found was a slight increase in head loss across the screen in June, with the differences between forebay and aftbay gages 0.05 in May and 0.13 in June. The NMFS (1995) recommends cleaning screens when head differentials of 0.1 are reached, to prevent approach hot spots. Brushes were set to run with a 7-minute delay on this date, and the screens looked clean. We notified WDFW staff of the high approach values on June 28, but they felt the site was running as designed and there was nothing more to be done. High approach values have been a consistent problem for the Naches-Selah site in the past. In 2006, we would like to look at design flows for the diversion and bypass as well as the operating procedures for the screens at this site, and work together with WDFW personnel to see whether changes to louver positions or other facility settings can be made to keep the site within criteria.

Screen condition was good throughout the year. Seal condition also was good, although what appeared to be significant deterioration of the cement beneath the bottom seal could be seen in two places. The WDFW has been notified of these potential problem areas. Juvenile salmonids were abundant in the forebay during each of the surveys this year.

Figure 59. Naches-Selah water velocities and sediment accumulation, May 2005. Error bars represent turbulence.

Figure 60. Naches-Selah water velocities and sediment accumulation, June 2005. Error bars represent turbulence.

Figure 61. Naches-Selah water velocities and sediment accumulation, September 2005. Error bars represent turbulence.

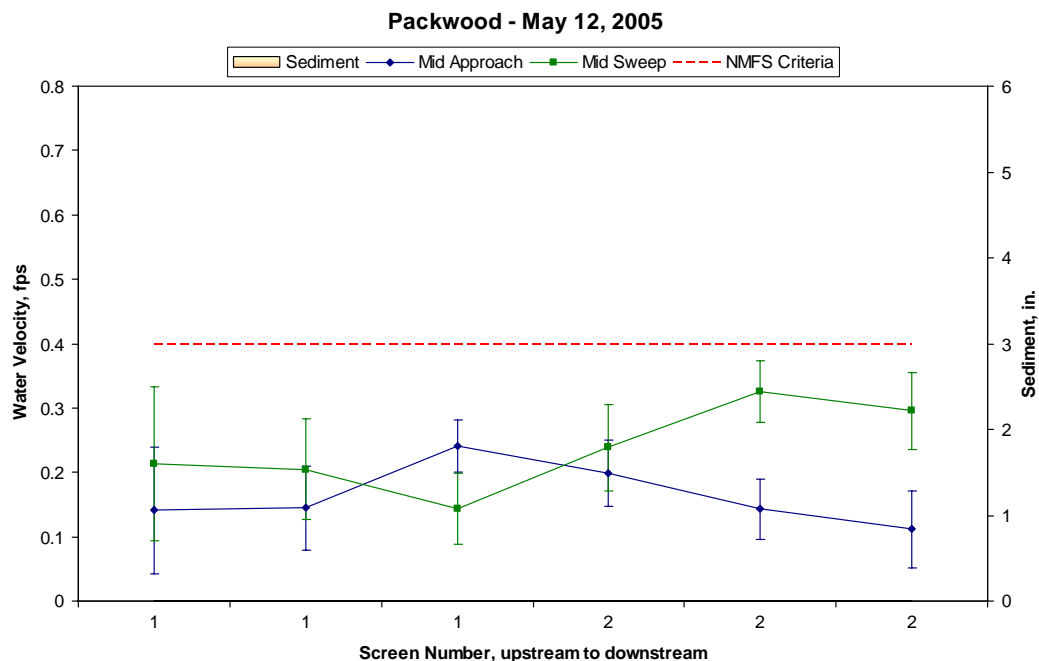
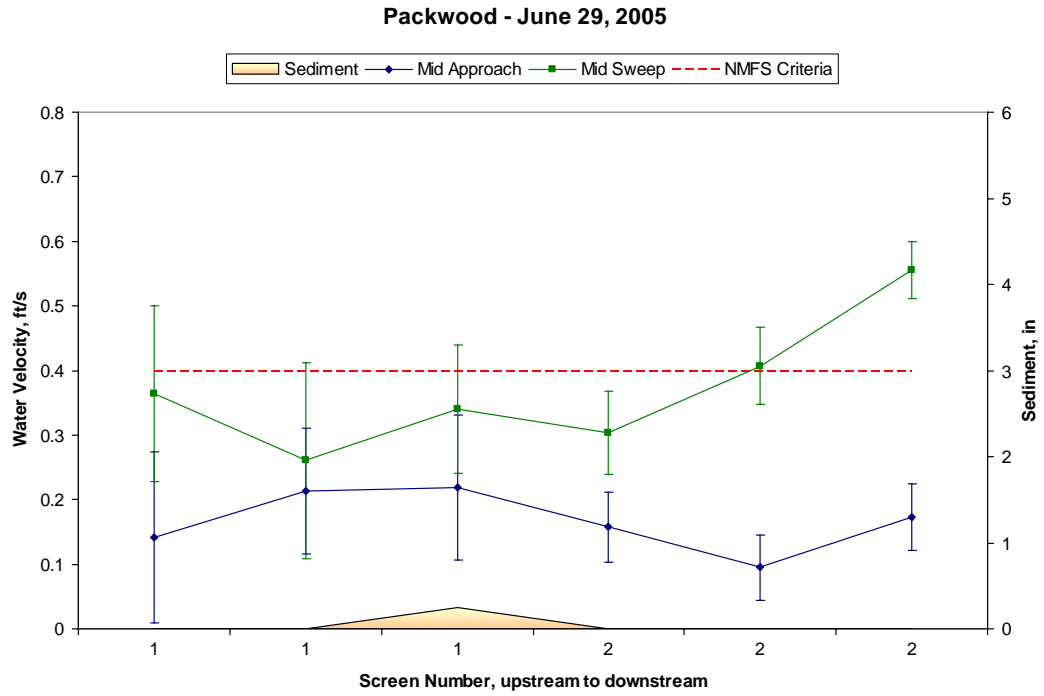
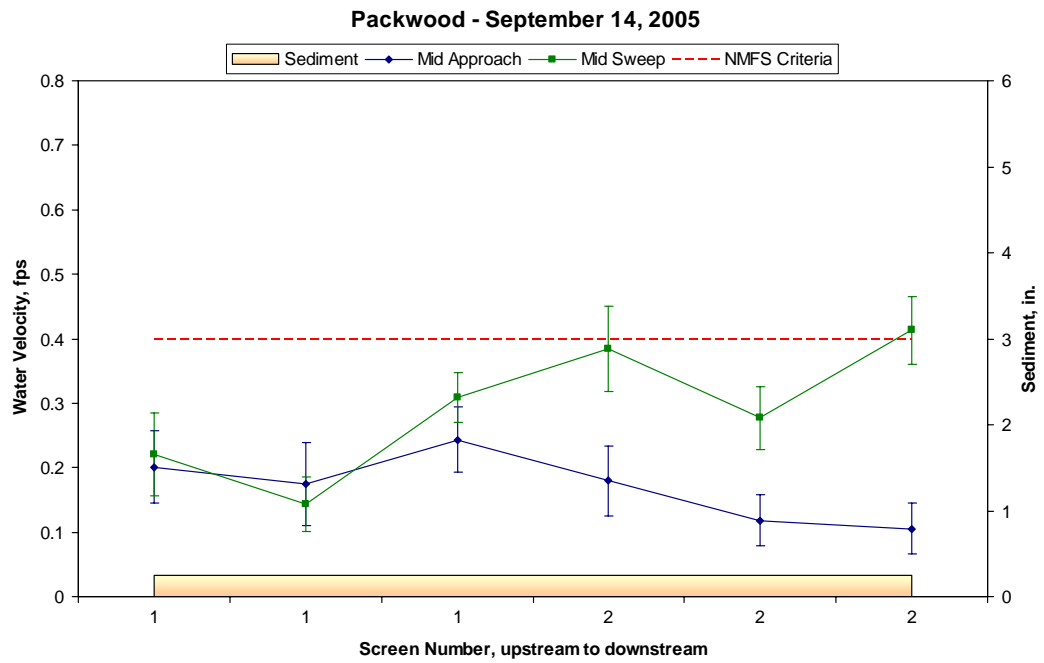
Sweep increased toward the bypass during every visit (Figures 62, 63, and 64). Sweep was greater than approach 83, 100, and 83% of the time in May, June, and September, respectively. Approach velocities always were below the NMFS criterion of 0.4 fps. The bypass was generally clear of debris and had adequate flow over the weir to provide fish passage. The mouth of the outfall channel had a significant amount of woody debris all the way across, which could prevent adult fish from moving into the river. The WDFW removed this debris at least once in 2005, but it builds back up over time. This should be watched to ensure fish of all sizes can move safely back to the river.

Figure 62. Packwood water velocities and sediment accumulation, May 2005. Error bars represent turbulence.

Figure 63. Packwood water velocities and sediment accumulation, June 2005. Error bars represent turbulence.

Figure 64. Packwood water velocities and sediment accumulation, September 2005. Error bars represent turbulence.

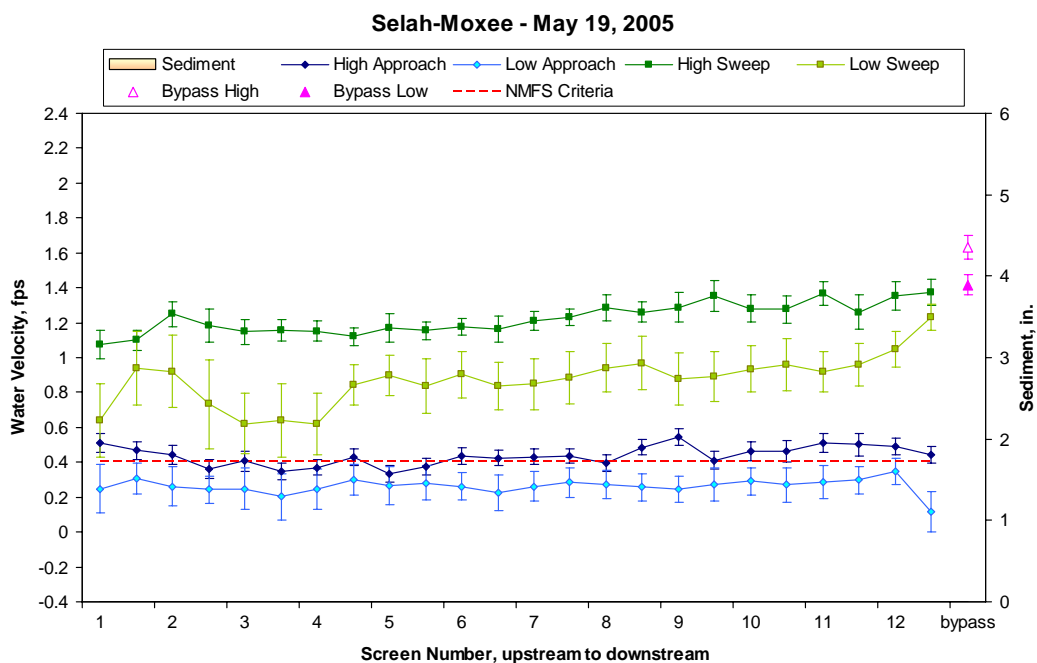
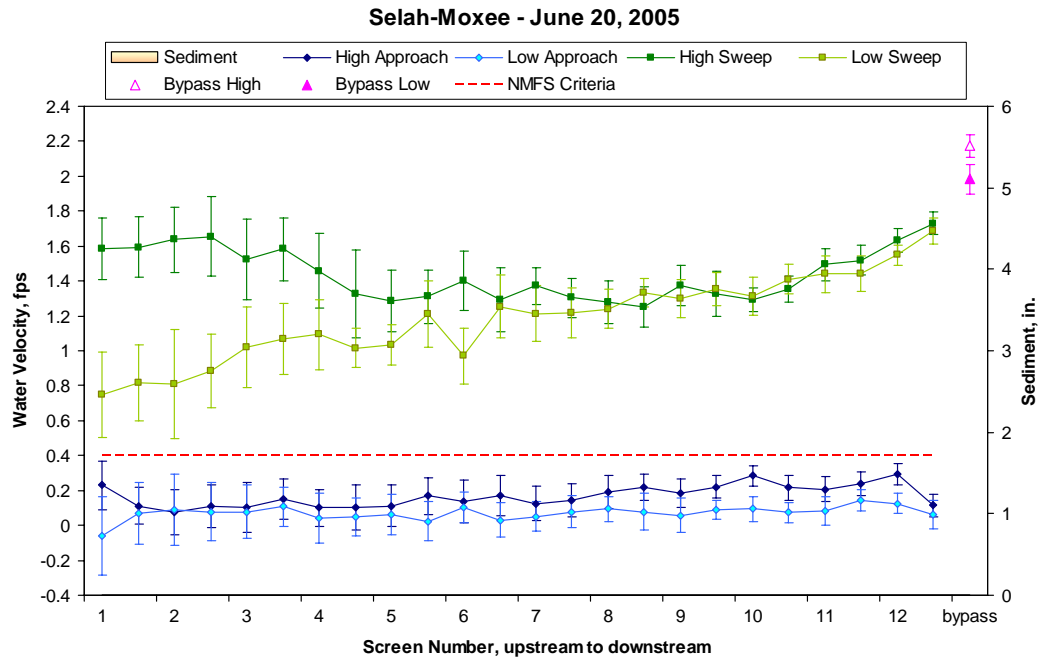
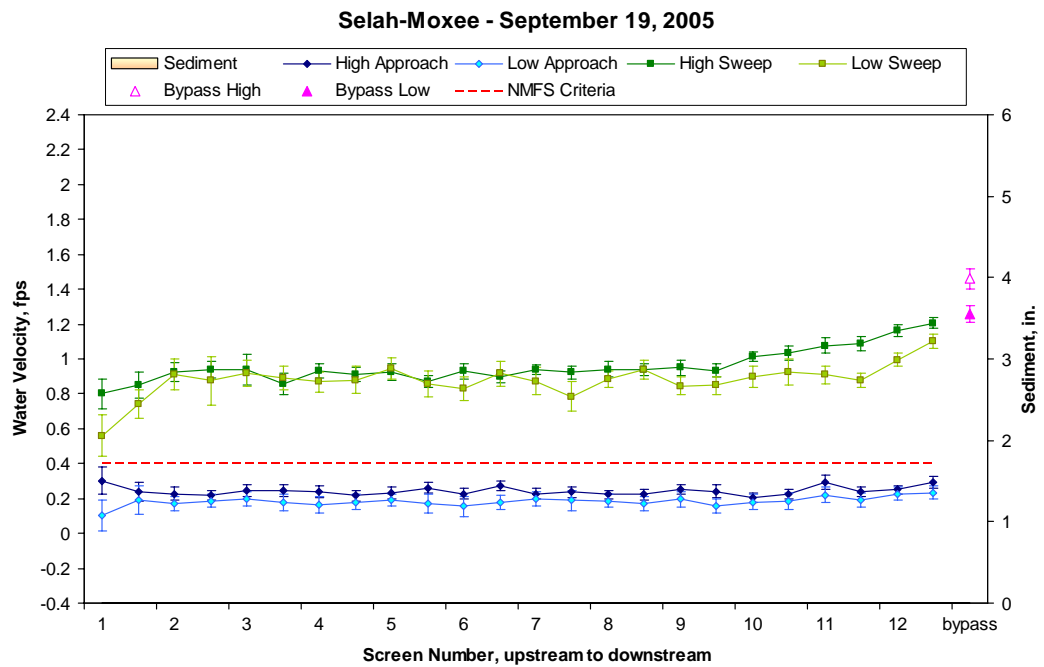
This site was inspected on May 19, June 20, and September 19. Sweep velocities always were higher than approach values and increased slightly toward the bypass in May and September (Figures 65, 66, and 67). In May, 63% of the approach values were below the NMFS criterion, with all the high approach values in the higher part of the water column. There was abundant aquatic plant growth in the forebay in May, and we feel this slowed water in the lower part of the water column, forcing the water to move more quickly in the upper water column. We notified WDFW personnel of the high approaches on May 24, and they cleaned out the forebay in June. In June and September, all approach values met the criterion.

Figure 65. Selah-Moxee water velocities and sediment accumulation, May 2005. Error bars represent turbulence.

Figure 66. Selah-Moxee water velocities and sediment accumulation, June 2005. Error bars represent turbulence.

Figure 67. Selah-Moxee water velocities and sediment accumulation, September 2005. Error bars represent turbulence.

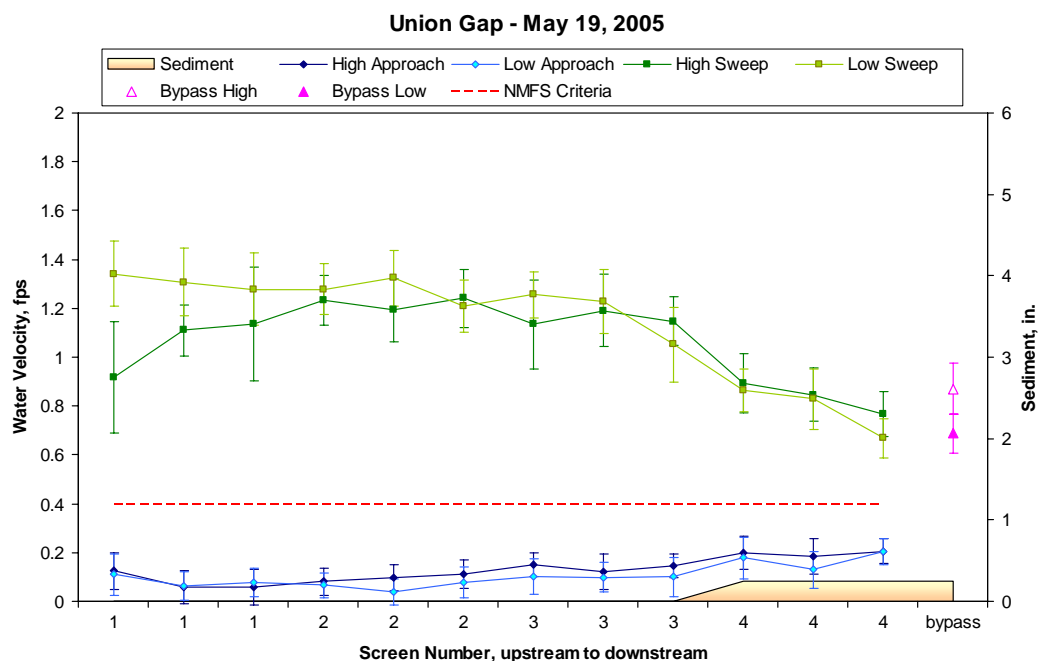
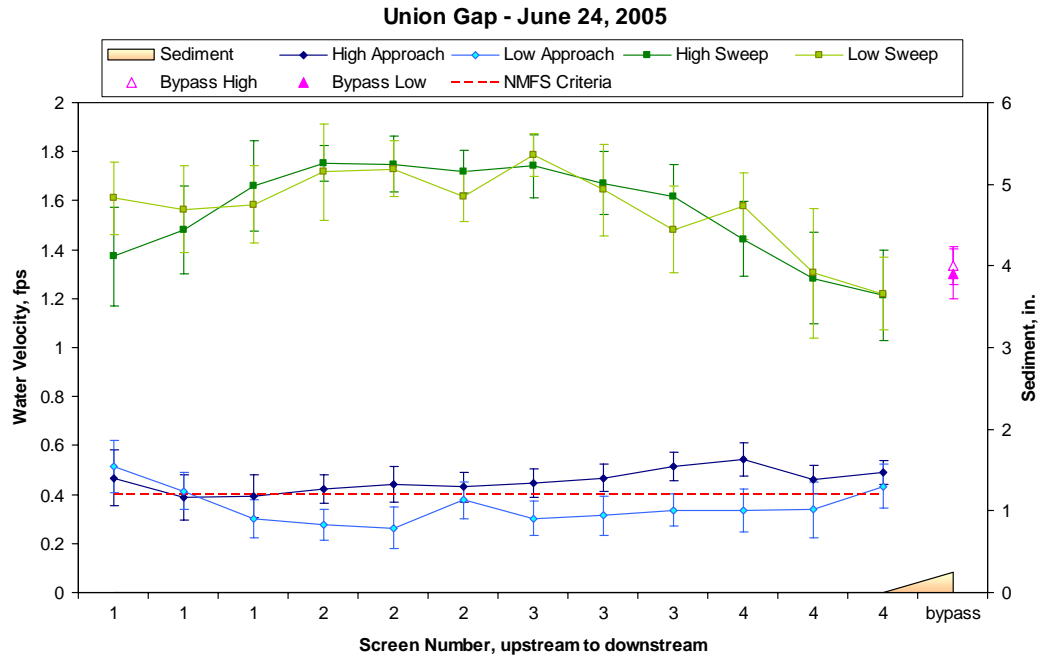
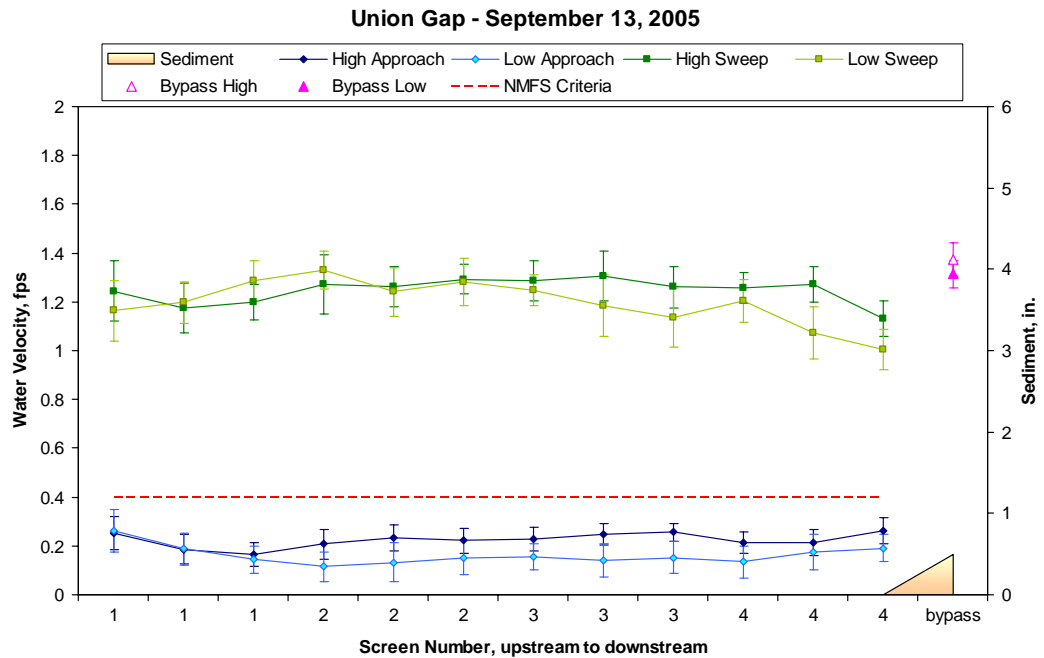
Our evaluations of the Union Gap site took place on May 19, June 24, and September 13, 2005. We found sweep velocities always greater than approach values and also higher than bypass velocities in May and June (Figures 68 and 69). Bypass velocities were higher than the average sweep velocity in September (Figure 70). Approach velocities met the NMFS criterion 100, 46, and 100% of the time in May, June, and September, respectively. Excessive approach values are a recurring problem at Union Gap. In 2006, we would like to look at design flows for the diversion and bypass as well as the operating procedures for the screens at this site, and work together with WDFW personnel to see whether changes to position or other facility settings can be made to keep the site within criteria.

Figure 68. Union Gap water velocities and sediment accumulation, May 2005. Error bars represent turbulence.

Figure 69. Union Gap water velocities and sediment accumulation, June 2005. Error bars represent turbulence.

Figure 70. Union Gap water velocities and sediment accumulation, September 2005. Error bars represent turbulence.

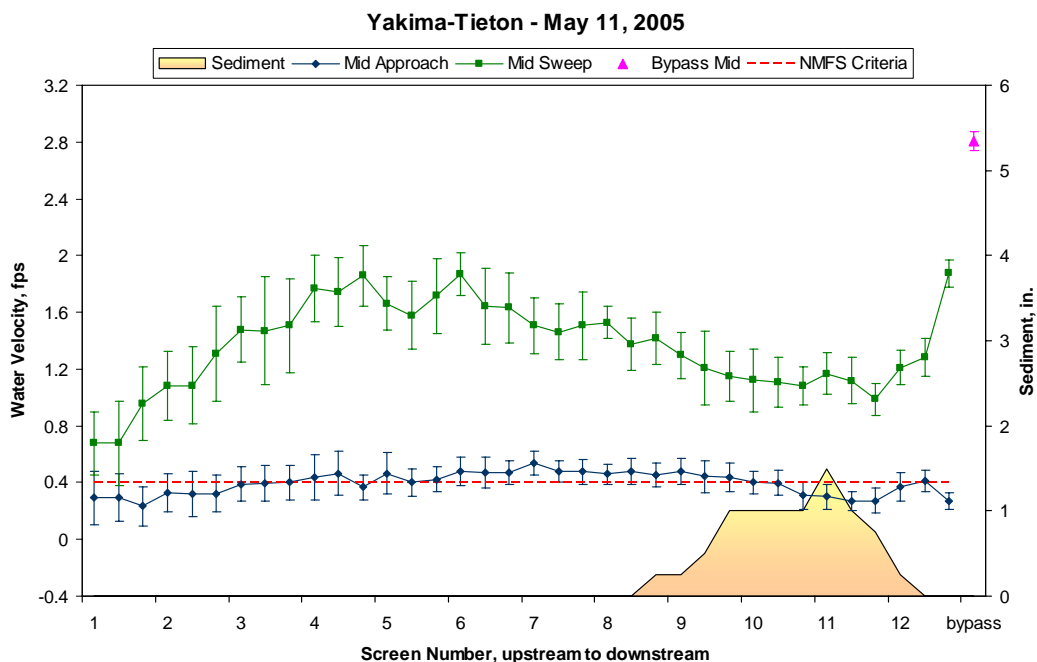
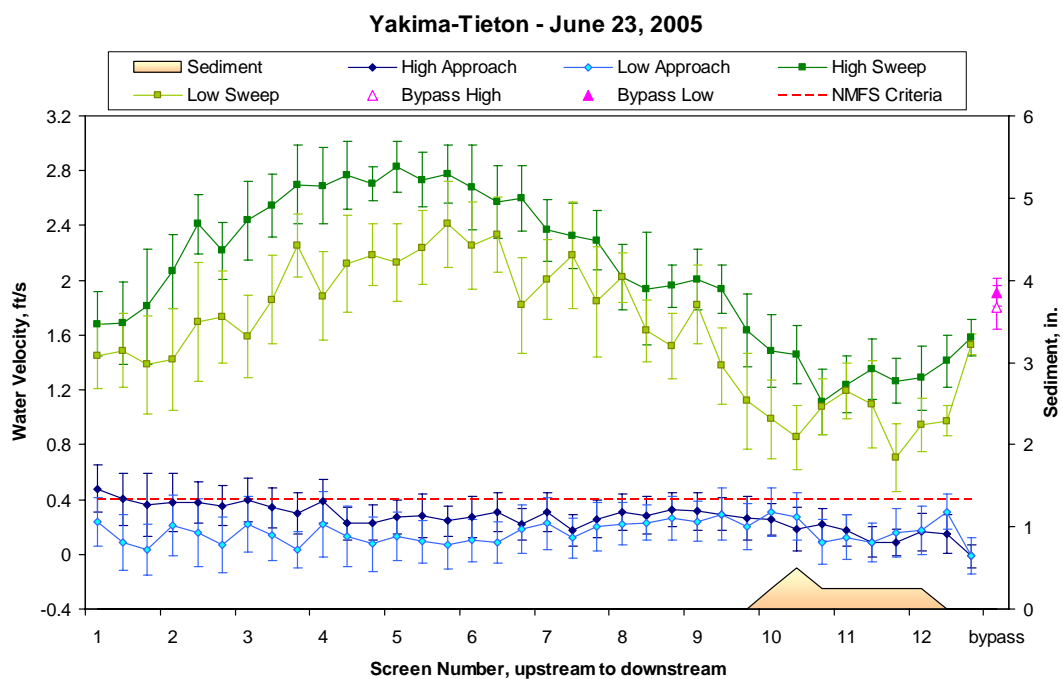
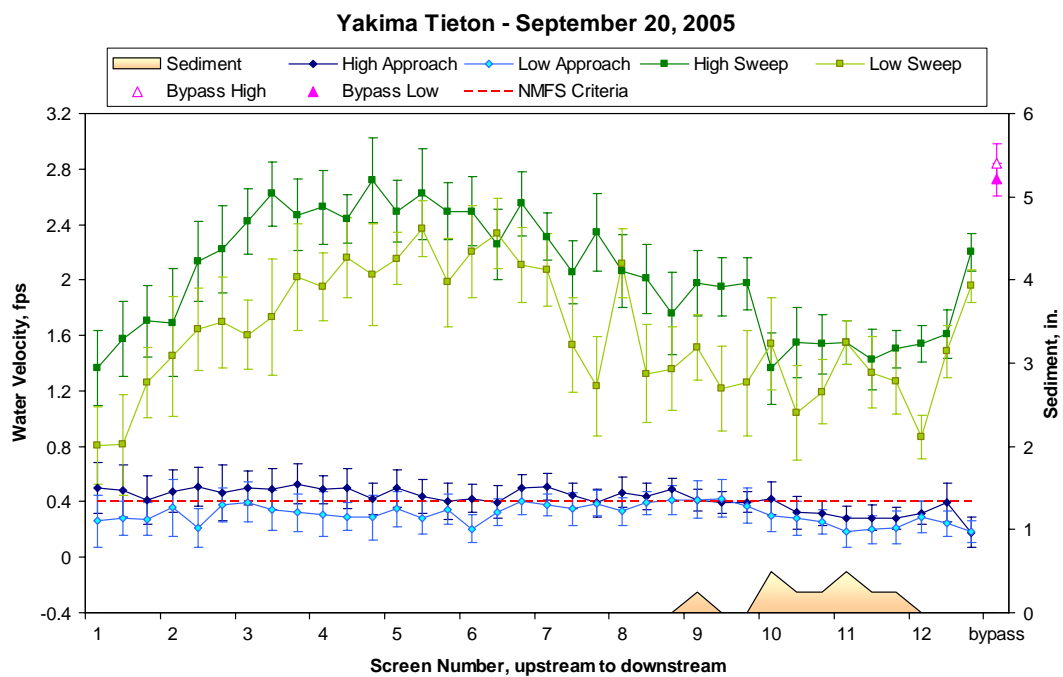
We inspected the Yakima-Tieton site on May 11, June 23, and September 20, 2005. Sweep velocities always were greater than approach velocities but did not increase toward the bypass during any of our inspections (Figures 71, 72, and 73). Bypass velocities always were greater than or equal to the average sweep. Approach velocities met the NMFS criterion 67, 97, and 61% of the time in May, June, and September, respectively. High approach values have occurred several times in the past few years at Yakima-Tieton. In 2006, we would like to look at design flows for the diversion and bypass as well as the operating procedures for the screens at this site, and work together with USBR personnel to see whether changes to louver position or other facility settings can be made to keep the site within criteria.

Figure 71. Yakima-Tieton water velocities and sediment accumulation, May 2005. Error bars represent turbulence.

Figure 72. Yakima-Tieton water velocities and sediment accumulation, June 2005. Error bars represent turbulence.

Figure 73. Yakima-Tieton water velocities and sediment accumulation, September 2005. Error bars represent turbulence.
