Washington Phase II Fish Diversion Screen Evaluations in the Yakima and Touchet River Basins

Annual Report 2005 - 2006

February 2006

DOE/BP-00000652-31

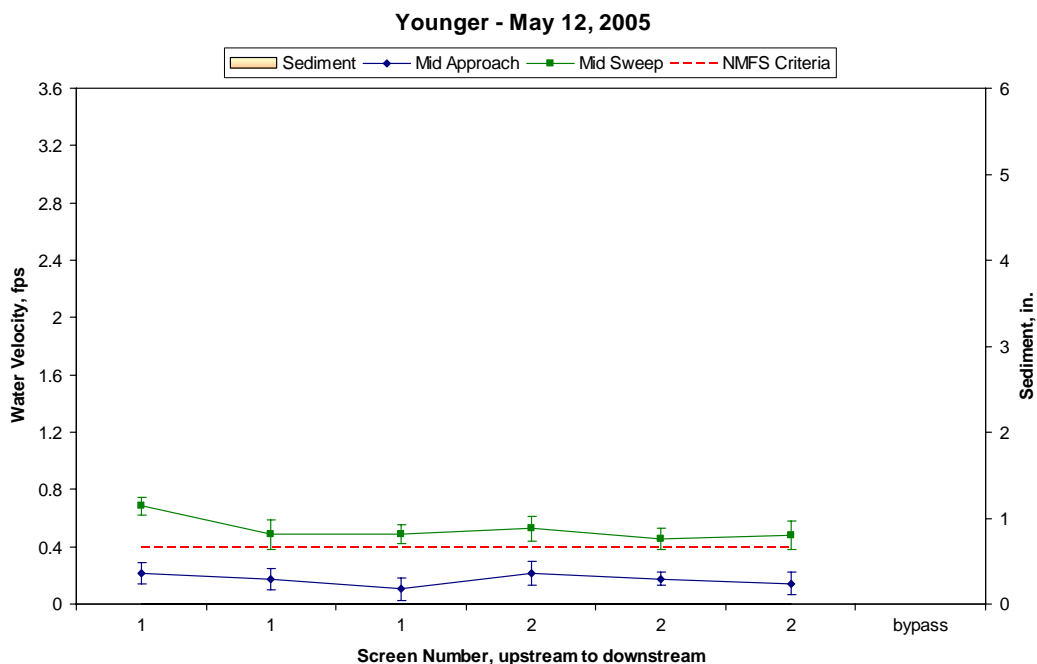
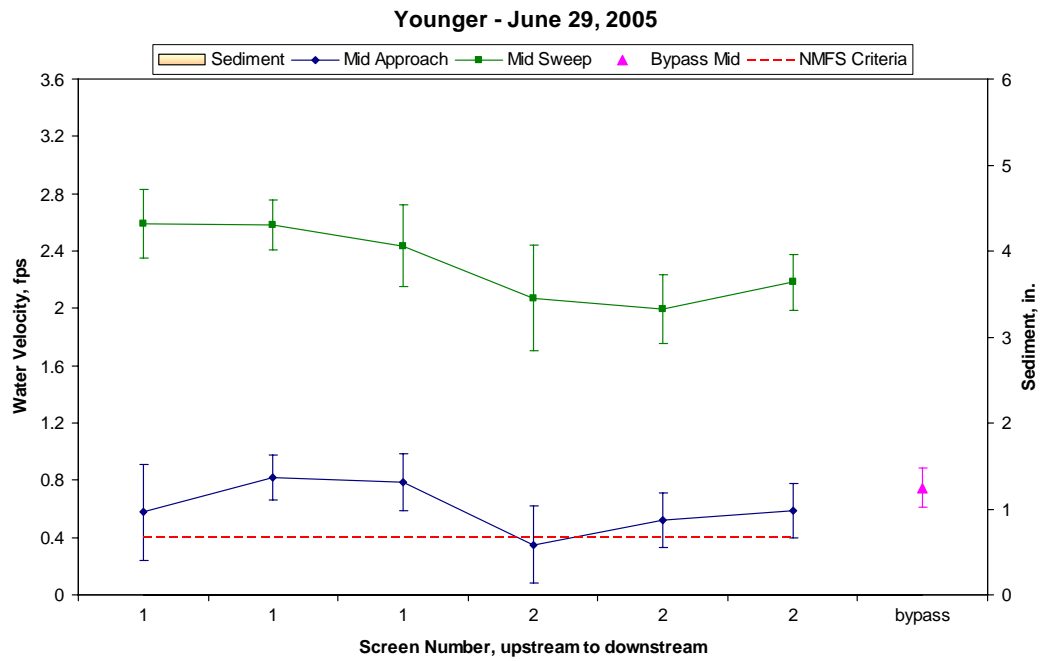
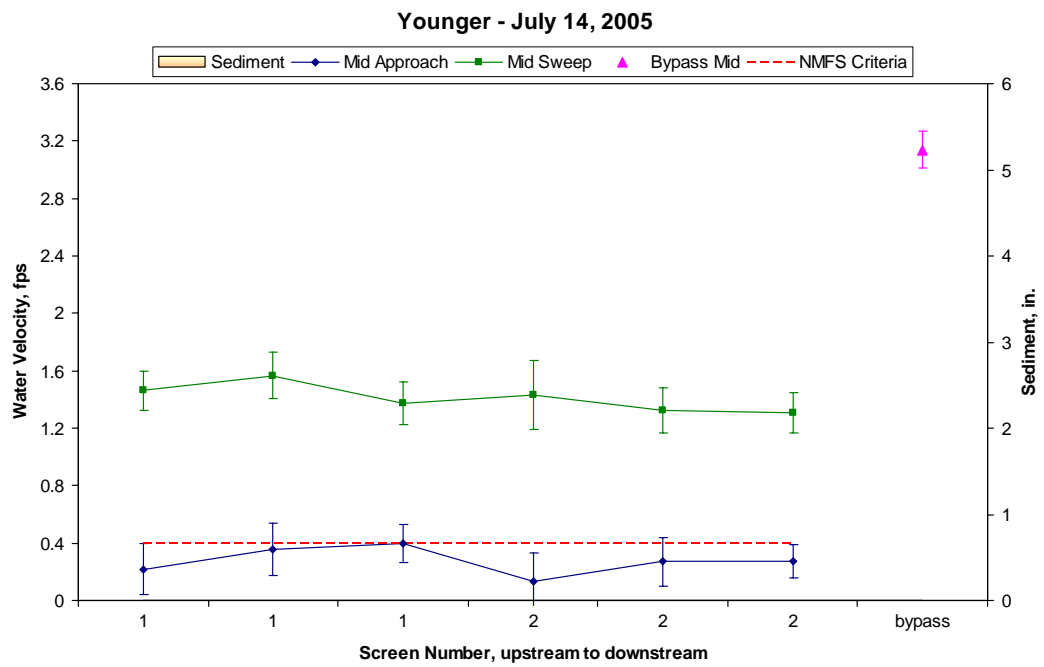
Inspections of the Younger fish screen site occurred on May 12, June 29, July 14, and September 14, 2005. Velocity measurements were conducted in May, June, and July. The site was essentially shut down for the season in September, and no velocity measurements were made. Sweep velocities always were greater than approach velocities, but sweep did not increase toward the bypass (Figures 74, 75, and 76). Approach velocities met the NMFS criterion 100% of the time in May and July. In June, however, approach velocities met the criterion only 17% of the time. We notified WDFW staff on June 30, and they added some checkboards to the forebay to increase submergence. We reevaluated the site on July 14 and found approach velocities greatly improved (Figure 76).

This site has three sets of checkboards in the forebay to provide submergence. At times, one set of checkboards has fewer boards, creating a notch for bypass flow. At other times, all three sets are equal in height, and there is marginal bypass flow over the tops of the boards. In June and July, we tried measuring bypass flow by placing the probe in the notch in the checkboards; these velocities are shown on the plots (Figures 75 and 76).

Figure 74. Younger water velocities and sediment accumulation, May 2005. Error bars represent turbulence.

Figure 75. Younger water velocities and sediment accumulation, June 2005. Error bars represent turbulence.

Figure 76. Younger water velocities and sediment accumulation, July 2005. Error bars represent turbulence.

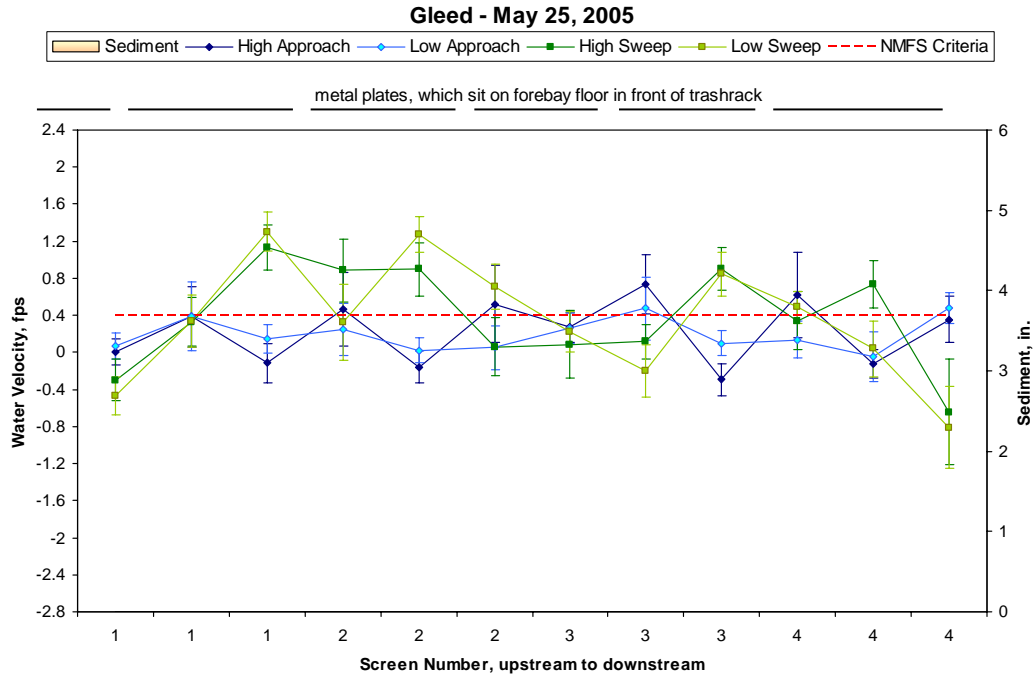
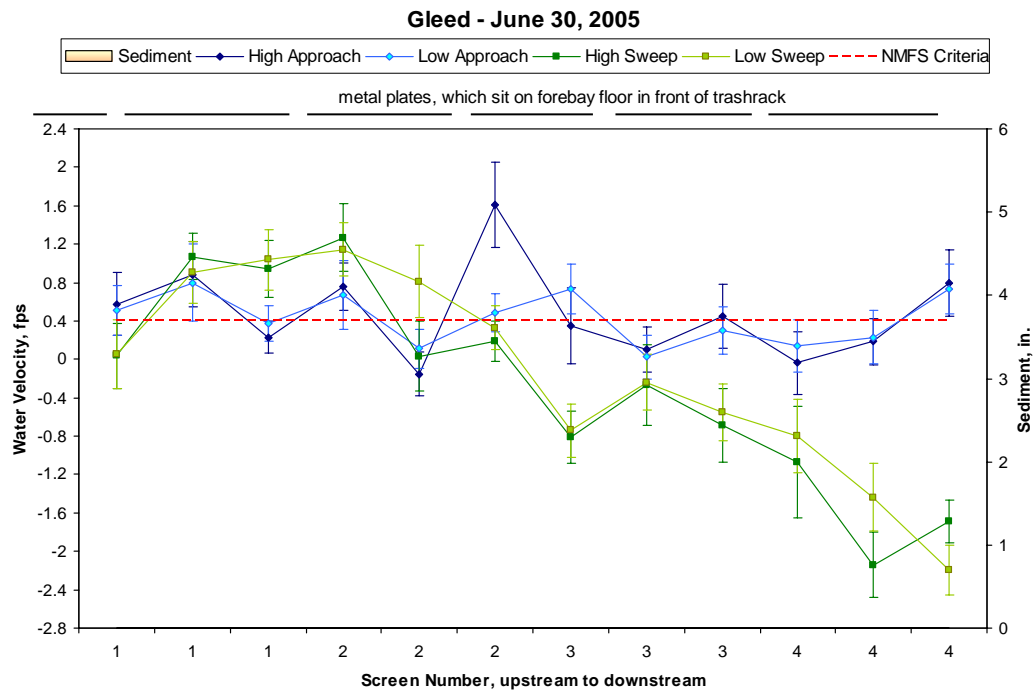
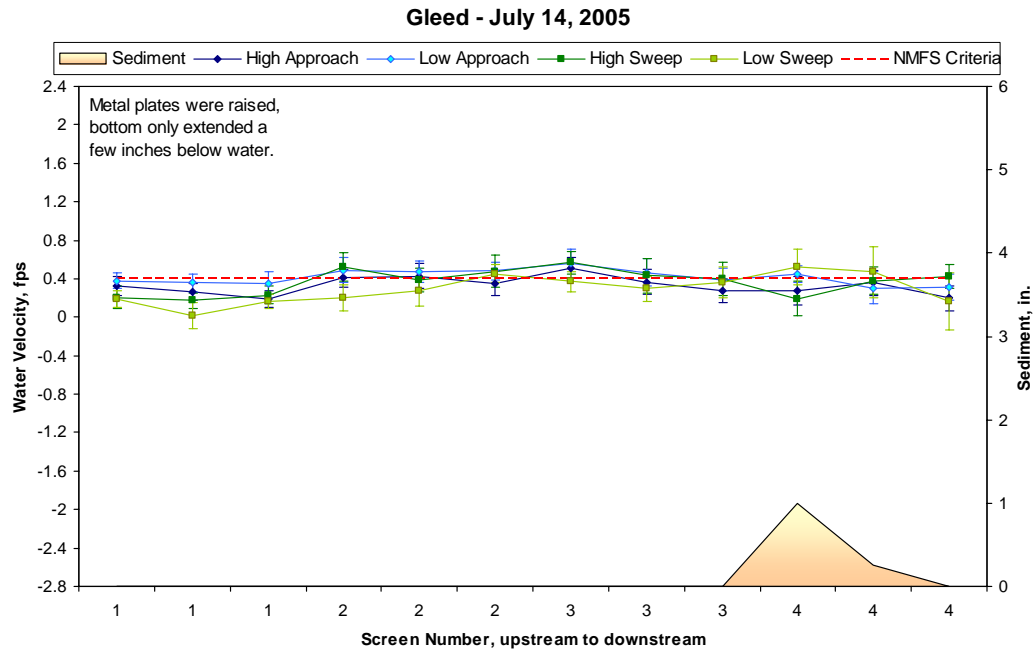
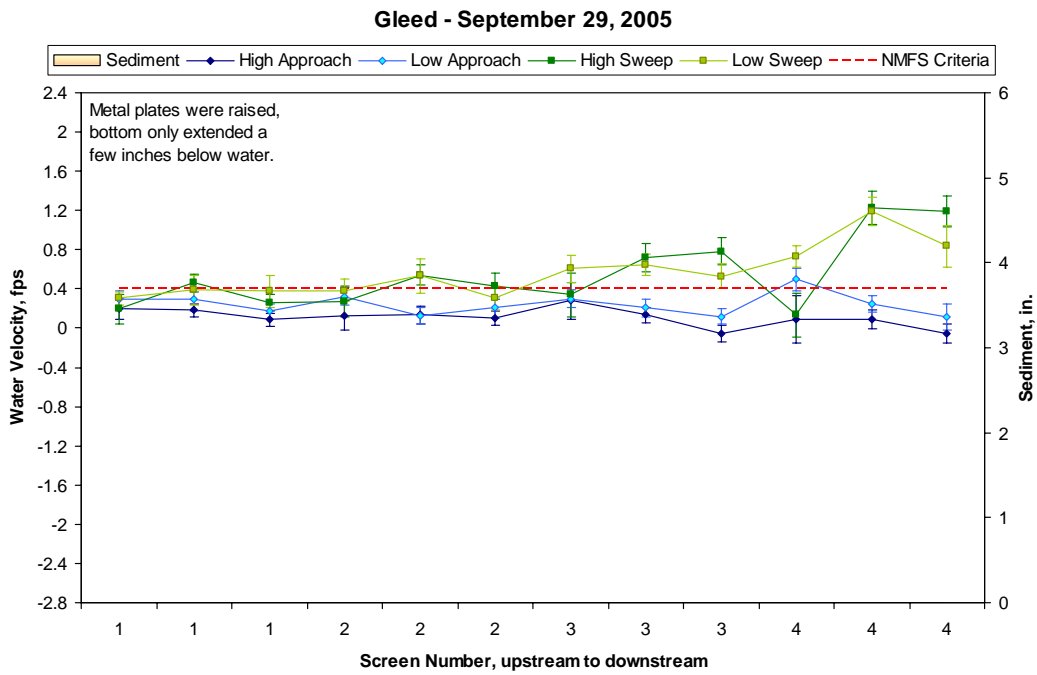
The Gleed site was evaluated on May 25, June 30, and September 29, 2005. The metal plates used to protect the screens from debris were in place from the bottom of the forebay floor to the surface during our May and June inspections; their locations are shown on Figures 77 and 78. This typically causes wide variations in the strength and direction of both the sweep and approach velocities, and this year was no exception. Approach values exceeded the NMFS criterion in both May and June, with 25% and 50% of the approach values above 0.4 fps and a maximum of 1.6 fps in June at one point. There was also a strong back eddy in the downstream end of the site in June. We notified the WDFW of the high approach values in May and again in June. Also in June, we suggested the metal plates be raised above water, because debris is usually less of a problem later in the spring. When we reevaluated the site in July, overall flow was much more smooth, and overall approach velocities were much lower, although 38% still exceeded the NMFS criterion (Figure 79). We would strongly suggest raising the metal plates out of the water as soon as the heaviest debris movement is over for the year. This would help reduce the extreme turbulence and approach velocity spikes that occur as water squirts between the plates straight at the screens, even though it may not reduce overall approach velocities enough to meet the criterion.

Average sweep was greater than average approach velocities in May and September (Figures 77 and 80). In June, the average of the sweep velocities showed upstream flow, while in July sweep and approach were nearly equal. Sweep generally did not increase toward the bypass except in September.

Figure 77. Gleed water velocities and sediment accumulation, May 2005. Error bars represent turbulence.

Figure 78. Gleed water velocities and sediment accumulation, June 2005. Error bars represent turbulence.

Figure 79. Gleed water velocities and sediment accumulation, July 2005. Error bars represent turbulence.

Figure 80. Gleed water velocities and sediment accumulation, September 2005. Error bars represent turbulence.
