**FIRST INTERIM STATUS REPORT: MODEL 9975 LIFE EXTENSION
PACKAGE TESTING**

Savannah River National Laboratory
Materials Science & Technology

Publication Date: December 2009

Document No. SRNL-TR-2009-00439

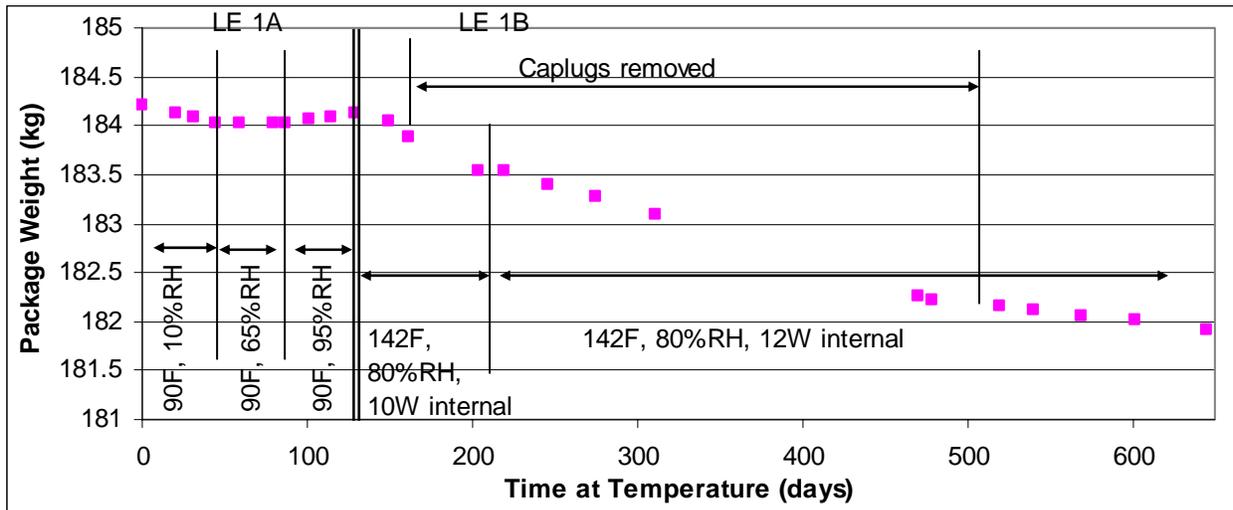
Variation in the total weight of each package is summarized in Figures 3-5. Test LE1 experienced several environments, and the rate of weight change varies with each environment. In phase LE1b, the LE1 fiberboard temperature ranged from ~140°F (OD surface) to 165°F (ID surface). Table 2 shows the rate of package weight loss ranged from 0.001 to 0.004 %/day. If the entire weight loss is attributed to the fiberboard (with a typical fiberboard weight of 31 kg, neglecting the bearing plates and air shield), the overall weight loss rate for the fiberboard is 0.006 – 0.026 %/day. In comparison, laboratory samples conditioned at 160°F and 50 %RH show weight loss at a rate of 0.008 to 0.02 %/day. Two factors should be considered in comparing the laboratory samples with LE1. Figure 6 indicates that the humidity towards the fiberboard ID surface of LE1 was ~50%, and it increased towards the outer surface. A higher humidity will tend to increase the rate of fiberboard weight loss for a given temperature. In addition, since an increased weight loss rate was observed for LE1 with the caplugs removed, weight loss from the continued slow escape of excess moisture from the drum would be added to any weight loss from fiberboard degradation.

Figure 3. Package weight of LE1 over time.

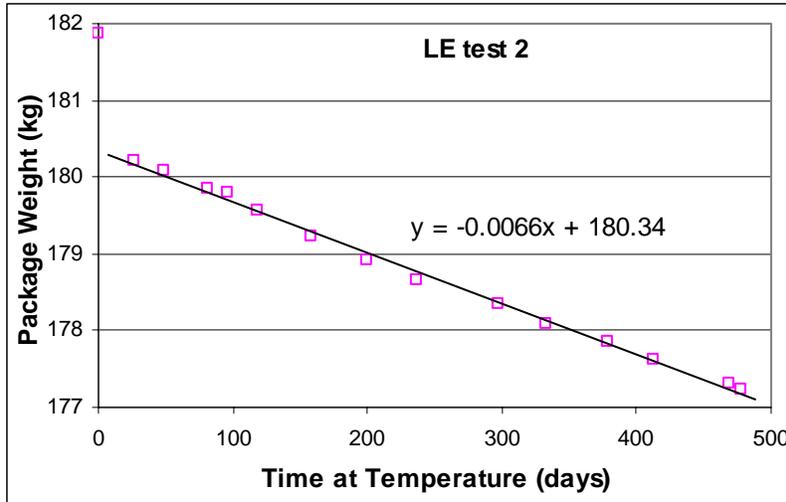
Package LE2 lost weight at an average rate of 0.004 %/day, with the fiberboard temperature ranging from ~190°F (OD surface) to 245°F (ID surface). If the entire weight loss is attributed to the fiberboard (with a typical fiberboard weight of 31 kg, neglecting the bearing plates and air shield), the overall weight loss rate for the fiberboard is 0.021 %/day. The weight loss of the upper fiberboard assembly from LE2 is shown in Figure 24, with an average rate of fiberboard weight loss of 0.027 %/day (neglecting weight of bearing plate and air shield). The range of temperature data for the LE2 fiberboard suggests a mid-range temperature of ~218°F. The average temperature at the higher elevations (near the upper assembly) is closer to 235°F, and the temperature near the bottom of the package is likely significantly cooler than 190°F (based on the steep moisture gradient).

Figure 4. Package weight of LE2 over time. The variation following the initial drop is approximated well by the linear trendline. The magnitude of the initial drop represents moisture loss. The subsequent decrease in weight represents a combination of additional moisture loss and fiberboard pyrolysis.

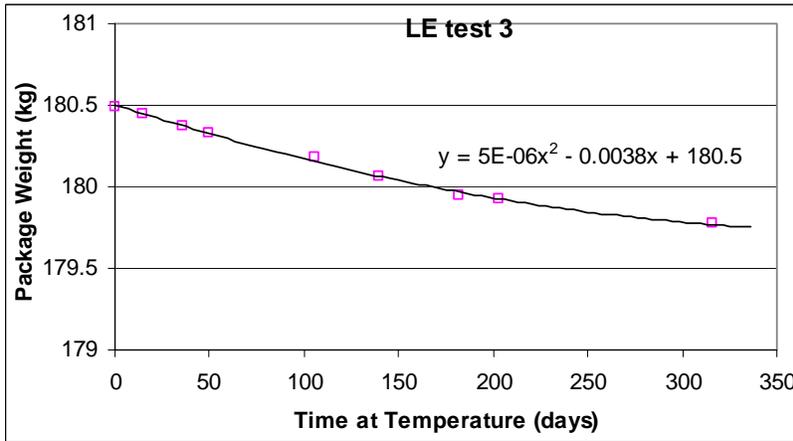
Figure 5. Package weight of LE3 over time. The data are well represented by a quadratic trendline.

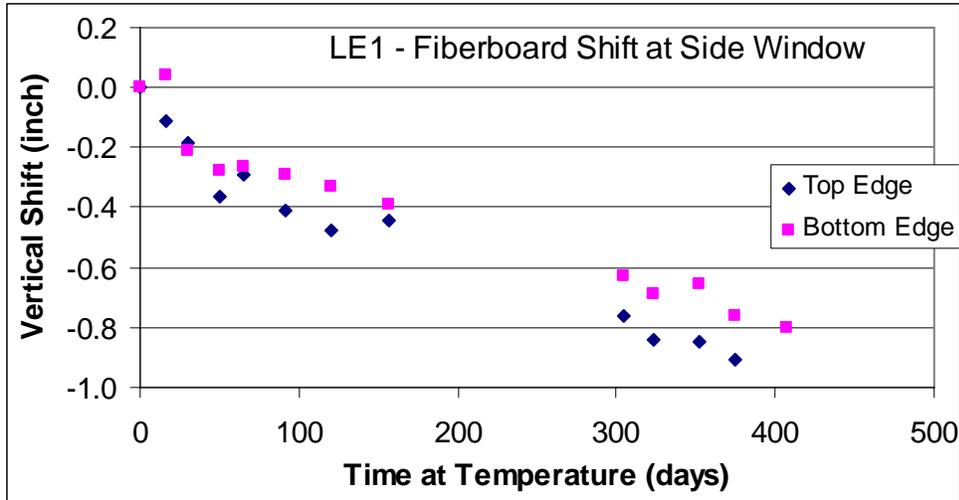
Figure 15. Vertical shift (downward) of fiberboard in LE1b, as viewed through the side view port.

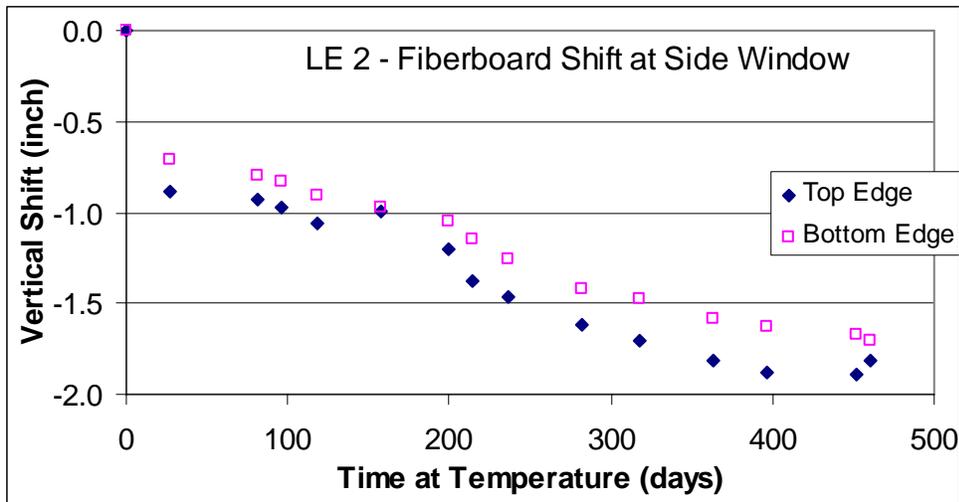
Figure 16. Vertical shift (downward) of fiberboard in LE2, as viewed through the side view port.

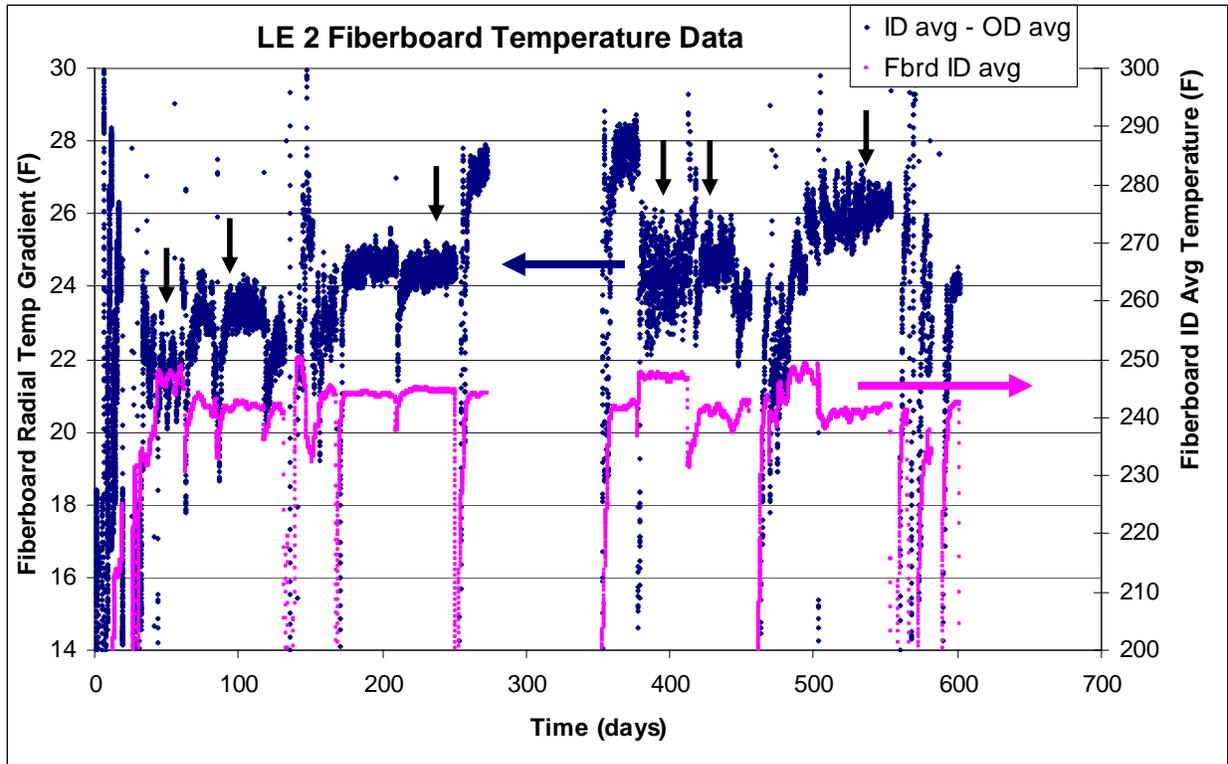
At each of the arrows in Figure 22, the radial temperature gradient and lower assembly thickness are combined per this relationship to get a value proportional to the thermal conductivity (see Table 5). The value for the first data point (at 52 days in test, 18 days at temperature) is taken as a reference point, and the values for subsequent data points are normalized to this first data point. (Since the actual heat flux through this region of fiberboard is unknown, the actual thermal conductivity cannot be calculated directly.)

Figure 22. LE package 2 average radial temperature gradient (blue symbols) in the fiberboard based on the upper 3 fiberboard ID thermocouples and the upper 3 fiberboard OD thermocouples, and average fiberboard ID temperature (pink symbols). The vertical arrows indicate times during steady state operation for which the relative thermal conductivity of the fiberboard was estimated.

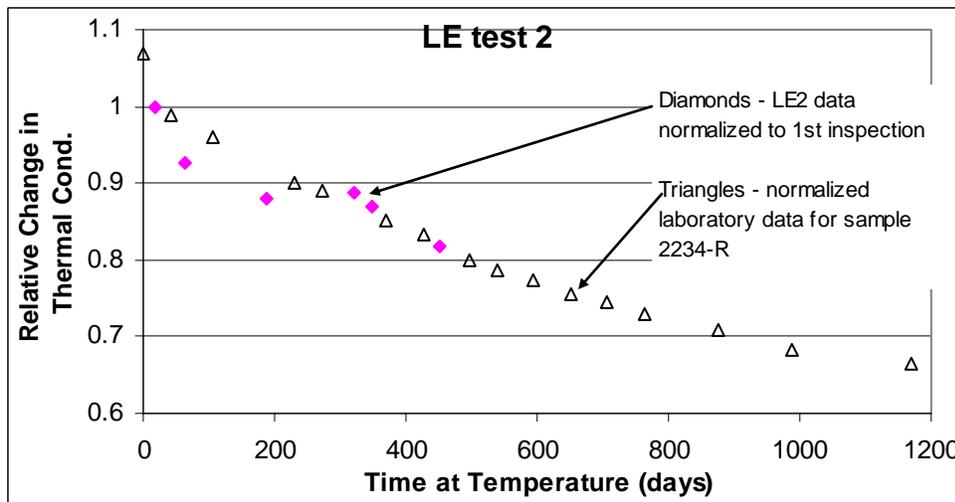
These normalized data are plotted in Figure 23, and show a decrease over time in the thermal conductivity. Data from laboratory sample 2234-R conditioned at 250°F are also shown in Figure 23 for comparison. These lab data are normalized to the value interpolated for 18 days at temperature to provide a direct comparison in change for the subsequent behavior. The data based on the LE2 temperature gradients provide an overall reasonable match to the laboratory data.

Figure 23. Relative change in thermal conductivity estimated from LE2 thermal gradient data, compared to comparable data from lab sample 2234-R. Data for the lab sample is shown for a mean test temperature of 185°F following conditioning at 250°F.
