# **Analysis of Failed and Nickel-Coated 3093 Beam Clamp Components at the East Tennessee Technology Park (ETTP)**

**ANALYSIS OF FAILED AND NICKEL-COATED 3093 BEAM  
CLAMP COMPONENTS AT THE EAST TENNESSEE  
TECHNOLOGY PARK (ETTP)**

**September 2010**

**Bechtel Jacobs Company, LLC  
Oak Ridge, TN**

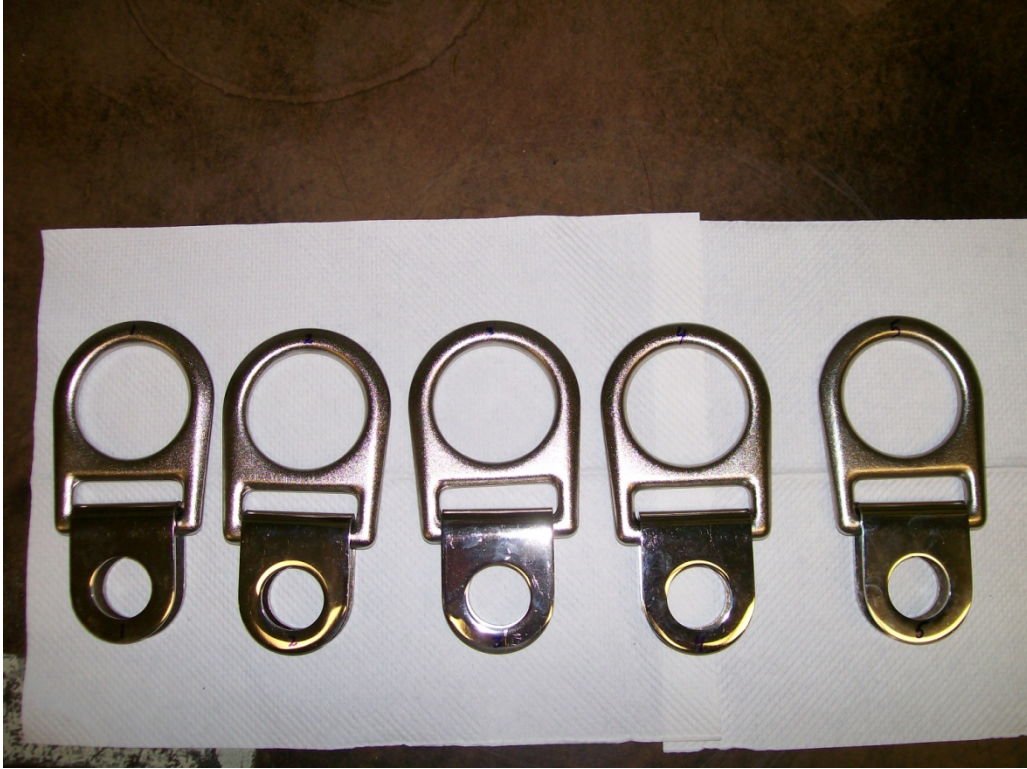
3. Five new pairs of yoke and D-rings. These samples were supplied by Reliance Industries and were coated with nickel (5% phosphorus). This coating was specified by the vendor to be 1 to 1.5 mils (25 to 38 microns) thick. Figure 5 shows the five sets of yoke/D-ring samples received. These yokes and D-ring samples were designated as NiARY1 to NiARY5 and NiARDR1 to NiARDR5, respectively.

**FIGURE 5 Five As-Received Ni-5% P Coated Yoke/D-ring Assemblies.**

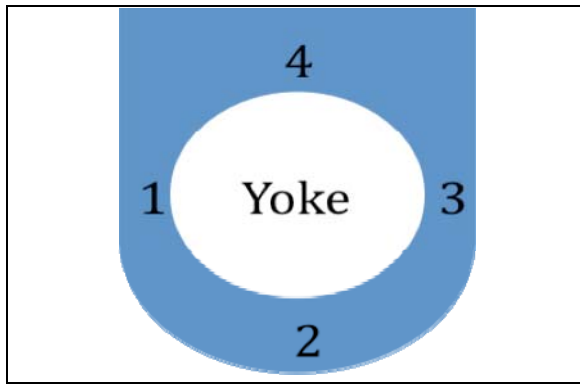
Prior to hardness testing, the yoke samples were cut such that each flat side was removed from the curved middle section for ease of testing. The hardness of both of these flat sides was then tested at least five times in each of four locations on the surface of both the shiny and dull sides (Figure 6). The D-ring was tested at least 10 times in each of two locations on both the top and bottom of the sample (see Figure 7). Photographs of the samples with the indents visible are shown in Figure 8 (NiARY1 yoke), Figure 9 (NiARDR1), Figure 10 (2YC yoke), and Figure 11 (2DRC).

**FIGURE 6 Schematic of Cut Yoke Sample for Hardness Measurements. Numbers indicate hardness measurement locations.**

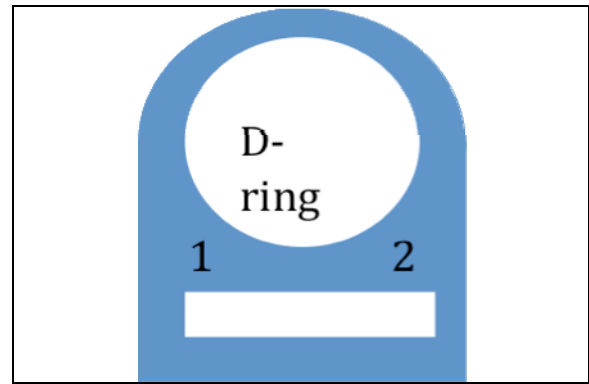
**FIGURE 7 Schematic of D-ring Sample for Hardness Measurements. Numbers indicate hardness measurement locations.**

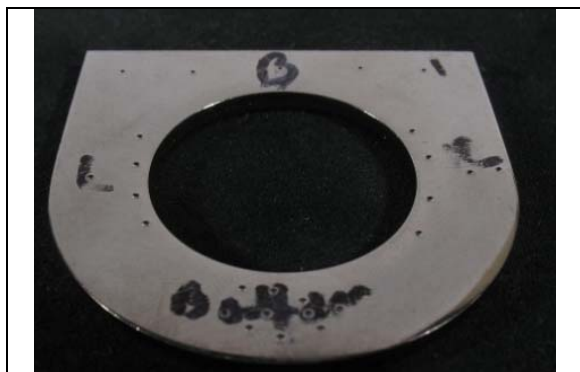
**FIGURE 8 As-Received Yoke Sample NiARY1 with Indents.**

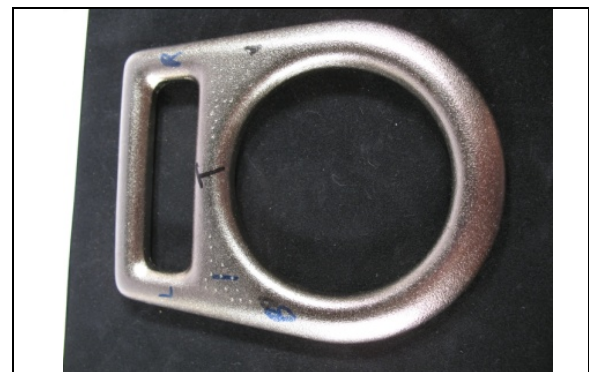
**FIGURE 9 As-Received D-ring Sample NiARDR1 with Indents.**

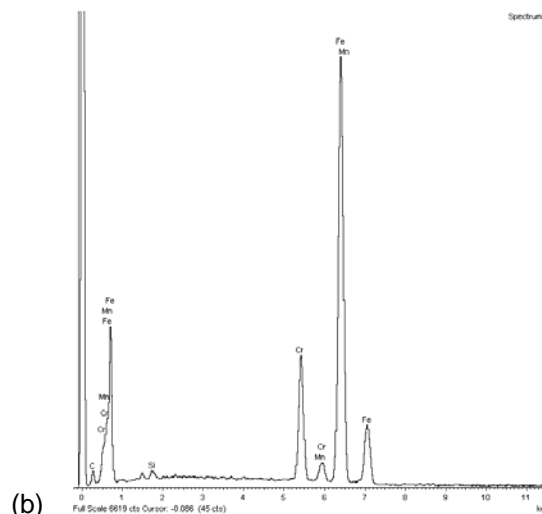
Figure 15(a) shows the fracture surface of the failed yoke (#2YC). There was no corrosion product observed in this region. Higher magnification shows intergranular fracture morphology normally associated with brittle failure. Figure 16(a) is a higher magnification of the same area as in Figure 15(b). Figure 16(b) shows the EDAX spectrum of the field of view of Figure 16(a). Clearly, the main components are detectable, such as iron and chromium.

**FIGURE 16(b) EDAX Analysis of the Area Shown in Figure 16(a).**

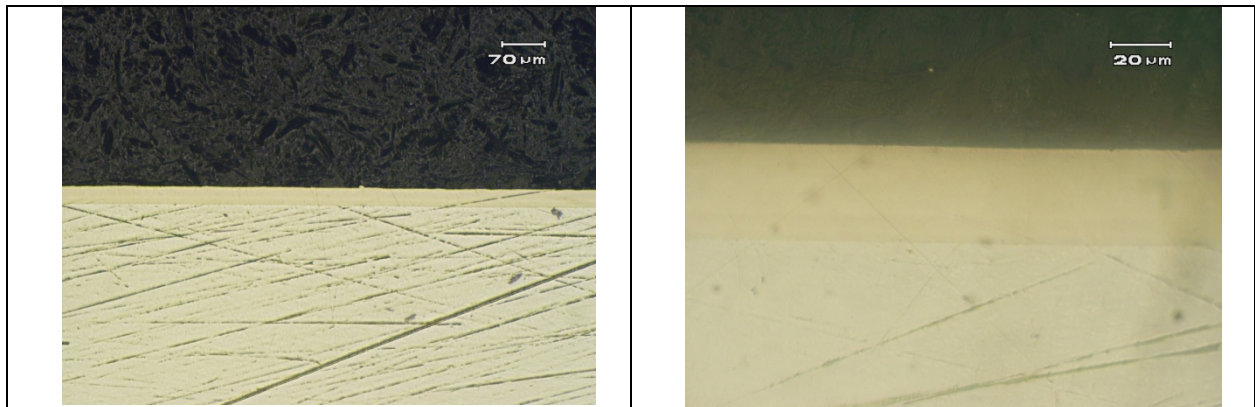
To evaluate the Ni-5% P coatings, two samples of as-received yokes (NiARY1 and NiARY2) were sliced, and a thin sliver retrieved. Smaller sample sections from two locations were cut out such that one section was from the middle, and the other was near the edge. One D-ring sample (NiARDR3) was sliced at two locations, and two sample pieces were retrieved. Subsequently, the retrieved samples from the yoke and D-ring were polished by standard metallographic techniques. The polished surfaces for the typical yoke and D-ring sample at low and high magnifications are shown in Figures 20 to 25. Clearly, the deposited Ni coating on the steel surface is visible. Nickel coating thickness was measured on a standard optical microscope equipped with a precision micrometer with a digital readout. Nickel coating thicknesses were measured at several locations, and an average value was determined.

**FIGURE 20 Low Magnification Image of the Ni-5% P Coating on Yoke (NiARY1).**

**FIGURE 21 High Magnification Image of the Ni-5% P Coating on Yoke (NiARY1).**

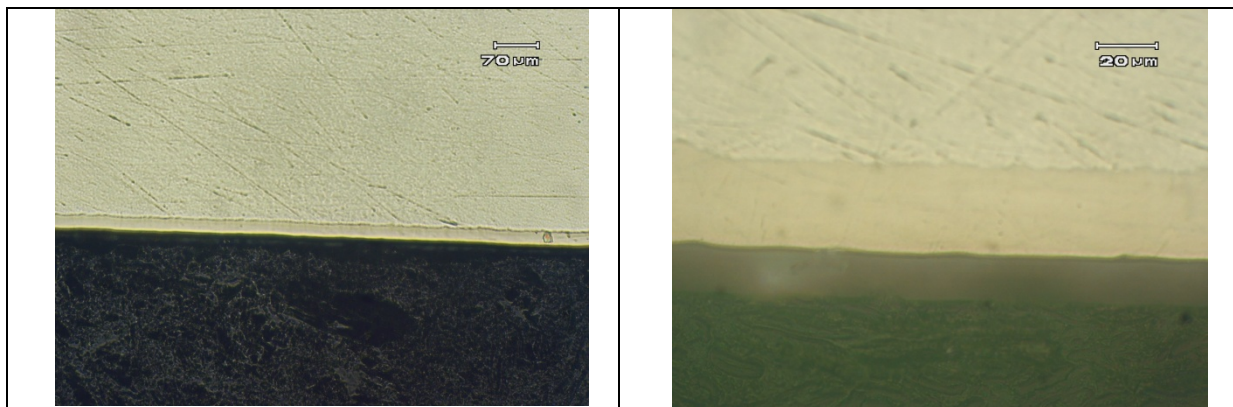
**FIGURE 22 Low Magnification Image of the Ni-5% P Coating on Yoke (NiARY2).**

**FIGURE 23 High Magnification Image of the Ni-5% P Coating on Yoke (NiARY2).**

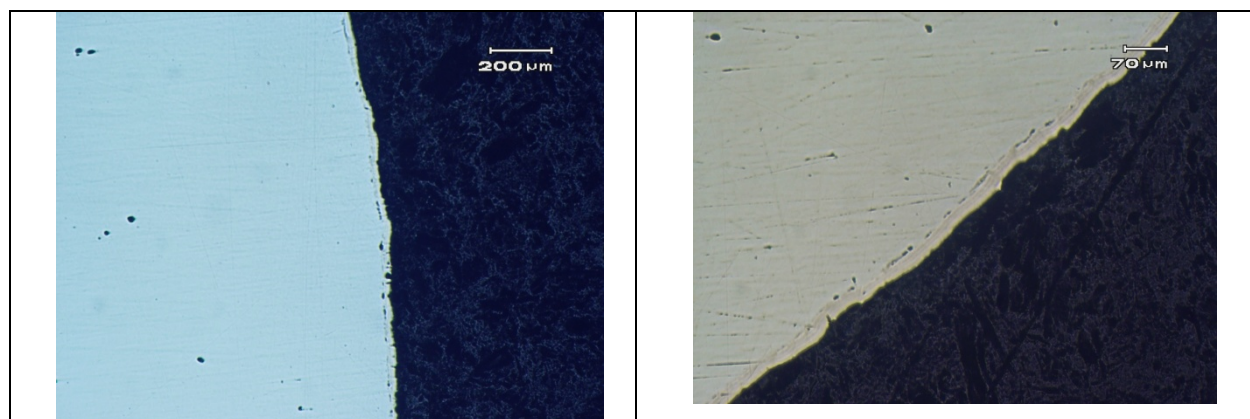
**FIGURE 24 Low Magnification Image of the Ni-5% P Coating on D-ring (NiARDR3).**

**FIGURE 25 High Magnification Image of the Ni-5% P Coating on D-ring (NiARDR3).**

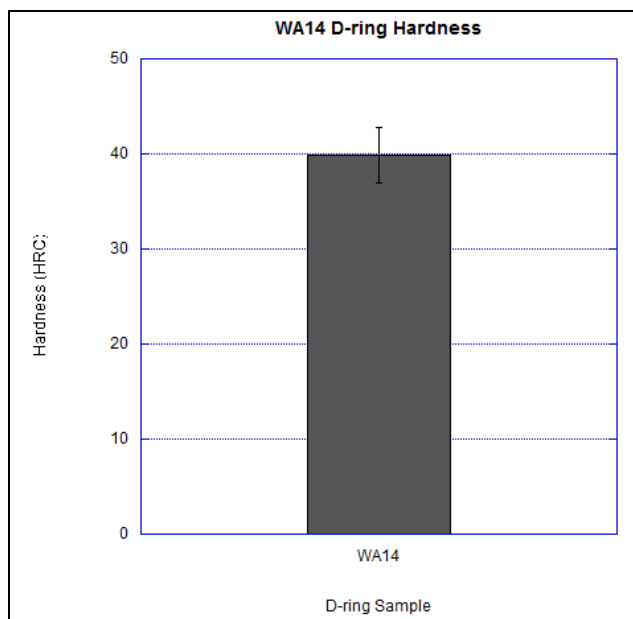
As described before, Rockwell C hardness measurements were made on the WA14 D-ring and yoke samples, and the data are presented in Figures 28 and 29, respectively. The D-ring hardness ( $R_c \sim 40$ ) was consistent with the measurements on the Ni-5% P coated samples, as discussed in Section 4. The yoke values were in agreement with the annealed yoke samples with the Ni-5% P coating.

**FIGURE 28 Hardness Measurements on WA14 D-ring.**

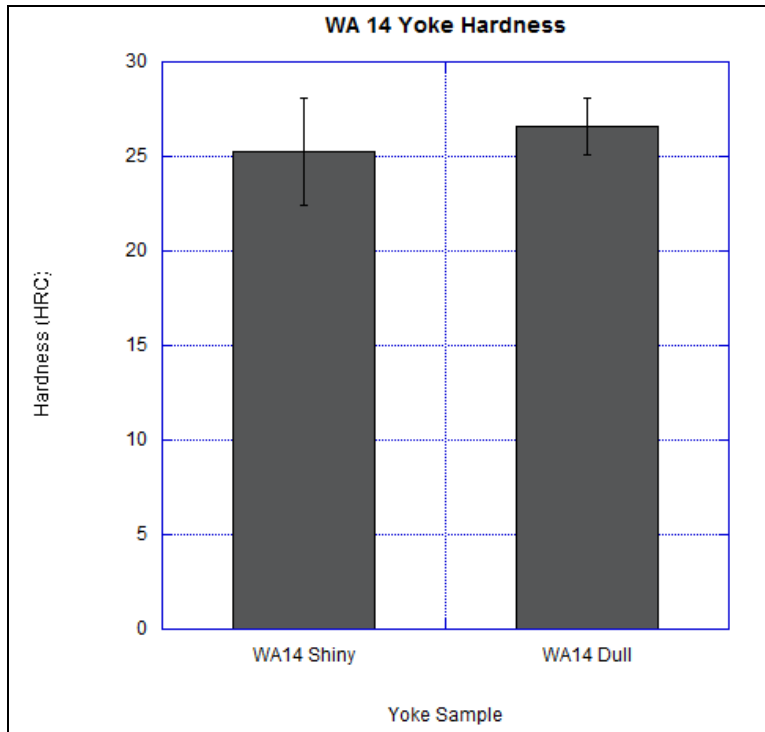
**FIGURE 29 Hardness Values of the WA14 Yoke on the Shiny and Dull Surfaces.**

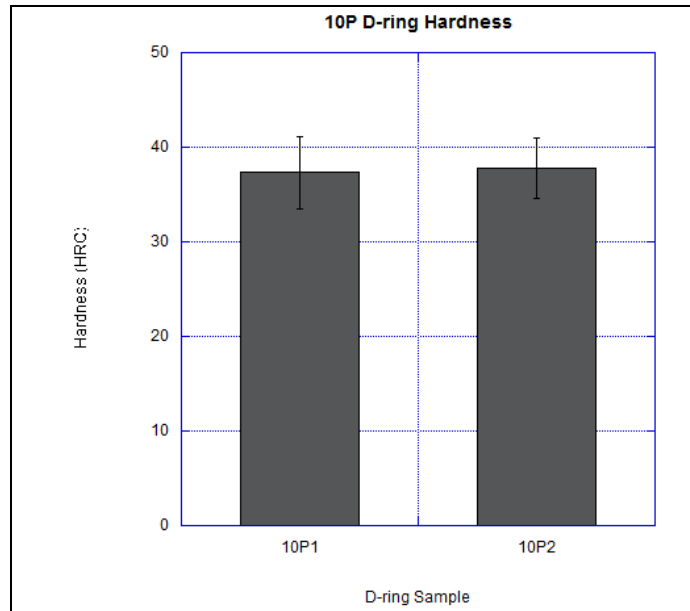
The Rockwell C hardness values for both D-ring and yoke samples with Ni-10% P coating are shown in Figures 33 and 34. The average hardness for the D-rings was  $R_c \sim 37$ , which is slightly lower than that for the Ni-5% P coated samples. For the yoke samples, the hardness values are significantly higher than those of the Ni-5% P samples, indicating that the yoke was not annealed. Further, there is a larger difference in the hardness values between the dull and shiny side of the yokes for both samples; the shiny side gives a higher hardness.

**FIGURE 33 Hardness Values for 10P1 and 10P2 D-Ring Samples.**

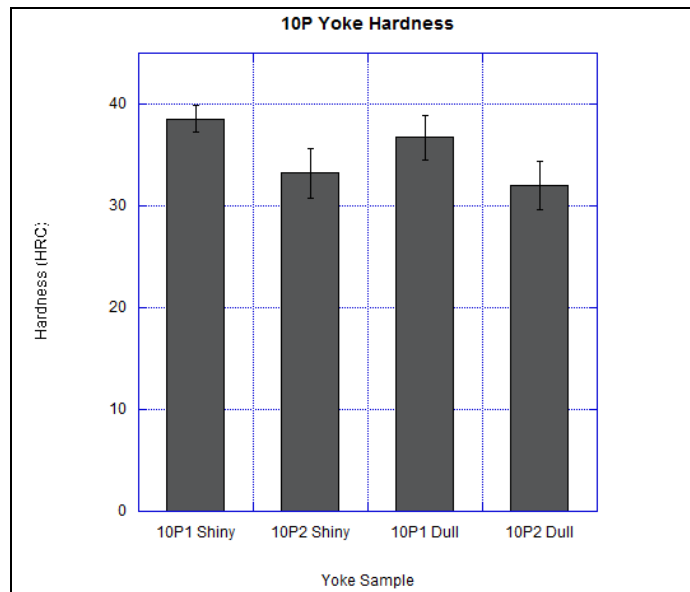
**FIGURE 34 Hardness Values for 10P1 and 10P2 Yoke Samples.**

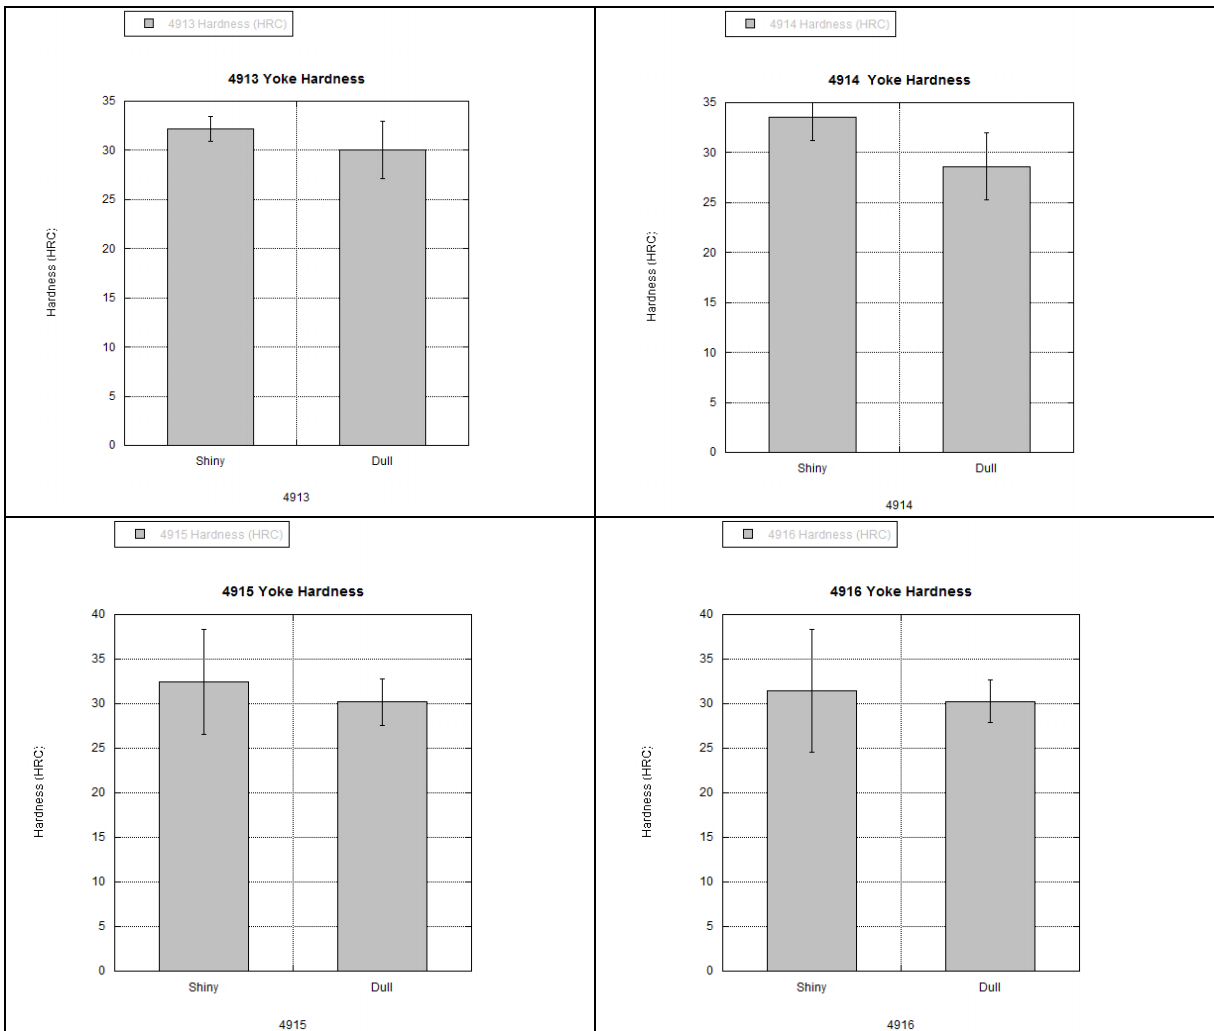
Figure 35 shows the hardness values measured on the four sets of aluminum-coated yoke samples. Hardness values were measured both on the dull and shiny sides at several locations. In

**FIGURE 35 Hardness Values for Aluminum-Coated Yoke Samples.**

all samples, hardness values were between  $R_c \sim 25$  and 35. Further, average hardness values for the shiny side were slightly higher than those of the dull side in all cases.

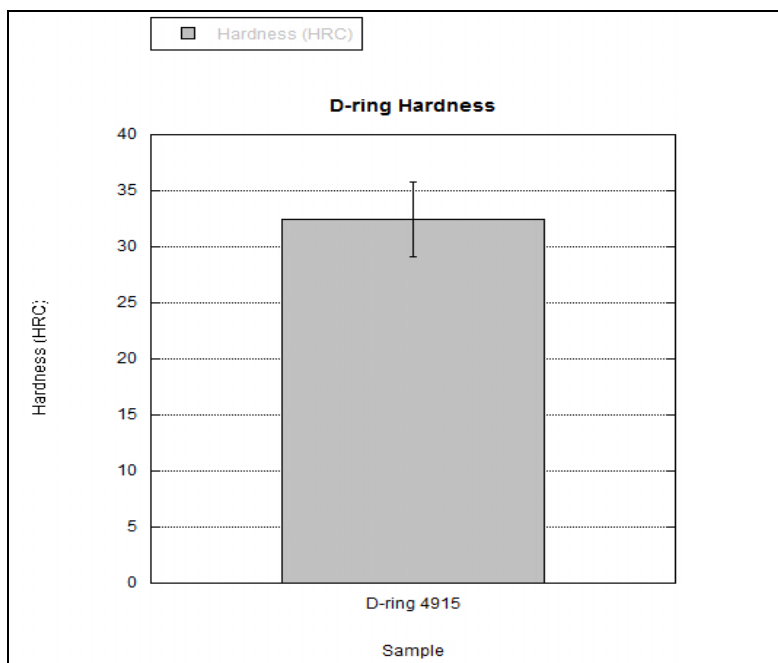
Figure 36 shows the hardness values measured on one D-ring sample, 4915. Here again, the average hardness value was  $R_c = 32$ .

**FIGURE 36 Hardness value for D-ring 4915.**

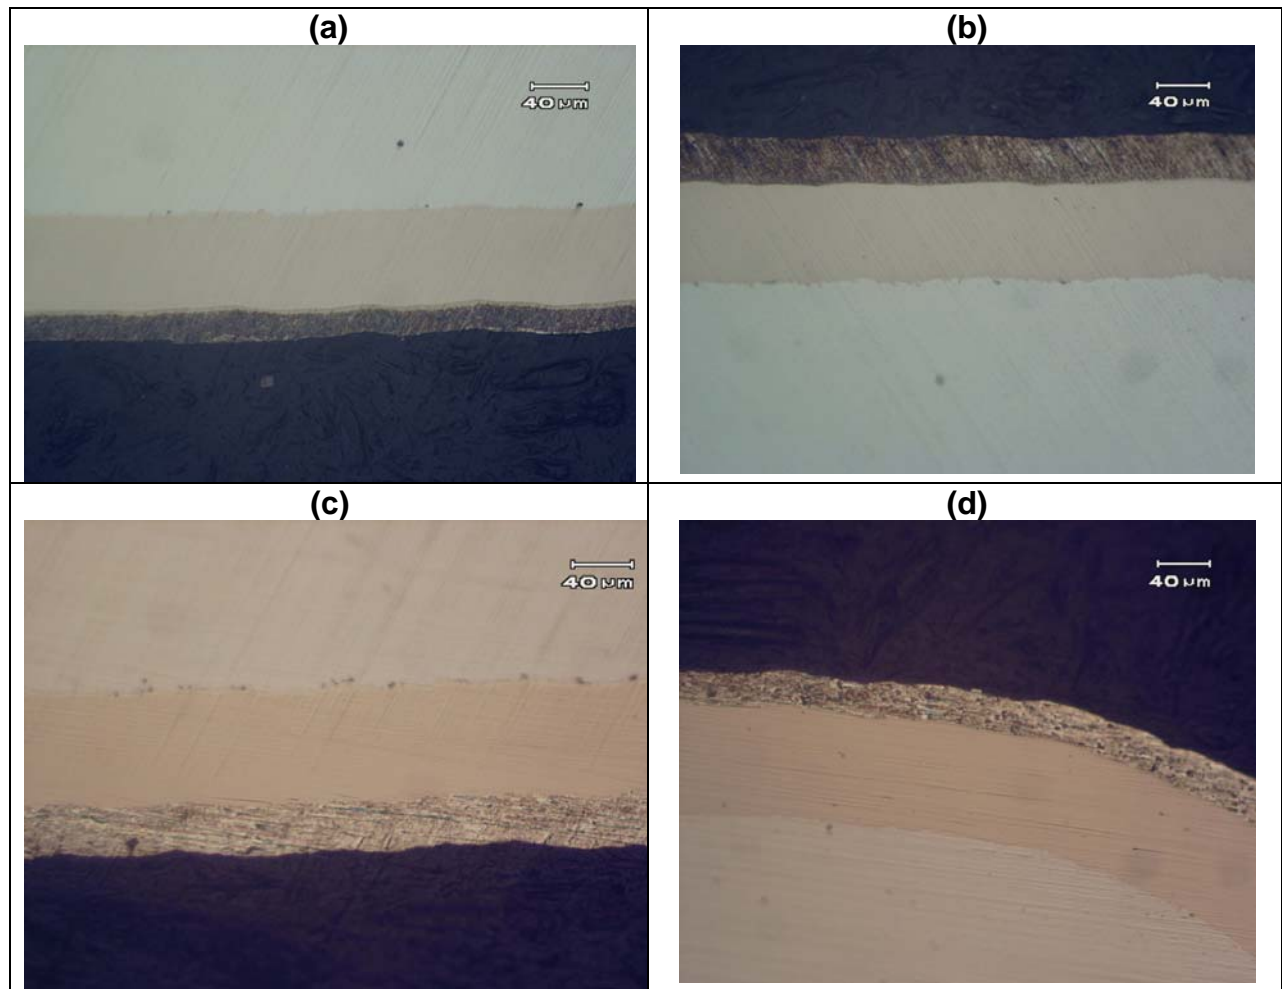
As described before, coating thickness was measured by examining the polished cross section of the samples in an optical microscope. Figure 37 shows the typical cross sections of the four yoke samples. Clearly, the Ni (middle layer) is thicker than the outer aluminum layer. Similarly, Figure 38 shows the polished cross section of D-rings (samples 4916 and 4915). The relative coating thicknesses of nickel and aluminum are quite similar to those observed for the yoke samples.

**FIGURE 37 Cross Sections of Aluminum-Coated Yoke Samples: (a) 4913, (b) 4914, (c) 4915, and (d) 4916. Notice the thicker nickel layer and thinner aluminum coating.**

Polished cross sections were scanned to qualitatively determine the durability of the coating as a result of the slicing and subsequent polishing actions. For the most part, the coatings were intact in both the yoke and D-rings. However, in a few (<25% of the scanned) areas, part of the aluminum coating was missing, nickel coating had debonded, or both coatings disappeared, as shown in Figure 41. This effect is probably a result of the sample preparation, which involved cutting of the samples by using a band saw and polishing the cut surfaces.

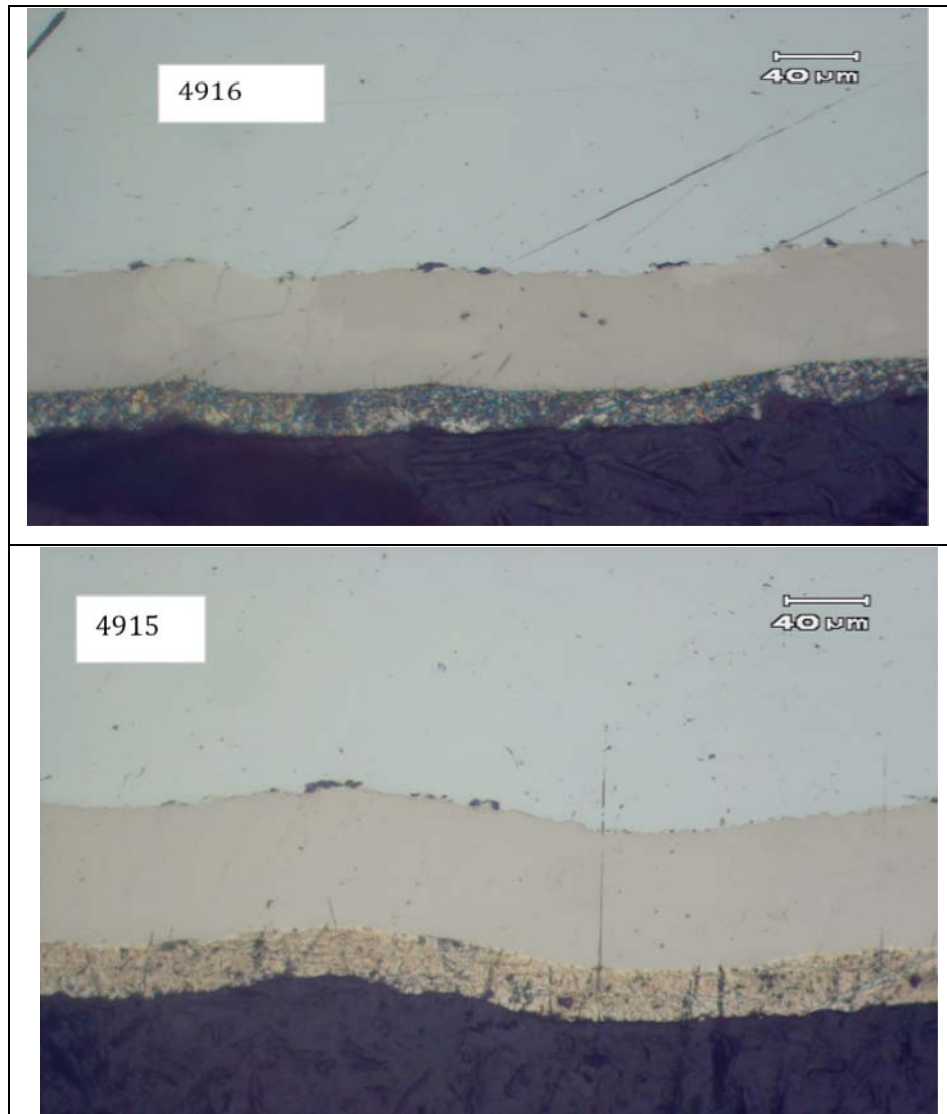
**FIGURE 38 Cross Section of Aluminum-Coated D-ring Samples.**

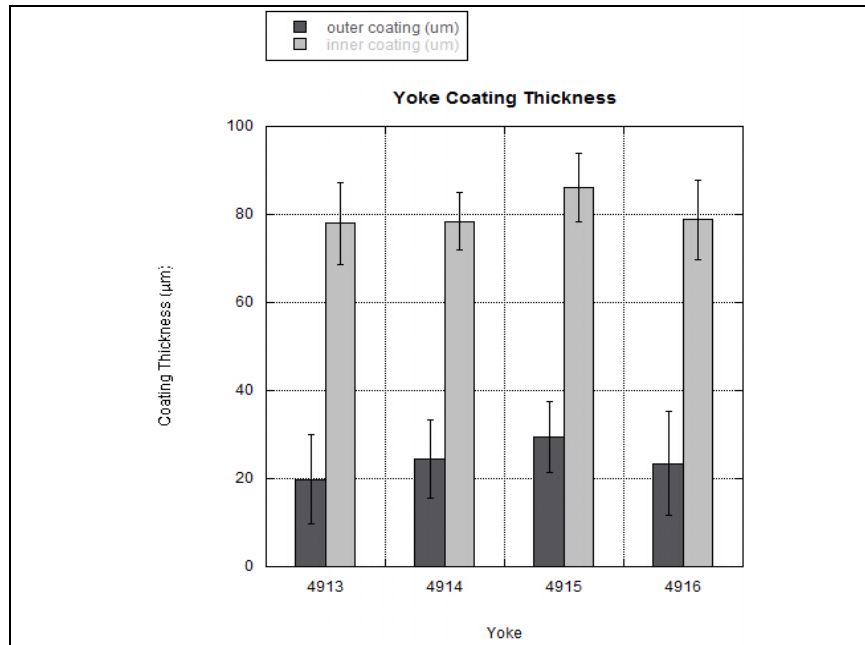
The average measured values of the nickel and aluminum coatings for the yoke and D-ring samples are graphically represented in Figures 39 and 40. For the yoke samples (Figure 39), the nickel-coating thickness was approximately  $80 \mu\text{m}$  (3 mils), whereas the aluminum-coating thickness was about  $22 \mu\text{m}$  (0.9 mils). Similar values were estimated on the D-ring samples, as shown in Figure 40. The variation in aluminum-coating thicknesses, particularly for the yoke samples, was quite large ( $\pm 10 \mu\text{m}$ ).

**FIGURE 39 Aluminum (outer) and Nickel (inner) Coating Thicknesses for the Four Yoke Samples.**

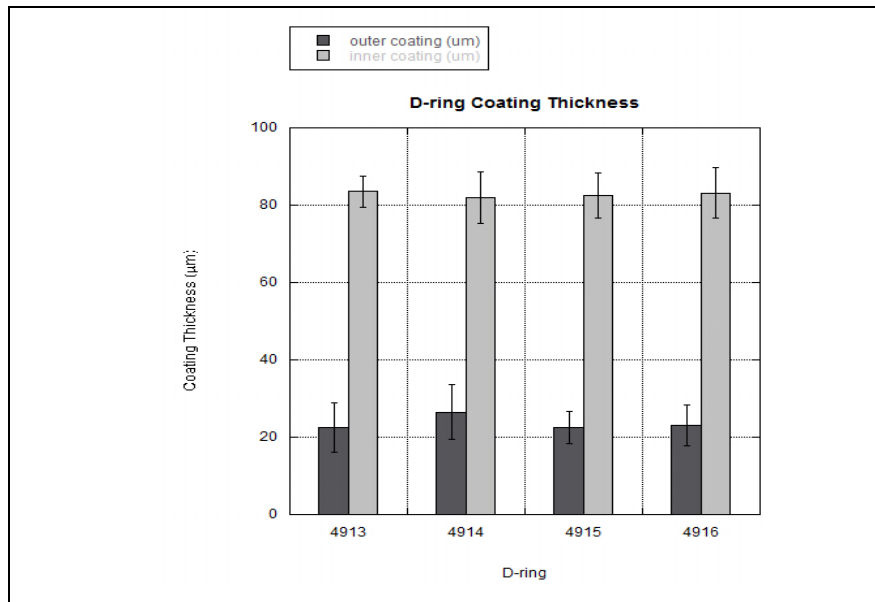
**FIGURE 40 Aluminum (outer) and Nickel (inner) Coating Thicknesses for the Four D-ring Samples.**
