GEOTECHNICAL ASPECTS OF THE SUMATRA EARTHQUAKE OF SEPTEMBER 30, 2009, INDONESIA

ABSTRACT

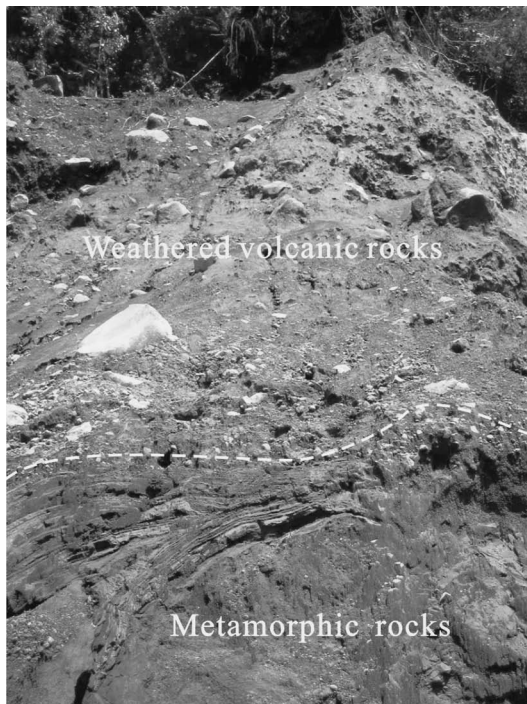
Fig. 13. Geologic characteristics of rock falls

earthquake were observed along the road connecting Pariaman with Padang Panjang (Fig. 1). Figure 12 shows a slope failure that blocked the road at a place called Salaing, suspending the traffic for 2 days. Huge rocks with a diameter of 3 m and weathered colluvium were the material that cascaded down the slope and plunged into the river (Fig. 12(b)). The slope inclination was measured to be about 45 degrees and the height was estimated to be approximately 70 m. The geologic characteristics of such rock slides can be described as follows: the top part of the slope is comprised of volcanic material (andesite or basalt) while the toe part is typically represented by metamorphic rocks (Fig. 13).

It seems that the main cause of rock slides was weathering; however, at the time of the survey, it was not clear whether the road construction of previous years affected

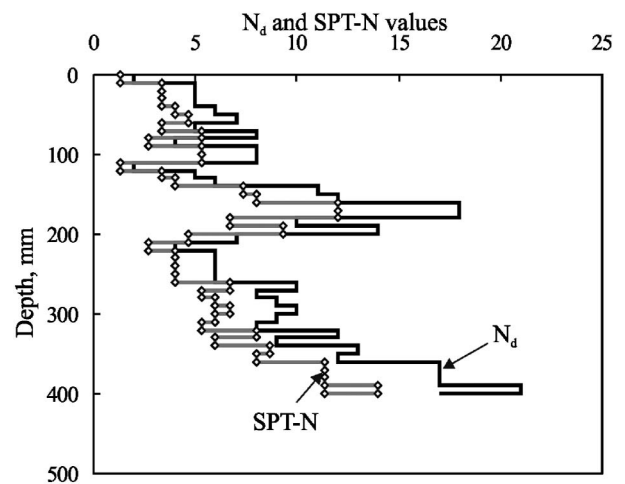
Fig. 15. Results of dynamic cone penetration test. N_d —measured values during testing, SPT N —corresponding values of standard penetration test

A penetration test was conducted on the top of the sliding mass near the scarp area of the landslide shown in Fig. 9. Figure 15 shows the variation of measured N_d values with depth and the corresponding SPT N -values. From these data it can be inferred that the soil was weak: the N -values were typically in the range of 3 to 7. According to the Field Investigation Handbook of the Japanese Geotechnical Society (2004), granular soil with such penetration characteristics can be described as loose material with a friction angle of about 30 degrees.

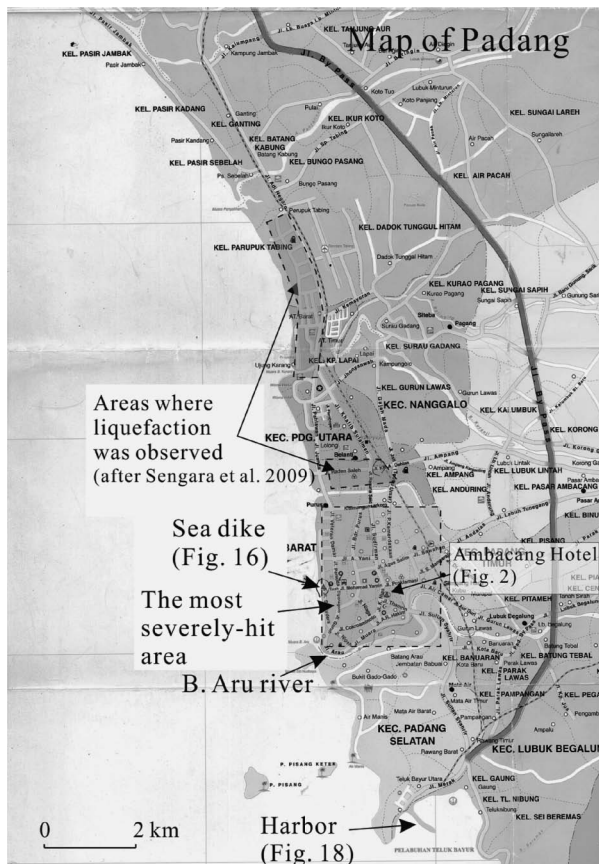
Fig. 17. A map of Padang city showing the areas which were the most severely affected by the earthquake

Local soil conditions seem to have played an important role in the stability of houses and institutional buildings during the earthquake in Padang. It was observed that the most severely-hit area with the largest structural damage was located in the vicinity of the B. Aru river (Fig. 17). It is likely that soft alluvial deposits caused considerable amplification of the ground motion, resulting in larger deformations. It is noted that in Sumatra, a
