## FAILURE OF REINFORCED EARTH AS ATTACKED BY TYPHOON NO. 23 IN 2004

In October 2004, Typhoon No. 23 attacked western part of Japan, causing severe damage to infrastructures over a wide area in Kansai. In the early morning on 21st October, failure of a large Reinforced Earth wall with the maximum height of about 23 m took place in a mountainous area in Yabu city, Hyogo Prefecture. The debris flow from the reinforced embankment attacked a warehouse at the foot of the mountain, however, no casualties were reported. Immediately after the incident, an investigation committee was set up with missions to investigate the causes of this catastrophic embankment failure and also to examine any possible occurrence of further slope disasters in this region. In this paper, the failure mechanism by considering causes of the slope failure is discussed based on the results of stability analysis performed using laboratory and field data, coupled with topological information and the rainfall data. Some lessons learnt from this unique case study are described with reference to the design and construction of Reinforced Earth wall in rainy mountainous areas, in particular.

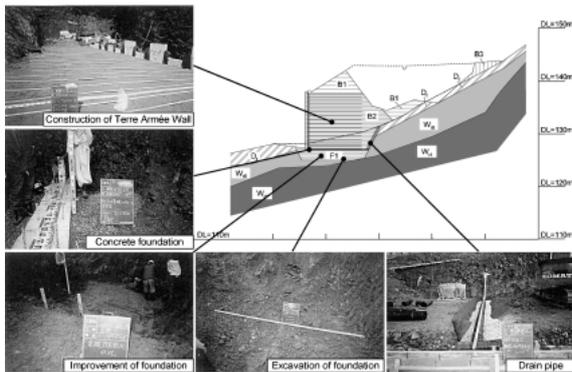
Fig. 5. Construction sequence of the wall

Figure 5 shows the sequence of construction of this wall in the year of 2000. Some features pertaining to the design and construction of the wall are summarized in the below (Shibuya and Kawaguchi, 2006):

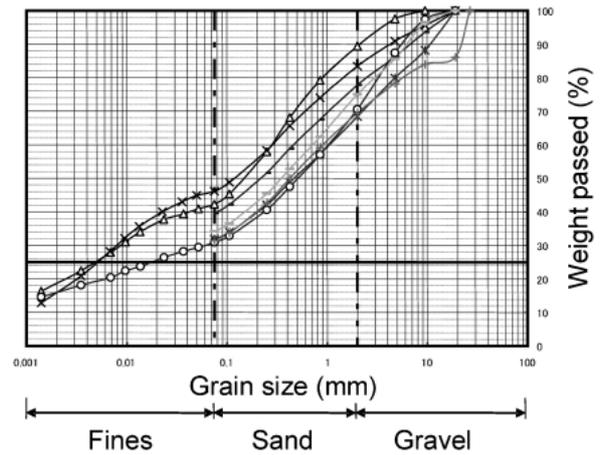
Fig. 6. Grain size distribution of soil

- i) Local geomaterials, i.e., weathered silty soil originated from yellow tuff, with the fines content well in excess of 25% was employed for constructing the wall, noting that Fig. 6 shows the distribution curve of several samples from B2 layer,
- ii) Drain pipe with a small diameter of 200 mm was employed at the bottom of the wall, but it did not extend to cover an area behind the wall (see Fig. 5),
- iii) The surface of the road had been unpaved over the past four years, and
- iv) SPT *N*-value in the foundation ranged between 15 and 20, which was surprisingly low to support the soil wall with the maximum height of 23 m.

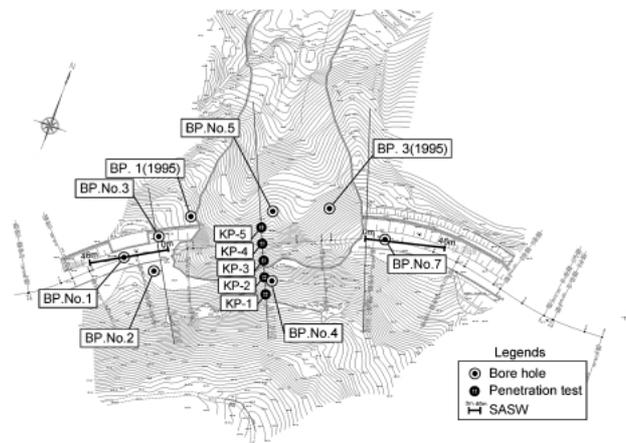
Fig. 7. Geotechnical site investigation performed

The site is covered with heavily weathered soil originated from yellow tuff. Geotechnical site investigation performed is shown in Fig. 7. The scheme consisted of SPT sounding and in-situ seismic survey to cover the survived as well as the collapsed portions of the wall. The SPT sounding along three survey lines from south to north involved with soil sampling by using the Japanese thin-wall sampler. Spectrum analysis of surface wave (SASW) (Stokoe et al., 1988) was also carried out at the survived parts of the wall.

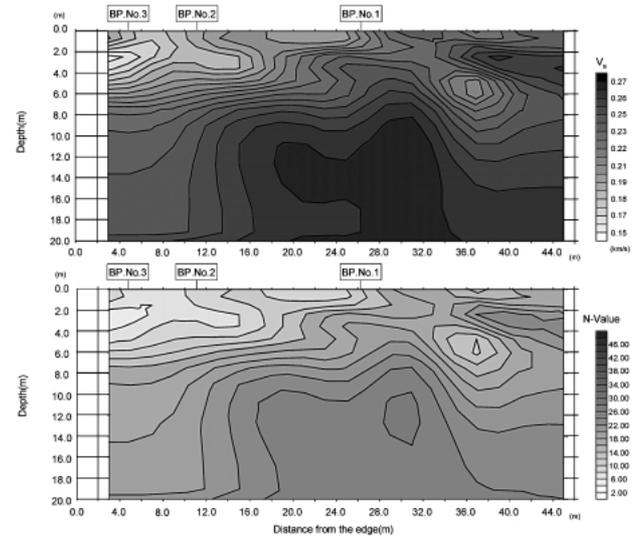
Fig. 9. Profile of shear wave velocity from SASW method (west side)

SASW survey is a non-destructive method by which the profile of shear wave velocity,  $V_s$ , with depth is easily manifested down to the depth of about 20 m. Figure 9 shows the result of the survey performed at west end of the remaining wall (see Fig. 7). In this figure, the  $N$ -value estimated using the following empirical expression is also shown for comparison.

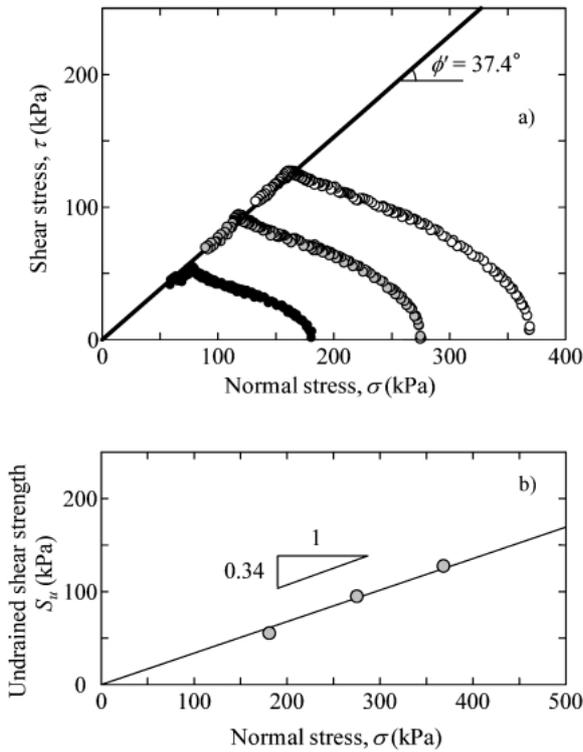
Fig. 12. Results of conventional direct shear test: a) effective stress paths and b) undrained shear strength

Regarding a sketch shown in Fig. 11, three samples in the first series were each consolidated to the vertical consolidation stress,  $\sigma_{vc}$  of about 200, 300 and 400 kPa, respectively. Afterwards, the samples were sheared under constant-volume conditions by using a constant rate of horizontal displacement of 2 mm/min. The undrained effective stress paths of this conventional consolidated-undrained (CU) test are shown in Fig. 12, in which the variation of normal (= vertical) effective stress is plotted against the horizontal shear stress,  $\tau$ . The effective strength parameters of  $(c', \phi') = (0, 37.4^\circ)$ , together with the total stress parameters,  $S_u/\sigma_{vc} = 0.34$  were obtained

consequence, the undrained shear strength  $S_u$  (i.e., the maximum shear stress) also increased with the sustained period of initial shear. On the other hand, the effective strength parameters of  $(c', \phi') = (0, 37.4^\circ)$  were not affected at all by the application of initial shear (refer to Fig. 12). The significant softening behavior observed in the second series suggests strongly that a catastrophic type of failure would take place once the foundation soil exceeds the peak strength.

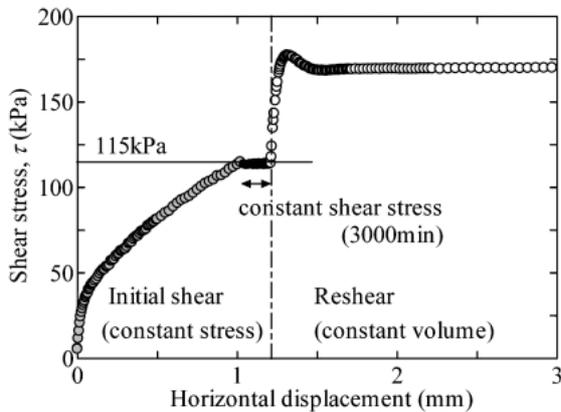
Fig. 13. Relationship between horizontal shear stress and horizontal displacement in a test with initial shear

Figures 13 and 14 show the results of five tests performed in the second series. As can be seen in Fig. 13, each sample was first consolidated to a prescribed initial (and common) vertical stress of  $\sigma_i = 246$  kPa ( $= 300 \times \cos^2 25^\circ$ ), where the angle of  $25^\circ$  corresponds to the averaged angle of the collapsed slope from the horizontal (see Fig. 3). The sample was then subjected to application of drained initial shear to the value of  $\tau_i = 115$  kPa ( $= 300 \times$

- i) Concentration of in-soil seepage and surface water flow into the collapsed area,
- ii) Relatively low permeability of embankment (B1, B2 and B3 layers) as compared to the weathered rock foundation ( $W_{r0}$ -layer) (see Fig. 8),
- iii) Poor drain system behind the wall in particular,
- iv) Low bearing capacity of the foundation, and
- v) Softening characteristic of the foundation soil as sheared undrained (see Figs. 13 and 14).

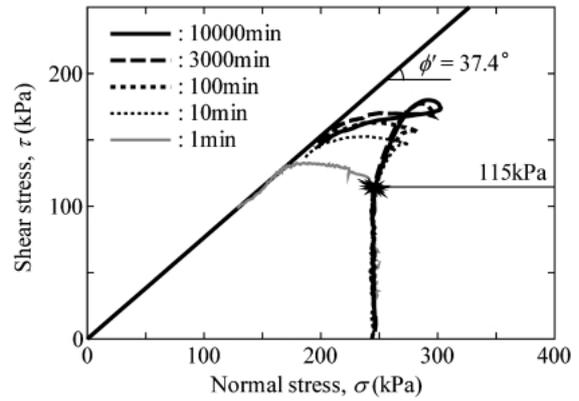
Fig. 14. Undrained effective stress paths in direct shear box test with initial shear

$\cos 25^\circ \sin 25^\circ$ ) by using a slower rate of horizontal shear displacement of 0.02 mm/min. The initial shear stress was then maintained constant over a prescribed period in each test. At this initial shear stage, the volume change of the sample was insignificant whereas the horizontal shear displacement developed as much as 0.2 mm (see Fig. 13). The sample was finally sheared to failure under the conditions of constant volume by using a faster rate of 2 mm/min. The initial shear stress was maintained over different, but fixed, periods of 1, 10, 100, 3,000 and 10,000 min, respectively. Surprisingly, the effective stress path was very much influenced by the duration of the initial shear stress application, showing that it rose more sharply as the duration increased (see Fig. 14). As a

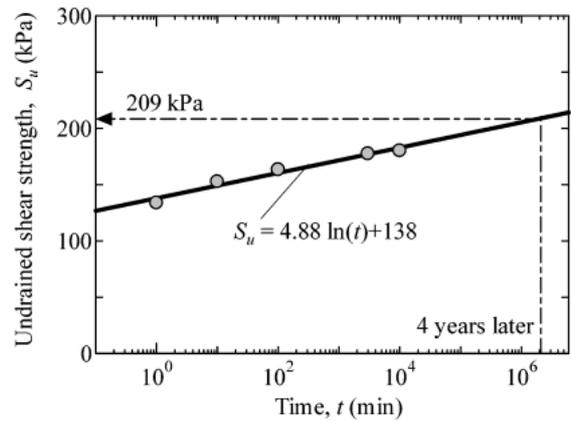
Fig. 15. Undrained shear strength versus duration of initial shear stress applied

Figure 15 shows the  $S_u$  value in the second series when examined against the sustained period of initial shear. Bearing in mind that the wall collapsed at 4 years after the construction, the value of 209 kPa for  $\sigma_{vc} = 300$  kPa, hence  $S_u/\sigma_{vc} = 209/300 = 0.70$ , was attained by extrapolating the  $S_u$  values from the laboratory test to an instant after 4 years.
