# Moving and Straightening the Building Segment

Krzysztof Gromysz<sup>1</sup>

<sup>1</sup> Silesian University of Technology, ul. Akademicka 5, 44-100 Gliwice, Poland

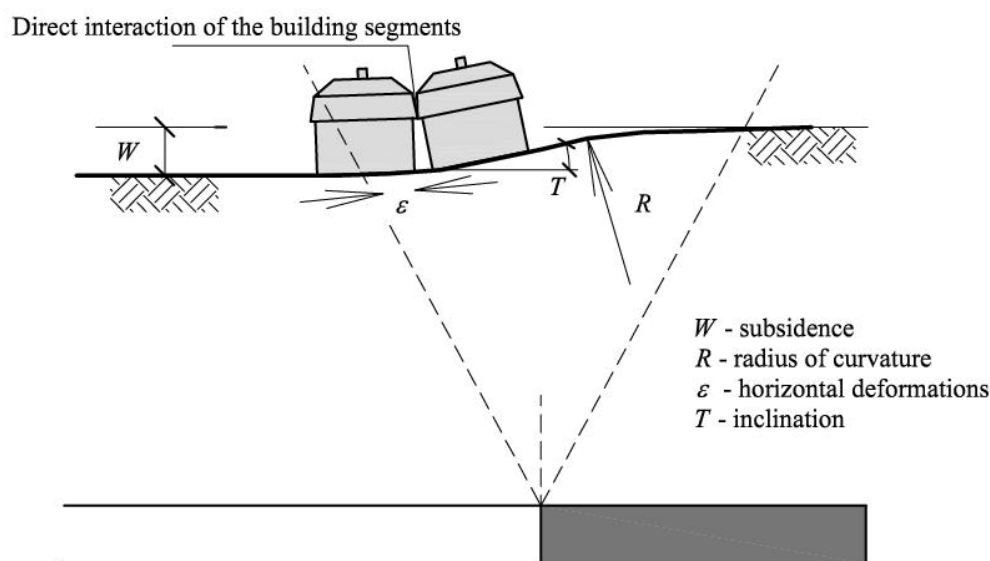
Underground coal mining causes land surface deformations characterised by the four basic parameters: depression –  $W$ , horizontal deformation –  $\varepsilon$ , radius of curvature–  $R$  and sloping  $T$  (Figure 1). As a consequence, the distance between segments of buildings is changed and their mutual rotation occurs. This may lead to a building failure in buildings with wrongly designed or constructed expansion joints. For example, [1] shows a failure of a multi-segment, ten-floor building made of large panels. Due to the wrongly shaped and located expansion joint, two segments were interacting with each other directly (compression in the expansion joint). The actual load-bearing capacity of the walls, upon which the ceiling was rested, was lost. The emergency protection procedures presented in [1], and then time- and cost-intensive renovation have allowed to avoid an advancing disaster and to use the structure again. A case is presented in [2, 3], where the lines of five-floor residential segments, built with the traditional technology, have their expansion joints closed down. Because the segments are interacting with each other, a failure of the structures' longitudinal walls took place during the occurrence of horizontal mining area deformations of the compression character. The extent of damages in this case was so large that a decision was made to disassemble the damaged buildings.

**Figure 1.** Direct interaction of the segments (compression and closing down of the expansion joint) as a result of mining land curvature ( $1/R$ ) and horizontal deformations ( $\epsilon$ )
