# Applications of Thermal Visual Measurements in Light of Toughened Up Legislation

**Abstract.** The purpose of research was to verify the impact of thermal modernization of existing buildings on their energy performance in light of toughened up legislation. The paper answers the question - how thermo-modernization can affect the reduction of its needs for the building and contribute to the reduction of dust emitted, when heating is based on solid fuels. Some houses of similar typical construction which was very popular in Poland in 70', were tested. In one of them, doors and windows were replaced, but its elevation was left without insulation, while in another one, the thermal insulation was made, but old wooden door and window framing has been left. The research carried out with the thermovision camera allows a qualitative estimation of heat leakage from buildings. The test results were developed in detail in the Flir Tools software and the value of the building's heat demand was estimated before and after the thermo-modernization of the building or replacement of framing. On the basis of the conducted research, it is justified that even very high quality framing not accompanied

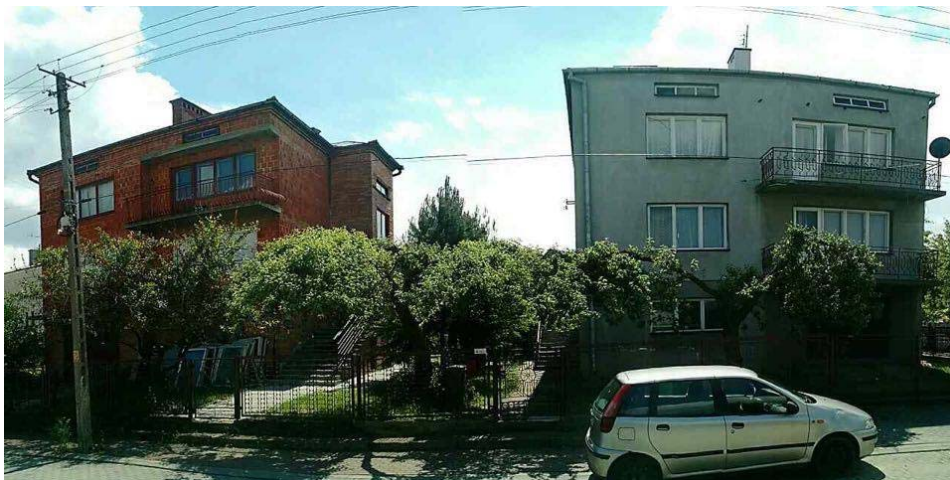
Figure 3 shows a digital photograph of objects, that are subject to the study. In the building located on the left, the wooden door and window framing on the first floor, was replaced by a polyvinyl chloride. For needs of the article, this building was given the number II. In the 1<sup>st</sup> building, thermo-modernization of the elevation was carried out. External walls were insulated with polystyrene boards with a thickness of 12cm, characterized by a thermal conductivity  $\lambda = 0,04$  [W/mK]. After installing the expanded polystyrene boards, the walls were pargeted with cement and lime plaster 1,5cm thickness. Thermovision studies were carried out for the western elevation. Before carrying out work, the following parameters were inputted in the measuring device:

**Figure 3.** Residential buildings subjected to thermal imaging. On the right side – 1<sup>st</sup> building, on the left side – 2<sup>nd</sup> building [authors discography resources]
