Experience of using the ultrasonic low-frequency tomograph for inspection of reinforced concrete structures

To cite this article: M S Kuznetsov *et al* 2019 *IOP Conf. Ser.: Mater. Sci. Eng.* **481** 012047

M S Kuznetsov¹, O V Maltseva,² A S Noskov,³ A S Kuznetsov⁴

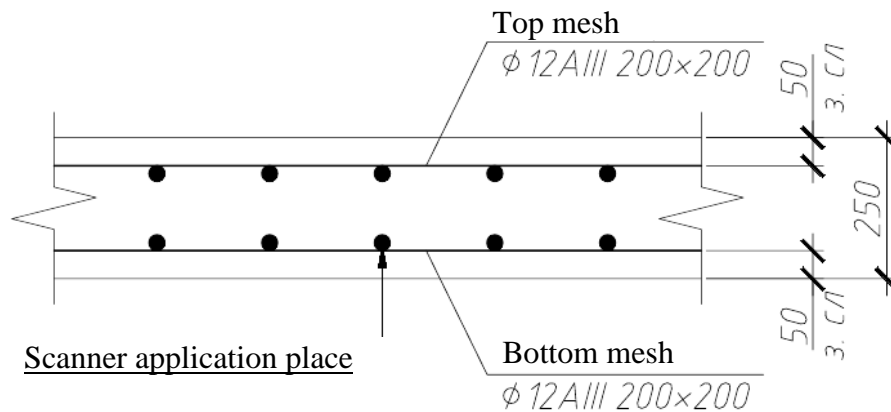
Please find below several examples. Scanning of the 250-mm floor. The reinforcement diagram and the antenna array application area are shown in Figure 2 below. The flooring is reinforced by two meshes, the bottom and the top, made of dia. 12-mm bars arranged in two orthogonally related directions with a 200-mm spacing. The protective mesh concrete layer thickness is 50 mm on both sides.

about 50 mm from the structure's surface where the device is located, show the bottom reinforcement mesh of the flooring. The top reinforcement mesh, judging by the scan, is located about 150 mm from the floor surface. The ultrasonic waves are echoed from the bottom surface of the flooring at the interface between concrete and air (by reference to the device location), which is seen on the scan as a large image with Z coordinates equal to 250 mm, or the so-called backwall image. Its location confirms the thickness of the flooring being tested. The B-scan shows no images other than those which belong to the design elements. Thus, there are no structural flaws (discontinuities) of concrete on the scanned area of the floor structure detected.

Figure 2. The floor reinforcement pattern and the device application place.

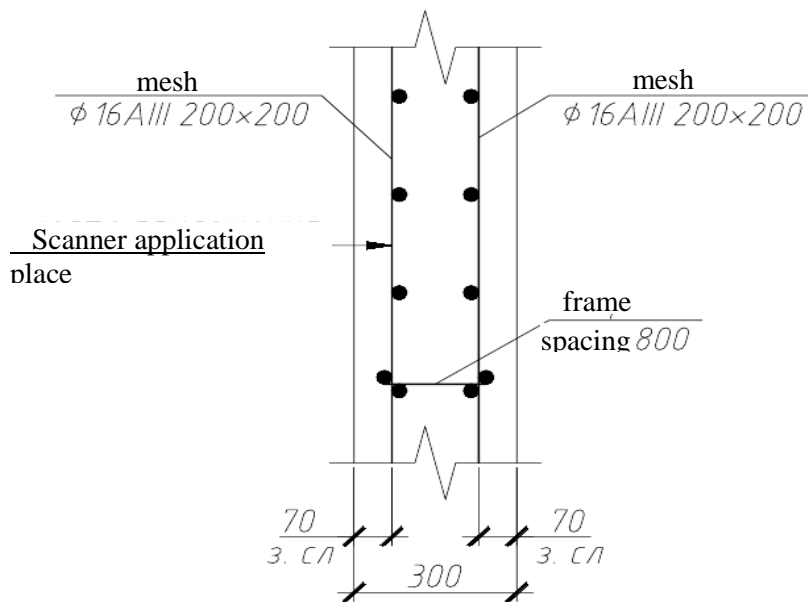
The scans below are made on the 300-mm wall of a tank. The wall reinforcement pattern and the tomograph's antenna array application diagram are shown at Fig. 4. The wall is reinforced by two meshes interconnected by transverse frames.

Figure 4. The tank wall reinforcement pattern and the tomograph's antenna array application diagram.
