# Failure analysis of the fracture surface of the crankshaft of a vehicle

**Abstract.** The purpose of this study was to determine the cause of a fracture in the crankshaft of a 1000 cc gasoline engine. On the broken surface, it could be seen that the cracks started from the direction of the oil hole. A visual examination revealed that there were beach marks on the surface of the fracture, which is usually common in fatigue failure due to a dynamic load. From the test for the chemical composition, it was found that the material was classified as alloy steel. The Rockwell-based material hardness values were different. The highest hardness value of 102.2 HR<sub>B</sub> was on the outer shell portion of the crankshaft on the *x* and *y* axes at points 1 and 14. Finally, it was concluded that the reason for the fracture in the crankshaft was fatigue failure, the material hardness that did not match that of the standard, as well as the initial crack contained within the radius of crank pin number 1.

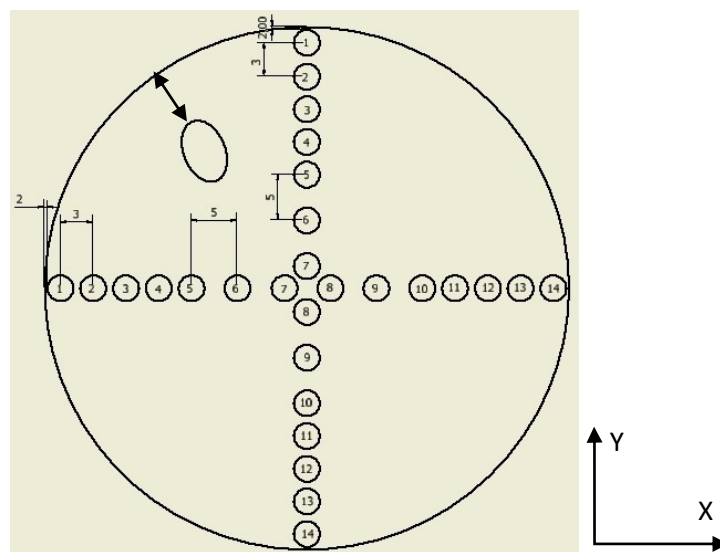
**Figure 4.** Hardness testing point.

From the hardness test results, it was found that the highest hardness value of 102.2 HR<sub>B</sub> was on the outer shell portion of the crankshaft on the  $x$  and  $y$  axes at points 1 and 14. The hardness testing point can be seen in Figure 5. The hardness of the shaft on the outer shell was greater than at the centre to avoid defects and rapid wear during work. The hardness reached 13 mm from the outer surface of the crankshaft. Due to the unsuitable heat treatment process, the crankshaft was harder than the standard AISI 1060 material, which was 94 HR<sub>B</sub>, while the average hardness of the crankshaft material that was tested was 100,83 HR<sub>B</sub>. Therefore, the crankshaft, which was too hard to overheat up to a depth 13 mm from the outer surface, was prone to failure.
