Load-deformation analysis on a slope at Gunung Pulai water treatment plant, Sultan Ibrahim Reservoir

K Azman*, M Mushairry¹, A R Ahmad Safuan¹, O Mohd Hanim¹, I Izni Syahrizal¹, V Mohammadreza¹, C A Sophia¹, M A Mohd Azreen¹, A Rini Asnida¹, S Radzuan¹, H Muhammad Azril¹, A Mohd Nur Asmawisham¹, M A Mohd For¹, T Sahrul Nizam¹, A R Afif¹, K Kamrul Zaman¹, H Hairul Hairi¹, A W Zulkifly¹, D S A Ismail¹ and M A R Muhammad Fateh¹

¹School of Civil Engineering, Faculty of Engineering, Universiti Teknologi Malaysia 81310 Johor Bahru, Johor, Malaysia

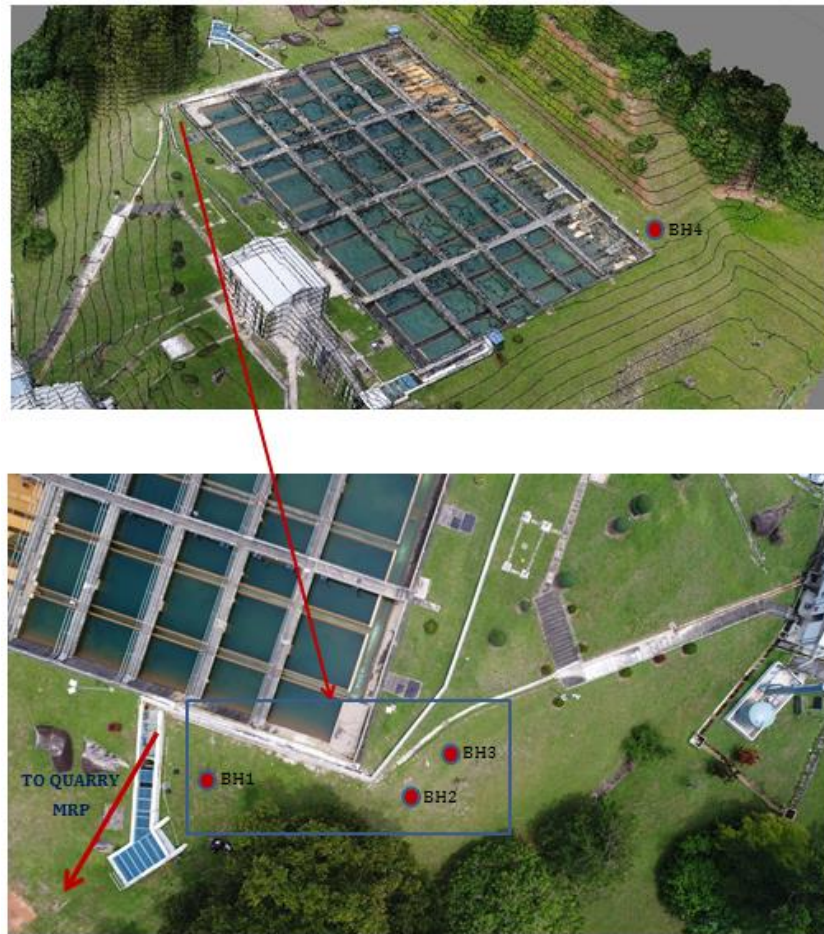
Figure 3. Location of BH1, BH2, BH3 and BH4.

The rotary boring was carried out in accordance to the British Standard Code of Practice BSI 5930: 1999 – “Site Investigation” and laboratory tests are accordance to BSI 1377: 1990. Altogether four (4) numbers of boreholes were conducted at the proposed site as shown in Figure 3. The borehole was advanced by mean of Rotary Boring Machine (YWE). However, due to condition on site, none of pneumatic piezometer and inclinometer has been successfully installed.
