## Study of leaf spring fracture behavior used in the suspension systems in the diesel truck vehicles

To cite this article: Husaini *et al* 2019 *IOP Conf. Ser.: Mater. Sci. Eng.* **541** 012046

# Study of leaf spring fracture behavior used in the suspension systems in the diesel truck vehicles

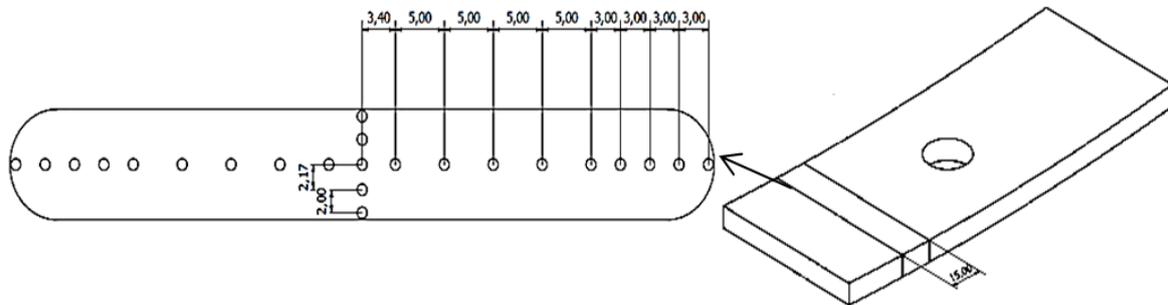
**Figure 5.** Specimen configuration with hardness testing points marked with small circles (o).

In this study also conducted a hardness test using Rockwell Type Zwick / Roell ZHR to measure hardness on the surface and core of leaf spring specimens [10]. The indenter used is a steel ball with a diameter of 1/16 in and 100 kg of loading. The hardness test specimen is shown in Figure 5.

The hardness test results in the horizontal direction from point A to B and the vertical direction from point C to D as shown in Figure 7. The distance between test points is approximately 2 to 5 mm (see Figure 6.a). Hardness in the area close to the bolt hole or at the core is lower than the hardness value in the part close to the side of the spring surface. It shows that the toughness of the material in the center of the leaf spring is higher than the part on the outer side of the spring. Therefore this spring is very susceptible to fracture. This result is in accordance with the results reported by previous researchers [2][7].
