Scuffing analysis of roller-shoe mechanism after an aggressive test

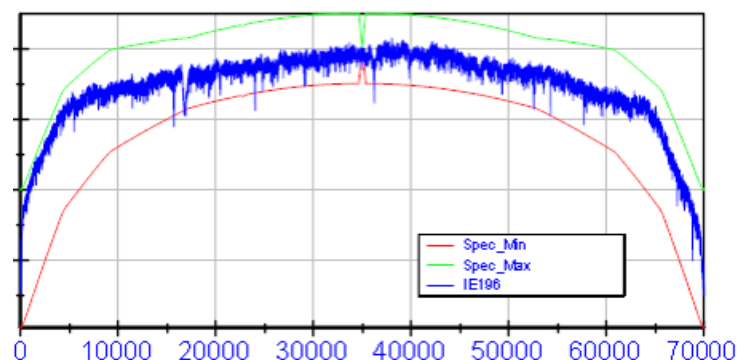
The second test is performed with a special assembled pump. The main defect is the low clearance between the components (figure 7). The roller profile (figure 8) and the dimensions of all components are within the manufacturer's imposed limits.

Figure 8. Roller profile – initial condition.
