## Risk Analysis of Rural Housing in yingshang County Anhui Province—For example Brick-Wood Structure

# Risk Analysis of Rural Housing in yingshang County Anhui Province—For example Brick-Wood Structure

**Abstract:** Through the observation and judgment of rural dilapidated houses in yingshang County, by inductive statistics and analysis of data, the criteria for identification of rural dilapidated buildings are used to define rural areas with qualitative and quantitative criteria. The housing is divided into hazard levels, and the structural damage form of the house is pointed out. According to above materials, professional treatment suggestions are given to provide reference and reference for the identification of rural dilapidated buildings in the future.

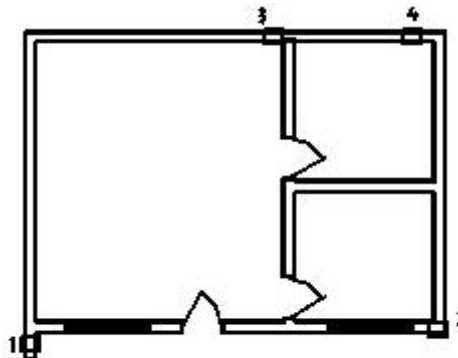
Figure 1. Construction Plan.

This paper takes a rural brick-wood structure house in Nongke Village, Jiangdian Town, Yingshang County, Anhui Province as an example to identify and analyze dangerous houses. This house was built in the 1980s with no repair or maintenance of the truss. After conducting on-site observation and inspection, taking photos and samples of the house, we observed four dangerous aspects in this rural house. See Figure 1.
