## Flashover characteristics of plastic cloth on $\pm 800$ kV HVDC transmission line

Hui Liu<sup>1,3</sup>, Chao Zhou<sup>1</sup>, Qinghe Shen<sup>1</sup>, Bo Yang<sup>2</sup>, Xiaobin Sun<sup>2</sup>, Zhenning Huang<sup>2</sup>, Rong Liu<sup>1</sup> and Chuanbin Liu<sup>1</sup>

<sup>1</sup> Shandong Electric Power Research Institute, Jinan 250002, China;

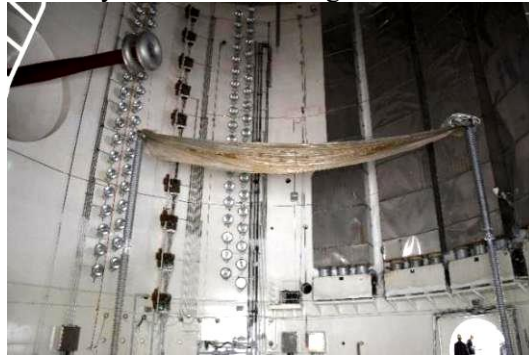
**Figure 11.** DC voltage flashover test layout.

Another plastic cloth, 19.4m long, 6m wide and 11.5m pole spacing, is selected from the same greenhouse at the fault point. DC voltage flashover test is carried out after wetting. Deionized water is used to moisten the plastic cloth and the water consumption is 8.5L. Add the DC voltage to the wetting plastic until the flashover. The test layout is shown in Figure 11.

During the process, the local arc appears near the high-voltage end of the plastic cloth. The plastics layout obviously heats up and starts small-scale combustion. The infrared spectrum has obvious hot spots. From figure. 12 (c), UV spectrum has violent discharge phenomenon. When approaching the flashover voltage of 640kV, whole arc of the plastic cloth appears from high voltage end to the ground end. After the gap breakdown, the plastic cloth near the high-voltage electrode continues to burn, the combustion is not intense, but doesn't extinguish naturally. The above test results show that the intense discharge at flashover moment is not enough to cause the break of plastic cloth. After the

discharge, the plastic cloth will continue to burn. Finally, the plastic cloth may break, separating from the conductor and even falling to the ground completely. This is consistent with the situation found by the inspectors But the process lasts for about 10 minutes.
