Repairs and Construction Technique of Neoteric Buildings in China: A Case Study of the Building of College of Engineering in Wuhan University

Yiwen Chen, Qing Zeng, Huiwang Cai and Zhi Liu

Office of Logistics Service, Wuhan University, Wuhan, Hubei Province, P. R. China

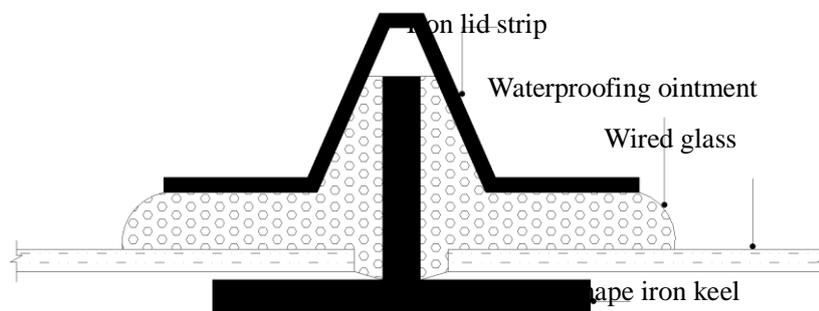
Figure 3. Partially Structure Schematic Diagram of the Glass Ceiling

Before the glass roof of the building was removed, the roof was photographed and imaged, and then the glass top surface was surveyed and mapped. According to the result of surveying and mapping, the components that couldn't continue to be safely used are processed according to the

original condition. Glass iron lid strip, original wired glass and T-shape iron keel were protectively disassembled from top to bottom (As shown in Fig.4).

Steel components of the roof structure were repaired. All oil paint in original steel roof trusses were removed and rusts were removed by polishing. All steel roof trusses were brushed with antirust paint. Steel roof trusses were embedded twice with fluorocarbon putty and polished, and then coated with fluorocarbon paint. As for the steel structure wrapped in concrete outside, the coating material on the concrete was washed with high-pressure water gun, then the cleaned concrete was embedded with fluorocarbon putty and brushed with fluorocarbon paint.

From the bottom up, the copper cover strips were covered, and tung oil lime paste was filled between the copper cover strip and the glass. Anti-fall stainless steel wire mesh was installed below the glass and in the inner side of the steel roof truss to prevent top surface glass from falling because of wind pressure and other factors.

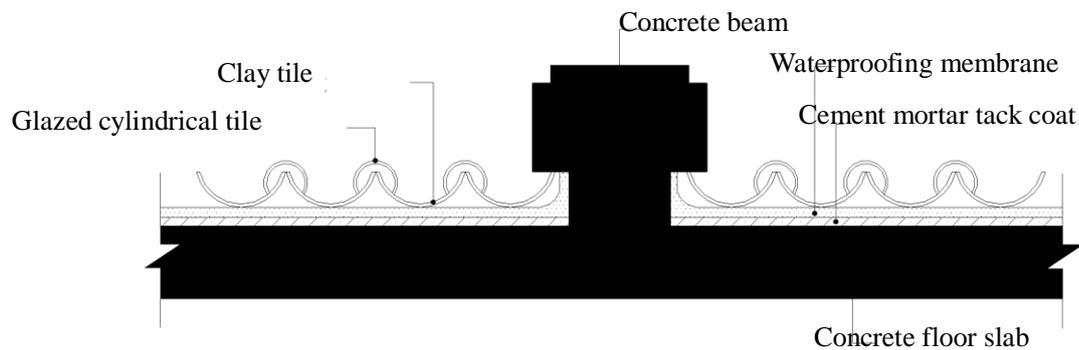
Figure 8. Structure schematic diagram for concrete tile roof

Fig.8 shows the structure schematic diagram for concrete tile roof. The plane layout and paving method of the original roof were surveyed and recorded. The damage data of glazed cylindrical tile, clay tile, drip tile and eave tile were obtained.

The supplementary tiles were custom processed according to the type, size and number of damage of the various tiles. These customized tiles were made of original size, original material and original color. The glazed cylindrical tiles and clay tiles were disassembled from top to bottom and classified and stacked (As shown in Fig. 9).
