Analysis and treatment of the shutdown reasons of ultra-supercritical 1000MW steam turbine generator set

Abstract. When a power plant ultra-supercritical 1000MW steam turbine generator set is running normally, the electric valve at the outlet of A steam feed pump appears serious leakage. Through on-site inspection and inspection of maintenance records, starting from the structure of the electric valve, the leakage fault of the electric valve at the outlet of A steam feed pump is diagnosed and investigated, and the cause of the fault is accurately analyzed. The leakage problem of the electric valve at the outlet of A steam feed pump has been thoroughly solved by taking effective measures such as changing the packing type, arrangement and improving the installation process.

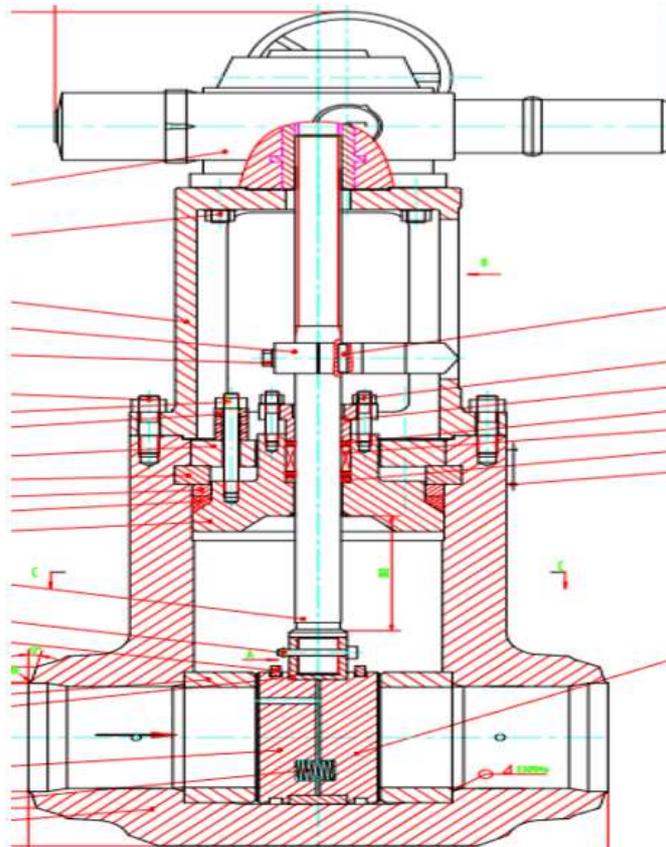
The export electric valves of A and B steam feed pump are provided by Harbin power station valve co., LTD. The types of A and B steam feed pump outlet electric valve are DN400, PN42 gate valve, which are parallel gate structures (seen in figure1). The valves are arranged on the running floor (17m) of the steam turbine room. The inlet of the outlet electric valve is connected to the outlet pipe of the steam feed pump, valve seal adopts packing graphite packing type. The valve consists of valve body, spring, left disc, right disc, packing chamber seat, packing seat ring, stem, packing gland, guide plate, electric device, support, clamping ring, gate, presser plate, pressing ring, pad block, four-way ring, sealing ring, locating pin, stud and nut, etc. There are two main types of sealing packing, top and bottom of the outermost for braided graphite packing, the middle layer for flexible graphite packing [1].

Figure 1. Profile of the A electric valve at the outlet of the steam feed pump the connection.
