Study on Breakage Cause of Copper Pipe

Bin Li¹, Song Guo¹, Wei Li¹, De-man Zhang¹, Bo Wang¹

¹Wuhan Second Ship Design and Research Institute, Wuhan, China

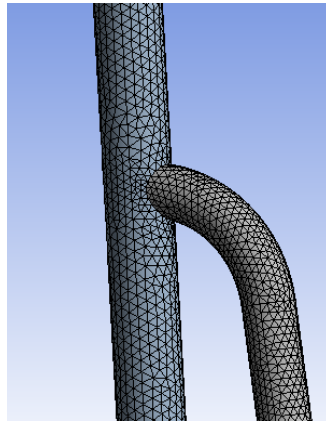
Fig 3 Schematic mesh diagram of water supply pipe

The meshes of the whole computational domain were divided by ANSYS ICEM software. The meshes were unstructured tetrahedron meshes. The single layer meshes on the wall were controlled between of 30-300. The unsteady simulation of the unstructured meshes mentioned above was carried out by CFD software Fluent. The boundary adjustment of the pipe wall was set as the wall boundary condition. As seen in Fig 3.
