Tree architecture models, canopy maintenance, and associated root problems of angsana (*Pterocarpus indicus* Willd.) in the urban trees of Yogyakarta

Abstract. Troll's architecture model of angsana (*Pterocarpus indicus* Willd.) serves as a shading tree in most of the main roads in Yogyakarta. However, its lateral roots potentially damage sidewalks and cause accidents to people. This research was aimed to understand the damage types associated with the root problem, the relationship between stem diameter and root development, and angsana maintenance. Data were collected during January-July 2015 by inventory, tree identification, and interview. We categorized the types of damage into three scales, respectively: scale 1. Cracks in pots if the trees grow in pots, slight cracks on the road surface; scale 2. Roots start to slightly appear on the road surface and cause cracks in the road or damage the pots; scale 3. Roots appear on the road surface and cause a bend that harms road users or pots raised by roots. There is a relation between the size of stem diameter and its damage. Angsana starts to cause damage with a diameter of 20–29 cm on the divider and 30–39 cm on the sidewalk. We s

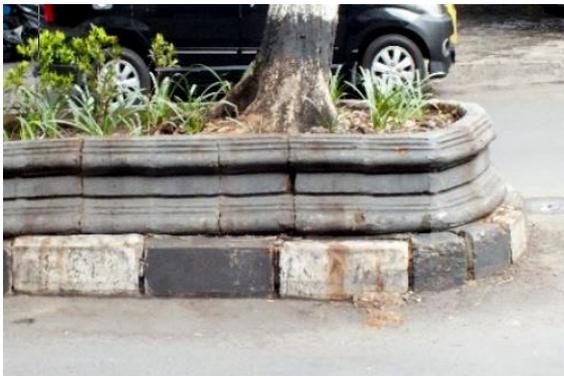
Figure 9. Angsana grows in Affandi road on the median road in the buis concrete and pots 68 cm in height (image source: [23]).

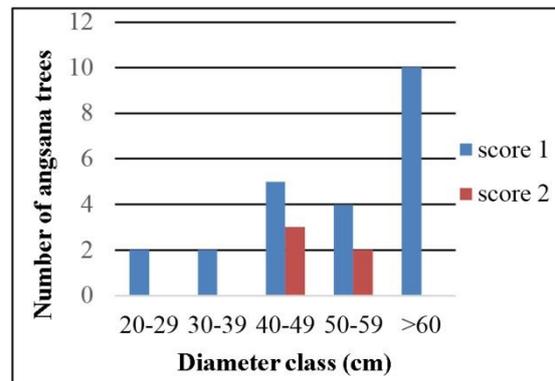
Figure 10. Characteristics of damage by the Angsana root in Affandi road. Score 1 is higher than score 2.

Figure 10 displays score 1, which is the lowest level of damage, found in each grade of the diameter with the highest diameter class is > 60 cm. However, score 2 is only found in two classes of diameter, which is the 40–49 cm class, and the 50–59 cm class, with the highest grade at 40–49 cm. The trees categorized in score 1 amounts up to 23 trees, and trees with score 2 amounts up to 5 trees.

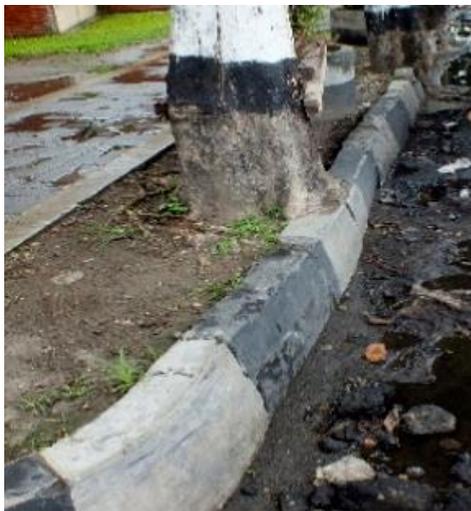
Figure 11. Angsana grows in Glagahsari street on the right-left side of the road (image source: [23]).

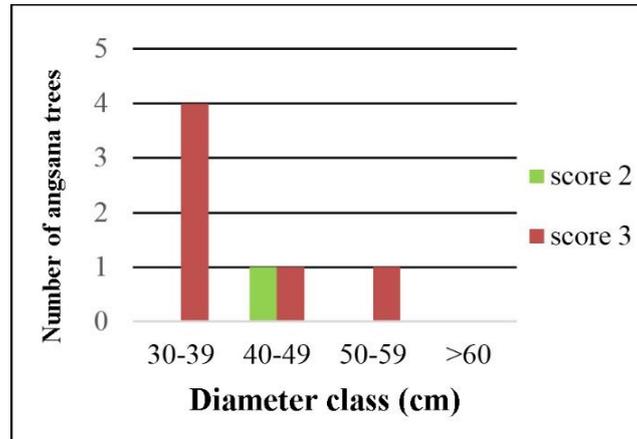
Figure 13. Damage characteristics by the root of the angana in Glagahsari street is dominated by score 3.

We recorded 51 angana trees, but only 7 trees that caused damage at Glagahsari street. Figure 12 and figure 13 displays the extent of damage encountered on this road is score 2 and score 3. Six trees have a score of 2 with a diameter range of 30–39 cm. One tree has a score of 3, which has the highest level of damage. This tree is categorized in the diameter class of 40–49 cm.

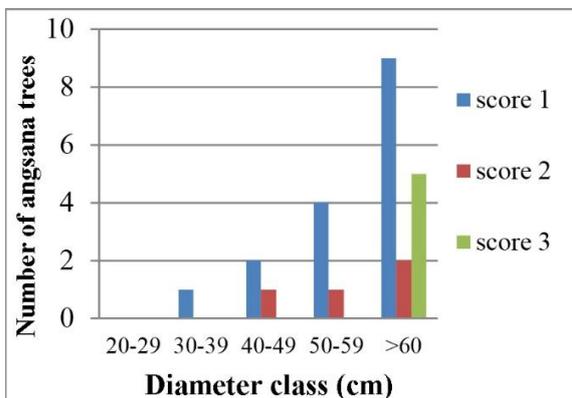
In Kusumanegara street, score 1 has the largest number of all scores. Score 1 almost exist in all diameter classes in which the biggest diameter size could be classified in diameter class ≥ 60 cm (figure 14). Trees included in score 2 are fewer, but the largest diameter size from this score can be classed in ≥ 60 cm of the diameter class. Score 3 has 5 trees and all those trees have been included in ≥ 60 cm diameter class. The characteristics of damage caused by angana roots are displayed in figure 15-figure 17.

Figure 14. Damage score by angana roots in Kusumanegara road, Yogyakarta.

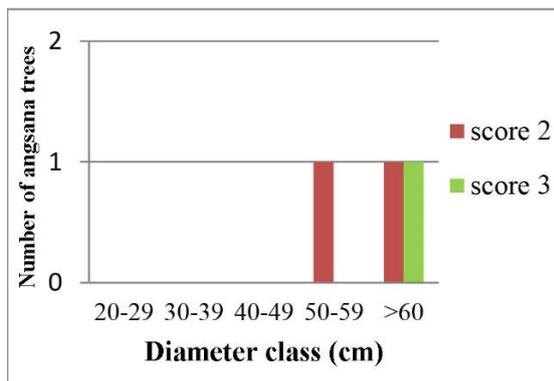
3.1.4. Laksda Adisucipto road. The Laksda Adisucipto road has a total length of 414 meters, width of 14 and a sidewalk of 2 meters on two sides of the road. We observed the distance of 53.31 meters (12,9%) and recorded 3 trees with damages characteristics of score 2 and score 3 (figure 18). Two trees, which are categorized in score 3, have the range diameter class of 50-59 cm and ≥ 60 cm, while the other one (score 2) has a diameter class of ≥ 60 cm. In Laksda Adisucipto street, the angšana root damaged the sidewalk (figure 19) and cracked the asphalt in the roadside (figure 20).

Figure 18. Damage score by angšana roots in Laksda Adisucipto road, Yogyakarta.
