The evaluation of damage mechanism of unreinforced masonry buildings after Van (2011) and Elazig (2010) Earthquakes

D Güney¹, E Aydın², B Öztürk³

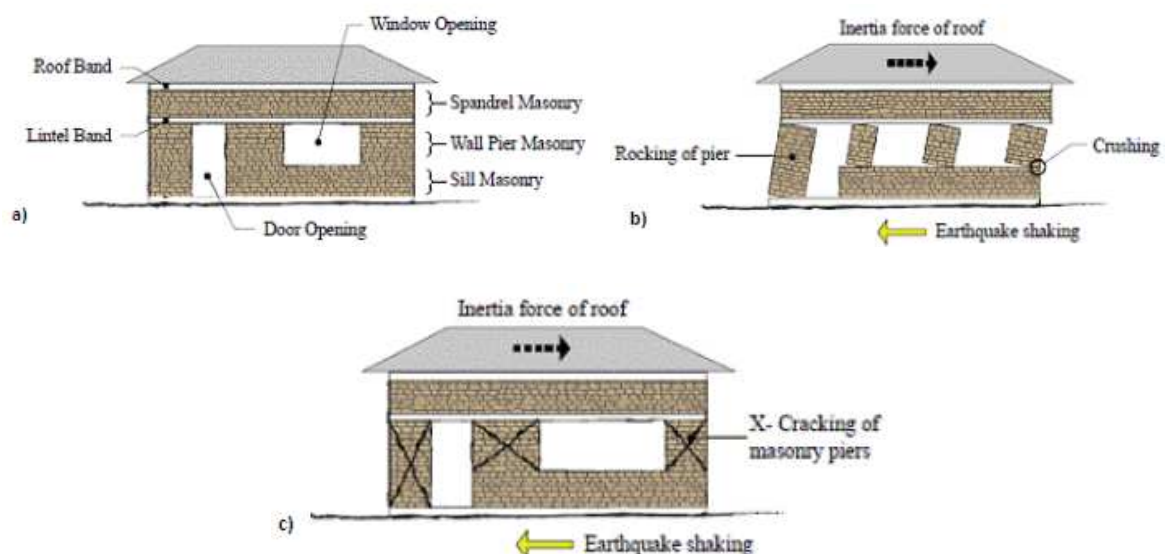
A typical masonry wall consists of piers between openings plus a portion below openings (sill masonry) and above openings (spandrel masonry), as shown in Figure 10a. When subjected to in-plane earthquake shaking, masonry walls demonstrate either rocking or diagonal cracking. Rocking is illustrated in Figure 10b, and is characterized by the rotation of an entire pier, which results in the crushing of pier end zones. Alternatively, masonry piers subjected to shear forces can experience diagonal shear cracking (also known as X-cracking), as shown in Figure 10c. Diagonal cracks develop when tensile stresses in the pier exceed the masonry tensile strength, which is inherently very low. This type of damage is typically observed in the bottom story of a building. Several factors influence the in-plane failure mechanism of stone masonry buildings, including pier dimensions; wall thickness, building height, and masonry shear strength. Rocking behavior is more desirable than diagonal shear cracking. [9]

Figure 10. In-plane damage of stone masonry walls: a) typical wall with openings; b) rocking failure, and c) diagonal shear cracking [10]
