Construction Shortfall and Forensic Investigation on Soft Ground

M Saravanan¹ and B N Ibrahim¹

¹Nexus EC Sdn Bhd, Kuala Lumpur, Malaysia

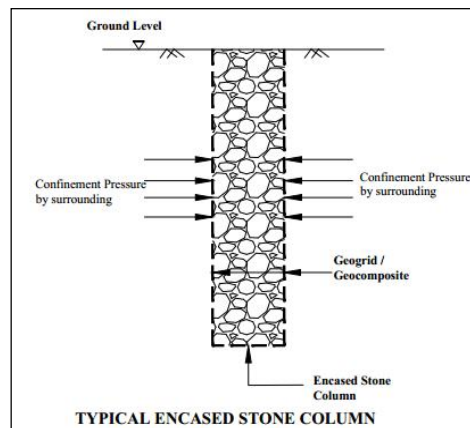
Plate C. Illustration of encased (reinforced) stone column.

The risk and project delivery responsibility for designing and constructing stone columns in ground weaker than the listed above, should not be shouldered by client and consultants. Consultant should not recommend the usage of stone column in such ground condition. Alternatively, instead of stone column, designer / consultant shall recommend more reliable ground improvement work (i.e. Pre-fabricated vertical drain or Encased stone column or pile foundation).
