Critical study of current situation of Vrăncioara tailing pond on Cavnicului Valley, risks and consequences

I Bud, S Duma, D Gusat, I Pasca and A Bud

Technical University of Cluj Napoca, North University Centre of Baia Mare, Faculty of Engineering, Romania

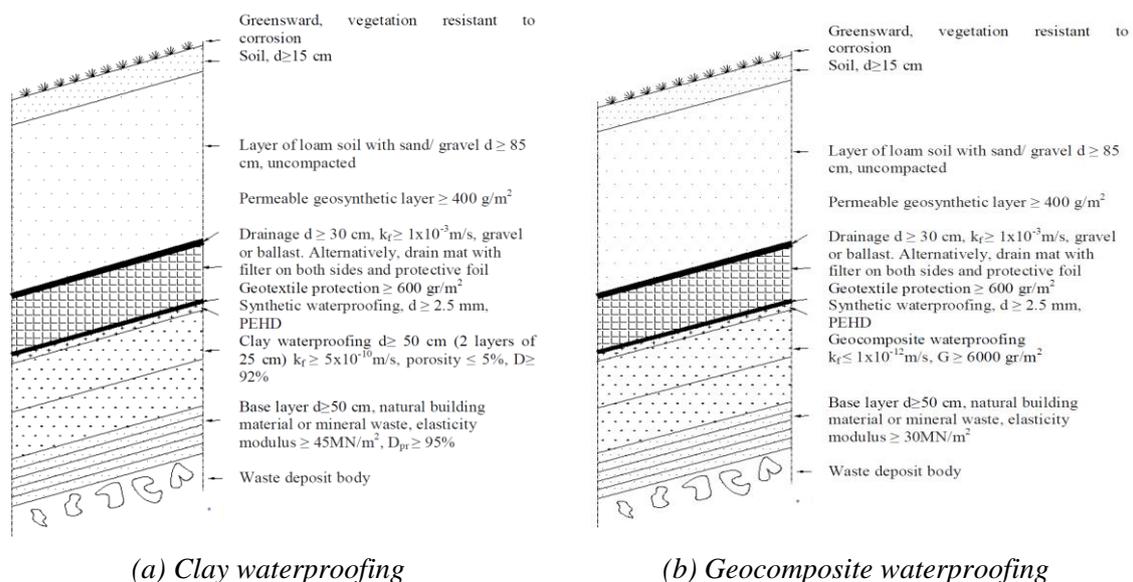
According to the Official Monitor of Romania, part I, no. 86bis/26.01.2005 the Methodology Rules detail the stratigraphy for closing cover material of hazardous waste. There are presented and accepted two variants, differentiated from each other by waterproofing layer nature: clay in first version (Figure 4a) and geocomposites in second version (Figure 4b).

For hazardous waste deposits, the coverage options provide minimum 2,3 m for successive layers - from the carrier layer up to soil in case of clay waterproofing (Figure 4a) and minimum 1,8 m in the case of weatherproofing with geocomposites (Figure 4b). These rules applied to areas exceeding tens of hectares lead to the necessity of finding viable technical solutions that optimize the realization of rehabilitation.

Figure 4. Stratigraphy of cover material for hazardous waste deposits

Being given the fact that the tailing pond is composed of reactive material - sulphides are oxidized in the presence of rainwater and oxygen - it is necessary, according to Technical Normative [5], a waterproofing meeting the requirements for closing dangerous waste deposits (Figure 4a and b).
