Degradation and Reinforcement of Industrial Gas Tank Support Structures. Thirty-Year Long Monitoring

Janusz R. Krentowski ¹, Piotr Knyziak ²

Abstract. An analysis of reinforced concrete supporting structures of more than a dozen liquid gas tanks mounted on tower support structures located at different sites on Poland's territory is presented. Stability testing of the degraded structures was carried out over a period of 30 years and pointed out significant defects that prevented safe operation of the tanks containing hazardous medium. Analysing complex stress states, as well as displacements of shell structure components, the authors developed a concept of strengthening the structures. Initial repair works, which had been carried out without proper supervision, failed to meet the mandatory requirements and were not compatible with the original design solutions. After several years of operation of the reinforced structures, their degradation states were assessed again. The next stage of repair works was carried out under the supervision of the authors together with authorized representatives of the investors.

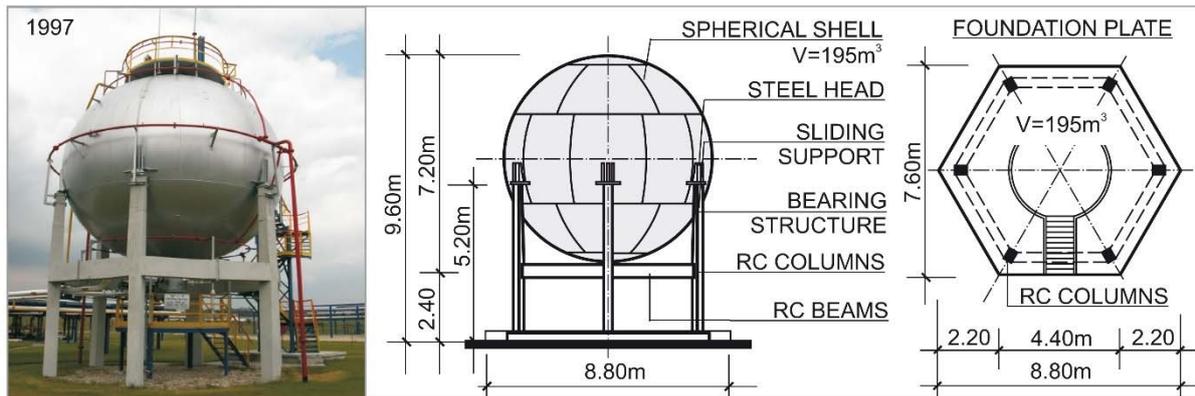
the columns is made of a reinforced concrete slab in the shape of an equilateral hexagon. The supporting columns are positioned on the perimeter of a circle with a radius of approx. 3.60 m. The connections between the tank's supporting columns in the column head zones have been formed as articulated ones in order to allow for interactive mutual displacements caused, for example, by thermal load. The lower segments of the columns are anchored to the foundation whereas the upper part remains free at the top end. The thrust plates of the tank shell are placed on the column heads in a sliding manner and stability of the contact zones is assured by using the friction forces (figure 2).

Figure 2. Construction details of the gas tank with a capacity of 195 m³

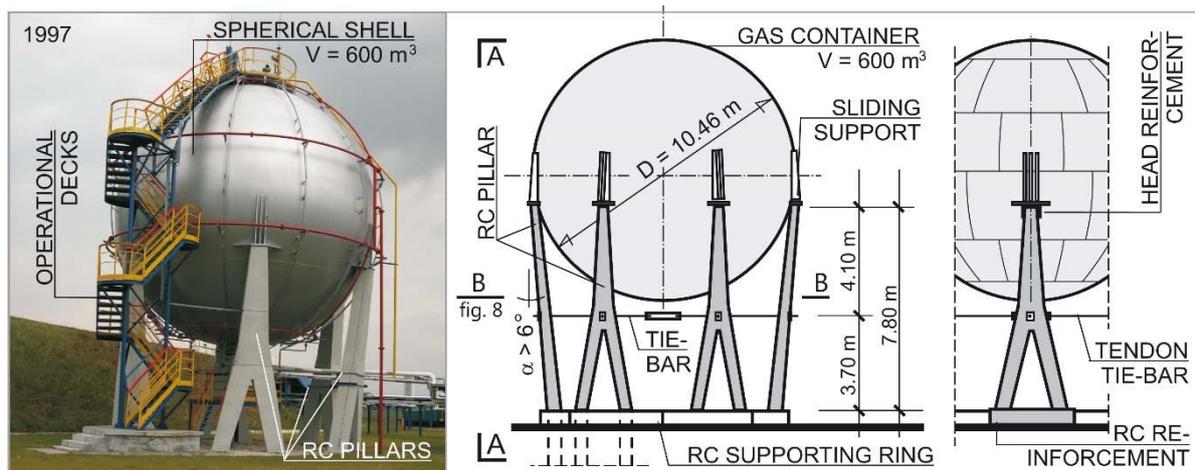
Spherical tanks of 600 m³ capacity are placed on structures in the form of six supporting trestles inclined at an angle of about 6° relative to the vertical axis, resembling an inverted letter "Y" (figure 3). The branches of the support trestles are positioned at the vertices of the reinforced concrete base constructed as a ring-shaped regular dodecahedron situated at ground level. The lower parts of the trestle are connected to the ring in an articulated manner. The ring is supported with twelve columns anchored in the lower foundation ring, transferring the load to the subsoil. The thrust plates of the tank shell are placed on the column heads in a sliding manner.

Figure 3. Construction details of the gas tank with a capacity of 600 m³
