# Failure Analysis on Tail Rotor Teeter Pivot Bolt on a Helicopter

**Abstract.** Tail rotor teeter pivot bolt of a helicopter fractured when in one flight. Failure analysis on the bolt was finished in laboratory. Macroscopic observation of the tail rotor teeter pivot bolt, macro and microscopic inspection on the fracture surface of the bolt was carried out. Chemical components and metallurgical structure was also carried out. Experiment results showed that fracture mode of the tail rotor teeter pivot bolt is fatigue fracture. Fatigue area is over 80% of the total fracture surface, obvious fatigue band characteristics can be found at the fracture face. According to the results were analyzed from the macroscopic and microcosmic aspects, fracture reasons of the tail rotor teeter pivot bolt were analyzed in detail

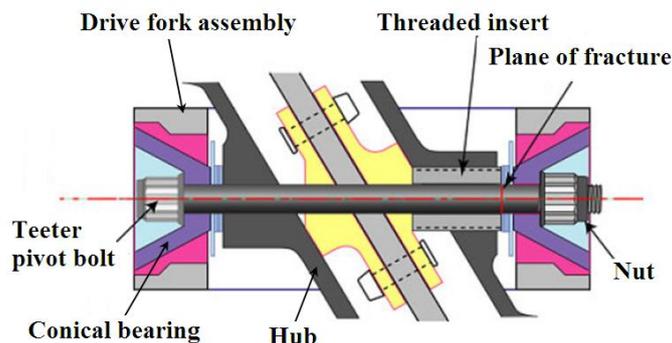
**Figure 2.** Structural layout of tail rotor hub components

The teeter pivot bolt is secured and tensioned by a nut which, when the assembly is correctly installed, ensures that the inner races, the nut, bolt, hub, shoe, threaded insert, shim washers and the dust shields all oscillate in unison relative to the fork as the rotor rotates during forward flight.
