Influence of Excessive Moisture in the Subgrade on the Durability and Load-Bearing Capacity of Road Pavements

Mieczkowski P., Budziński B.

West Pomeranian University of Technology Szczecin

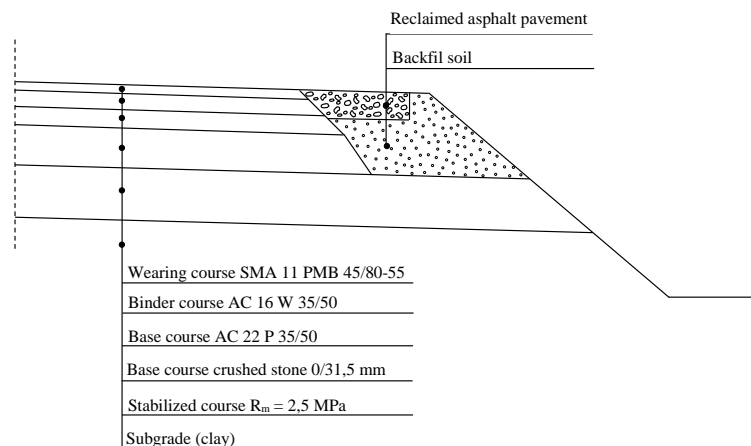
According to the construction program the works were to be carried out in spring and in summer. The scope of work included removal of existing layers, grading and compacting of the road subgrade, placing of the cement-treated soil layer ($R_m = 2.5$ MPa) and finally placing the remaining layers of pavement. The soil removed from shoulders was to be reused subject to meeting the permeability requirement. However, the design did not specify the required properties of soil (neither grading or permeability). The pavement configuration showing connection with the dirt shoulder is presented in Fig. 1.

Figure 1. Layers of pavement reconstructed on voivodeship road.

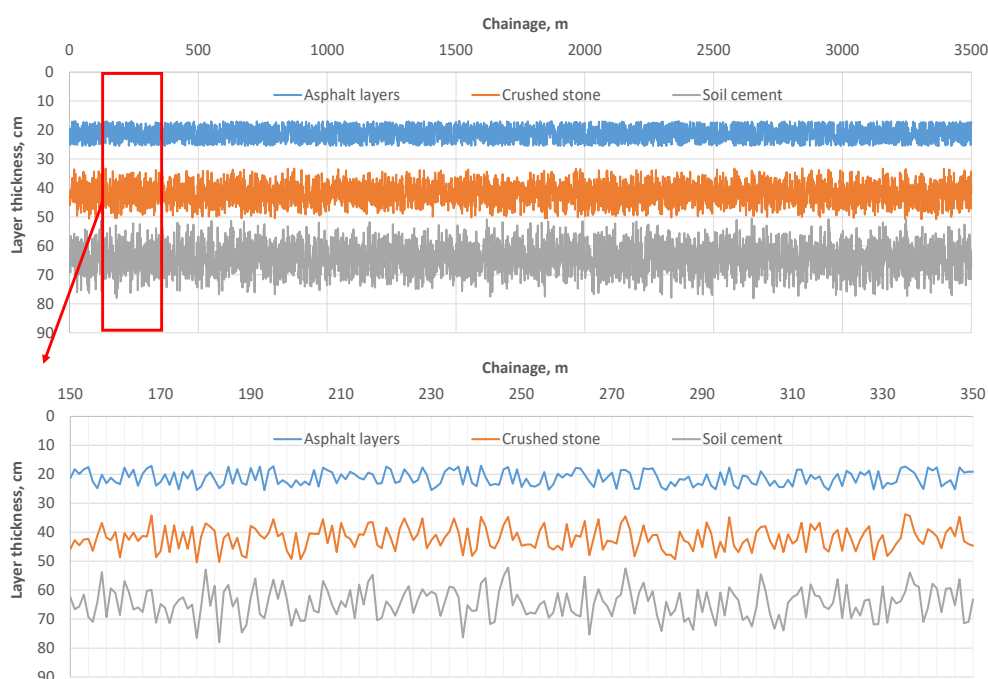
Additionally, the layer thicknesses measured in the slow lane in relation to the road chainage are presented graphically in Fig. 5. The analysis of GPR results did not reveal any loss of bonding between the bituminous layers or excessive moisture content in the lower layers of the pavement structure (soil subgrade, cement-treated soil or crushed aggregate base).

Figure 5. Layer thickness of pavement on nearest traffic line from ground radar test.
