Construction strengthening in historical wooden cupolas restoration

Yury Yuzhakov and Alexander Belkin

Moscow State University of Civil Engineering, Yaroslavskoye Shosse, 26, Moscow, 129337, Russia

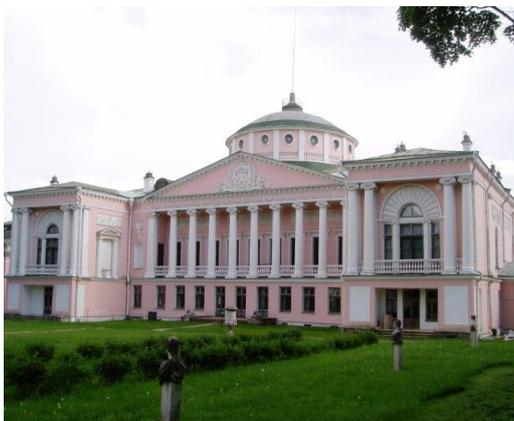
Figure 1. The main facade of the manor house in Ostankino, present condition

Complex analysis of the results of the investigations showed that wooden cupola support and framing constructions are in satisfactory condition. Laboratory research of the timber samples, choose after taking of a plaster, was done.

It was revealed, that some uprights of belvedere walls and some boards of the floor have surface rotting and damage caused by wood fretters and need prosthetic appliance. The testing of dome construction to bear permanent load and temporary load has shown that there is an overstress of 41,5 % in one of the elements in the upper multiangle construction. There is an overstress of 18 % in the lower inclined element of the intermediate rafter, weakened with junctions. The stresses in the other elements are below rated, in the floor beams deflection is below limit.

In the course of the cupola restoration the following was performed:

- reinforcement of tightening of the main arches and elements of the framework by means of steel tension bars with stop channel bars and splice pieces of wood boards [Fig. 2];

- reinforcement of the intermediate rafter, overstressed in the middle, with wood boards on both sides;
- taking the bark of some elements.

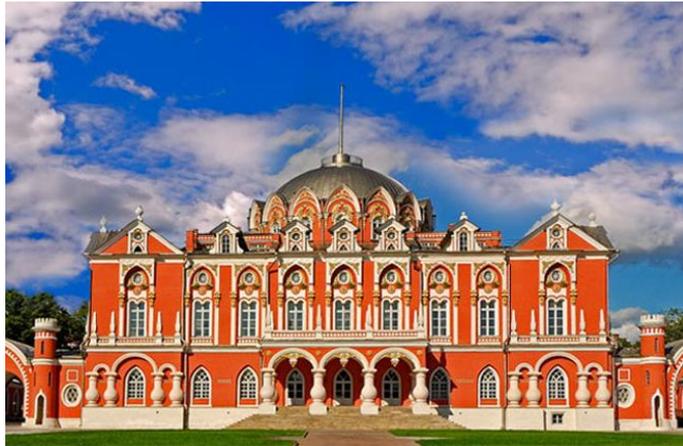
Figure 3. Petrovsky Putevoy Dvorets in Moscow; present condition

Complex analysis of constructions revealed biological and entomological decay of some elements (greyish-brown rot and white mould), caused the deterioration of physical-mechanical characteristics of wooden cupolas constructions. Separate elements, including the central support - flagstaff base, have rotting and damage from wood fretters [Fig. 4].

Physical wear of the external cupola below 20%, of the decorative cupola below 30%. General condition of wooden constructions is restrictedly durable. Some pieces are unsafe. The unsafe is caused with:

- absence of the ventilation of supporting ends of constructions;
- Condensation between the external and decorative cupolas, leads to biological decay;
- the roof leaks, the absence of hydro and steam isolation in framing constructions.

Testing calculations of external cupola constructions to bear permanent and temporary load has shown that there is over allowed deflection of triangular trusses of external cupola.

During the restoration of the cupola, the following was fulfilled:

- reinforcement of rafter trusses with installation of two three-hinge frames made of laminated wood with the section 100x500 mm, in parallel to historical trusses;
- replacement of some upper and lower knee braces and installation of bracings along the top and bottom chords of the trusses to include new trusses in the work of the whole structure.

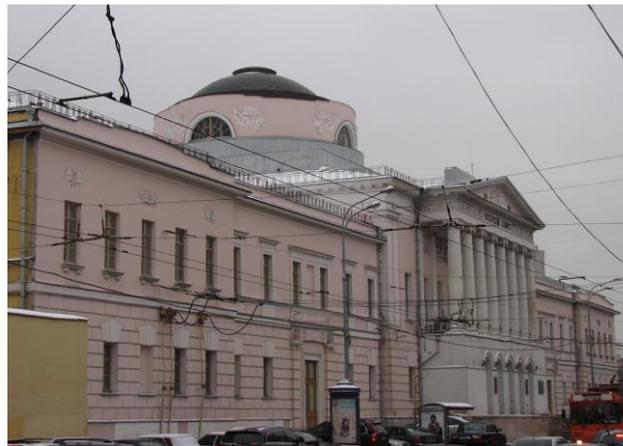
Figure 5. The Building of the Board of Guardians in Moscow; present condition

As a result of field observation it is established: diameter of the cupola – 13.26 m, rising height – 3.88 m; the bearing structures of the cupola consist of two cupolas - external and internal (disassembled in 1846), located one above another.

Dissemblance of the internal cupola changed the static scheme of a truss, broke the work of elements and junction, and caused numerous defects and damages. Nevertheless, main damages are the result of a long exploitation (more than 180 years [Fig. 6]).

The decision to partial changing and prosthetic appliance of some elements was adopted, based on the results of engineer-constructive and chemical-technological research. In the course of the cupola restoration the following was performed:

- full reconstruction of the original (authentic) framework of the internal cupola using whole timber, $\delta=60$ mm; junction of the elements with stub tenon [Fig. 8];
- addition of spatial bracings made of whole timber between the arches of the external and internal cupolas with the formation of crescent-shaped semi arches;
- replacement of wrought nails in nodes by bolted connection.

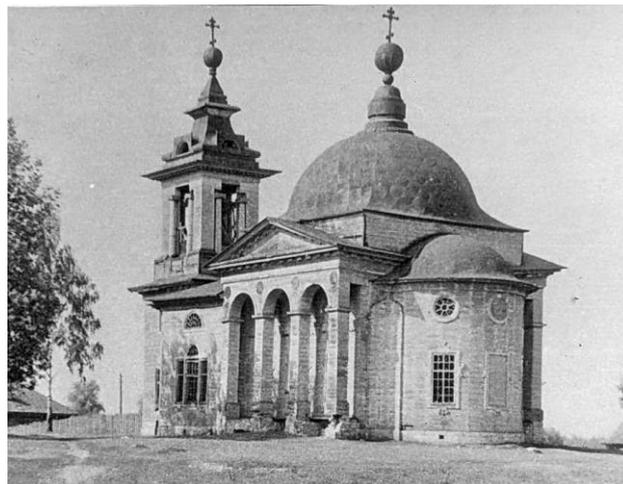
Figure 9. The Cathedral of the Transfiguration of Christ in vil. Snoved. Historical picture. 1966

Laboratory research revealed that timber was damaged by dry rot (*Poria vaporaria* and *Coniophora cerebella*). Humidity of beams and board facing is very high (30-50%). The walls of the Cathedral had extensive places of rotting and damage from wood fretters that caused the structures of the cupola to be brought down. The engineer N.A. Syomina on the samples of timber held the research of materials.

1. Prosthetics and strengthening of separate elements using:
 - whole timber or laminated wood, steel rolled elements, polymer concrete (epoxy resins) with built-in reinforcement.
2. Installation of backup and supporting elements made of laminated wood or steel rolled elements.
3. Full reconstitution with preservation of original (authentic) framework using whole timber or laminated wood.
4. Full reconstruction with change of original (authentic) design using:
 - whole timber or laminated wood, steel rolled elements, concrete components.
