Façade biological colonisation assessment

I Kukletová¹ and P Buchta¹

¹ Výzkumný ústav stavebních hmot, a.s. Hněvkovského 65, 617 00 Brno

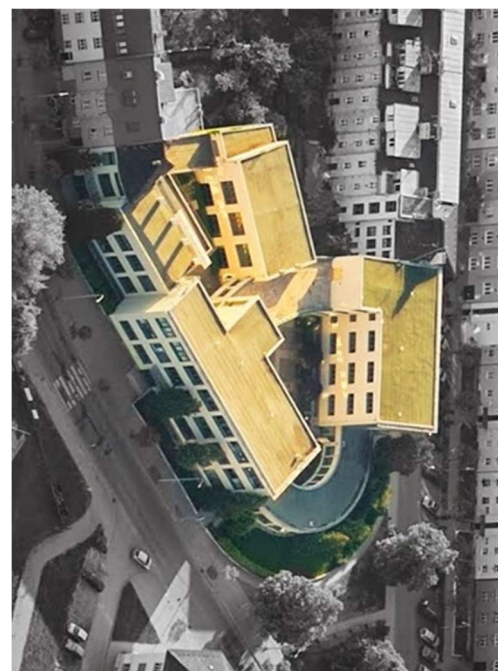
Figure 2. Aerial photograph.

The studied object was a school building with different degree of façade infestation over the outer surface. The building is V-shaped with the arc part directed to north-west and surrounded by a park. The school is situated in urban area. Figure 1 shows the building floor plan, aerial photograph is shown in Figure 2.
