Detection of reinforcement in the non-traditional building structures - historical statues

O Anton, L Vitek, V Hermankova, T Komarkova and P Cikrle

Department of Building Testing, Faculty of Civil Engineering, BUT in Brno, Veveri 95, Brno, Czech Republic

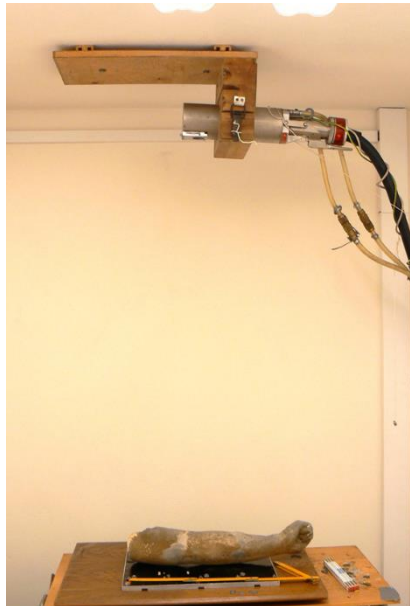
Figure 2. Radiography of the arm from the statue of Archangel Michael from Malešovice, above: x-ray tube of the Andrex CP 490 – 160 kV device, at the very bottom: cassette with an Agfa Testix C7 film.

The radiology revealed that the original reinforcement consists of one, probably forged, rod-like element with a diameter of approximately 13 mm. This element originally linked the arm with the corpus of the statue and ended at the elbow level, in the plane of the first repaired fracture. The image of this reinforcing element is well apparent in figure 3 and also in figure 5. The reinforcement is located in the cavity with a diameter of approximately 20 mm which is sealed with sulphur. An additional reinforcement was detected at the point of the repaired fracture in the elbow. The reinforcement consists of two steel reinforcing bars with a diameter of approximately 6 mm and a length of approx. 53 and 55 mm. According to the surface finish of the reinforcement apparent on the radiogram, it is probably a cut piece of the Kari net for concrete.
