# Sustainable structural rehabilitation and strengthening of the “Ponte delle Grazie” bridge in Faenza, Italy

**M Micheloni<sup>1</sup>, M La Monica<sup>1</sup>, D Parmeggiani<sup>2</sup>, P Barchi<sup>2</sup>**

**Abstract.** The “Ponte delle Grazie” is a three span bridge, with a total length of 72 meters, built between 1948 and 1952 in Faenza, Italy. The reinforced concrete main beams of the deck have undergone a strong deterioration over the years. In detail atmospheric agents and chemical aggressions caused a strong deterioration of the concrete, up to the point of making the structure not accessible and at risk of collapse. In fact, the five main beams were heavily damaged, as well as the concrete bearings were strongly compromised. So, an urgent intervention was necessary to save the structure of this historic bridge. A delicate restoration has allowed to remove the deteriorated concrete and to restore the resistant sections with new materials compatible with the old remaining structures. In particular, a specific rehabilitation procedure was studied using fiber-reinforced cement mortar with low elastic modulus, that is shrinkage compensated, in combination with composite m

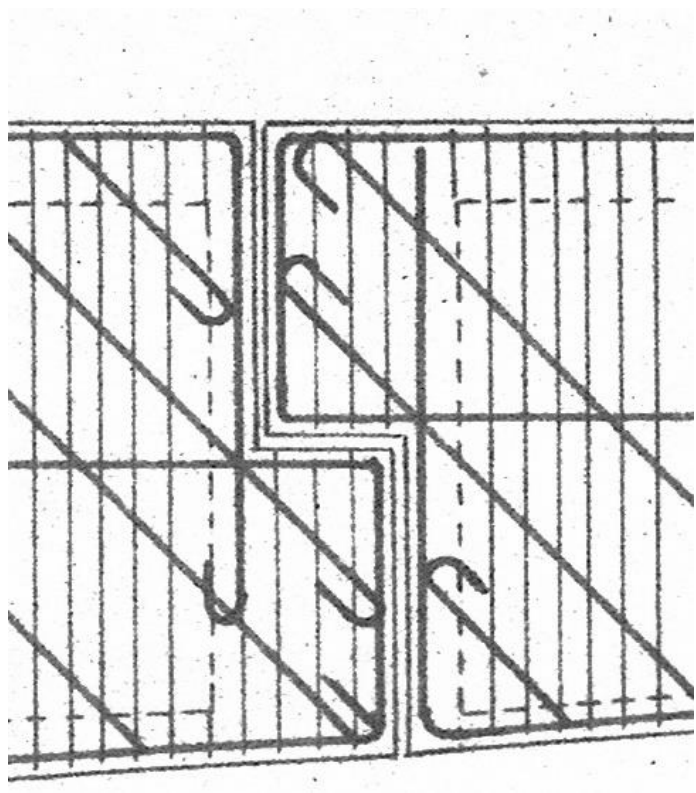
**Figure 8.** Gerber half joint in the original drawing from “Archivio di Stato di Faenza” [2]

A disadvantage inherent in “Gerber bridge” type of construction is that there are problems associated with leakage through the half joint. This enables moisture to accumulate at the beam seats thereby increasing the propensity for the deterioration of the concrete and reinforcement steel.

Furthermore, together with water leakage and moisture, there is also an accumulation of chlorides, dangerous for concrete and steel bars.

- Repair of concrete and reinforcement of the bearings on the abutment and of the side span of the main beams.
- Install of new steel structures to protect the bearings on the abutment and the Gerber half joints.

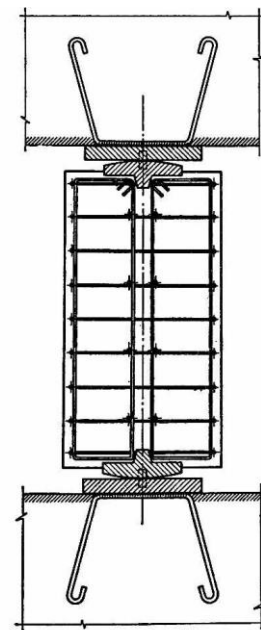
**Figure 10.** Concrete pendulum bearing typical scheme [1]

In detail this concrete bearings exhibit a strong degradation phenomena, with evident breaking lesions in place, as evidenced by the following images.
