## Application of Material Characterization Techniques to Electrical Forensic Analysis

**Abstract** – The application of forensic science techniques to electrical equipment failure investigation has not been widely documented in the engineering world. This paper is intended to share an example of using material characterization techniques to support an initial cause determination of an electrical component “failure” event. The resulting conclusion supported the initial cause determination and ruled out the possibility of design deficiencies. Thus, the qualification testing of the equipment was allowed to continue to successful completion.

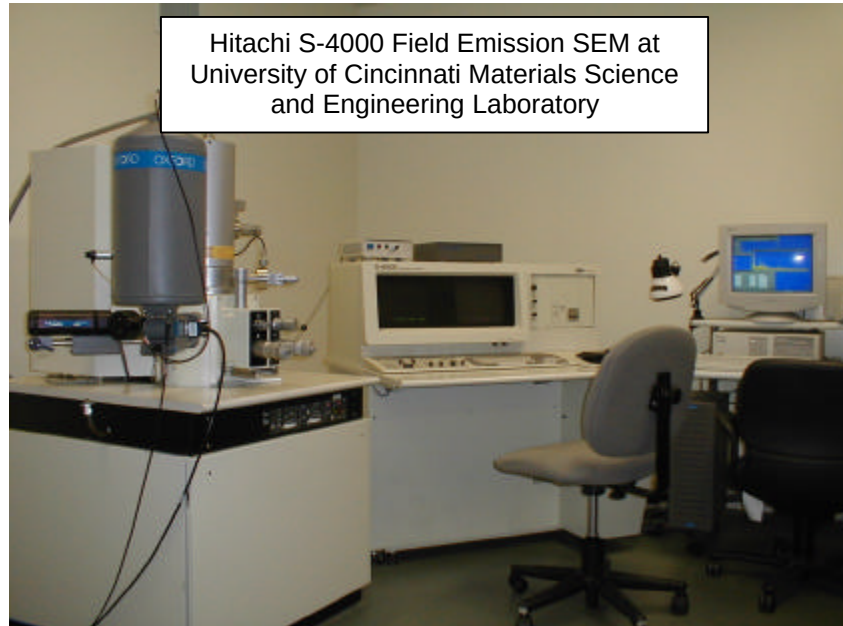
The samples were taken to the University of Cincinnati laboratory and the search for the “foreign” material began (Fig. 5).

Fig. 5, Scanning electron microscope at University of Cincinnati
