A Structural Impact Assessment of Flaws Detected During Ultrasonic Examination of Tank 15

**B. J. Wiersma
J. B. Elder**

Savannah River National Laboratory
Materials Science and Technology Directorate

Publication Date: August 2008

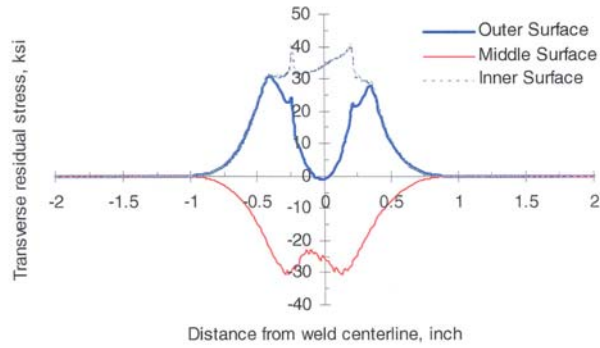
- Tensile transverse stresses are present at both the interior and exterior surfaces of the weld (see Figure 8). The tensile stresses at the interior surface are larger than those at the exterior surface. The tensile stresses at the interior surface are at a maximum approximately 0.25 inches from the weld centerline (40 ksi), while they are at a maximum slightly away from the fusion line on the exterior surface. At mid-plate, the residual stresses are in compression, which would hinder crack growth. Thus, through-wall cracks parallel to the weld, in the absence of attachments or repairs, would not be expected.

Figure 8. Tensile transverse residual stress at a seam weld [16].

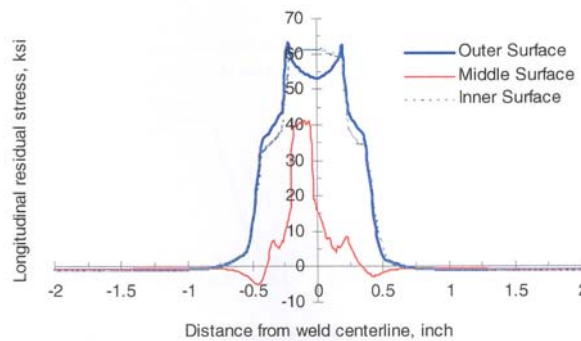
- The longitudinal stresses are predominantly tensile throughout the plate, except for a small section within the weld that is compressive (see Figure 9). The peak longitudinal stress on both the interior and exterior surfaces is approximately 62 ksi. The stresses are short range as it is estimated that they decay significantly approximately 0.5 inches from the weld centerline.

Figure 9. Tensile longitudinal residual stress at a seam weld [16].

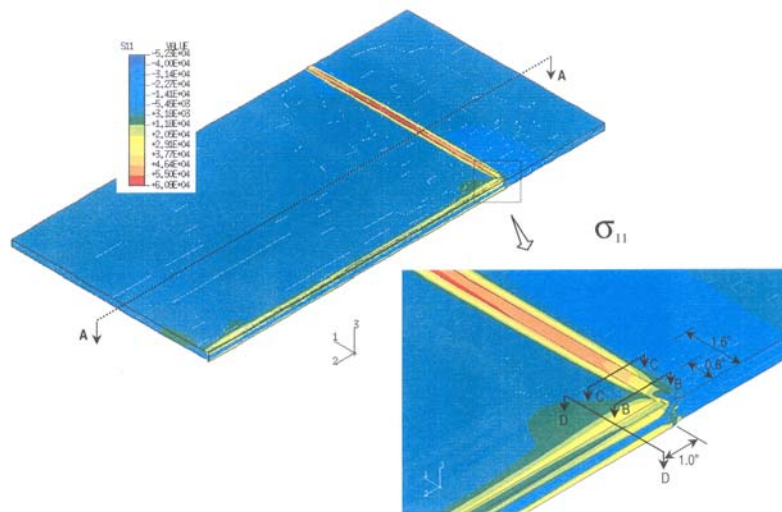
- The results showed that within 2 inches of the intersection significant changes in the residual stress distribution occurs. The longitudinal stress at the horizontal weld is significantly reduced due to the introduction of the vertical weld (see Figures 10 and 11). In contrast the transverse residual stress component of the vertical weld dominates (i.e., tendency to open a vertical crack parallel to the weld).

- A “pocket” of residual stress exists a couple of inches below the horizontal weld and parallel to the vertical weld where the transverse residual stresses increase significantly (see Figures 10 and 12). These stresses would tend to open a crack that was parallel to the vertical weld. However, the transverse stress in the middle of the plate remains in compression and therefore the crack is not predicted to go through-wall.

Figure 10. Contour plot of longitudinal stress distribution at the horizontal weld and transverse stress at the vertical weld. Horizontal weld is indicated by cross-sections B-B and C-C, while the vertical weld is indicated by cross-section D-D [17].

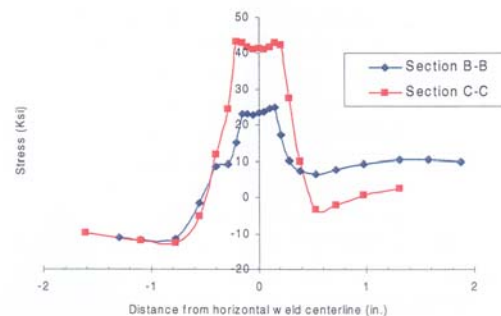
Figure 11. Magnitude of longitudinal residual stress at the horizontal weld at sections B-B and C-C [17].

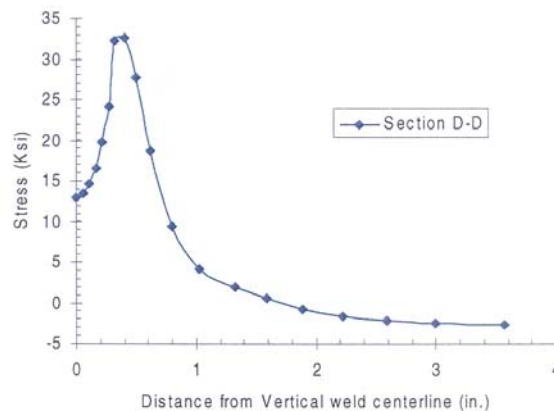
Figure 12. Magnitude of transverse residual stress at the vertical weld at section D-D [17].

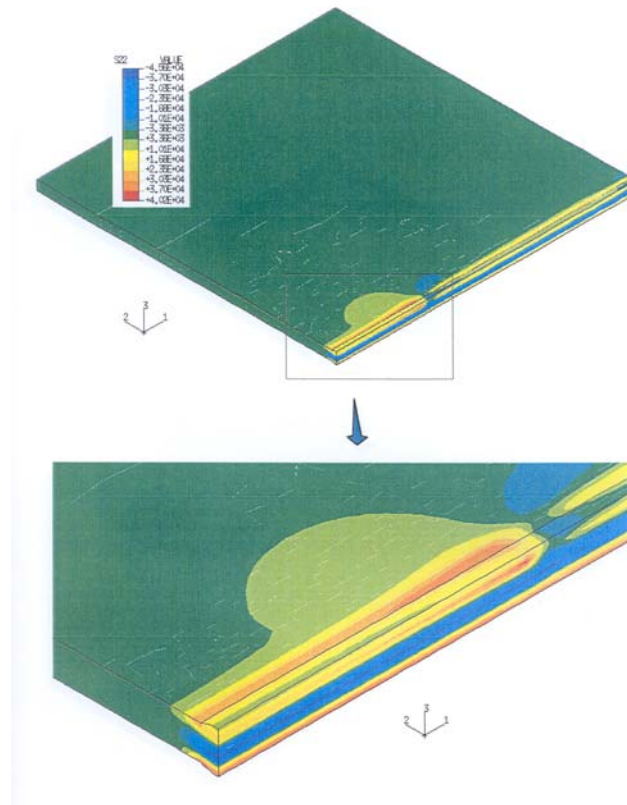
- High tensile transverse residual stresses occur perpendicular to the repair weld fusion line, extending beyond the heat affected zone on the exterior surface (see Figure 13) and the interior surface. Figure 13 shows a narrow repair weld (i.e., width of the repair weld is approximately equal to the original weld). These residual stresses would tend to drive cracks that are parallel to the repair weld. At the repair weld fusion line, the residual stresses on the interior surface and exterior surfaces are tensile (Note: The magnitude of the stresses on the interior is slightly greater than that on the exterior.). However, the large compressive stresses in the mid-thickness region of the plate would prevent growth of through-wall cracks near the repair weld fusion line. Away from the repair weld fusion line, the residual stresses at both the interior and exterior are still tensile, however, they are slightly lower in magnitude (Note: The magnitude of the stresses on the exterior is slightly greater than that on the interior). However, the residual stresses at the mid-thickness region of the plate are also tensile. Thus, through-wall tensile stresses parallel to the repair weld occur a short distance away from the repair weld fusion line.

Figure 13. Transverse residual stress distribution after repair [18].

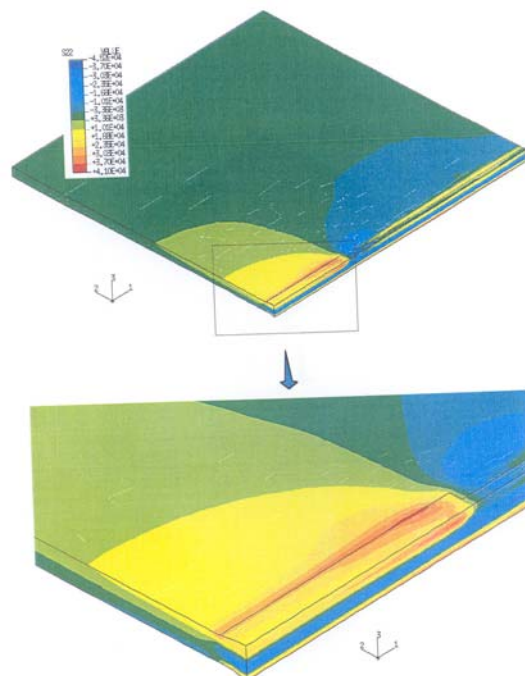
- The width of the repair weld has a significant effect on the transverse residual stress distribution. Wider repair welds (i.e., the repair weld is at least two times the width of the original weld) produce tensile stresses over a greater distance from the weld center-line on the exterior surface than narrow repair welds (see Figure 14). However, on the interior surface, a short distance from the repair weld fusion line, a large region of transverse compressive residual stress exists (see blue area on Figure 15). Therefore, for wide repair welds the through-wall tensile residual stresses reside very close to the repair weld fusion line.

Figure 14. Effect of width of repair on the transverse residual stress distribution. The exterior surface is shown in the figure [18].

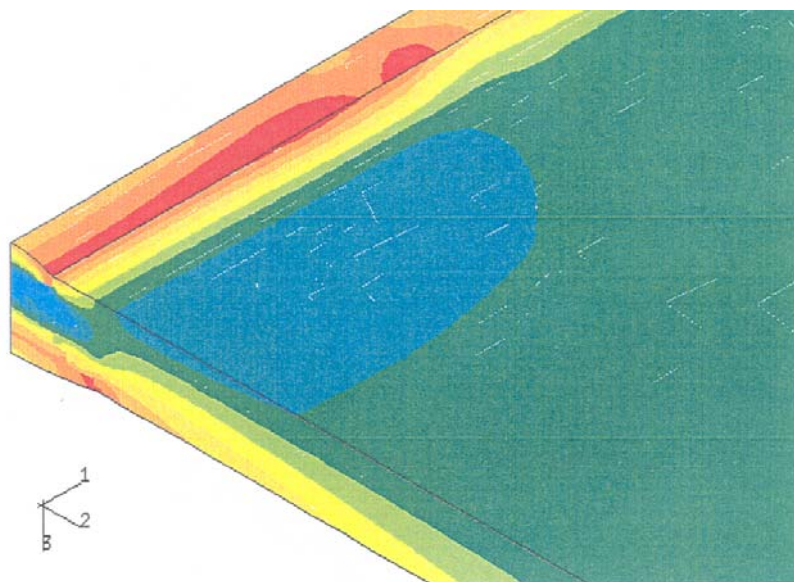
Figure 15. Effect of width of repair on the transverse residual stress distribution. The interior surface is shown in the figure [18].

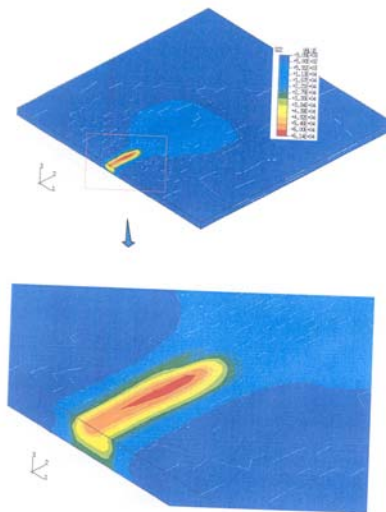
- The transverse residual stress for an attachment weld is of a bending type. The stress on the exterior surface is tensile, while that on the interior the stress is slightly compressive.
- The longitudinal stress is tensile throughout the thickness of the shell for the attachment weld. The maximum stress occurs on the exterior surface within the weld area (see Figure 16).
- K solutions for cracks parallel to the weld fusion line were developed. The K values were dominated by the local bending type of residual stresses.

Figure 16. Longitudinal residual stress distribution near an attachment weld [17].
