# **Incident Analysis Report: B696 MOVER Event, August 19, 2004**

**Report Serial Number: 0514**

**November 11, 2004, Rev. 1**

Lawrence  
Livermore  
National  
Laboratory

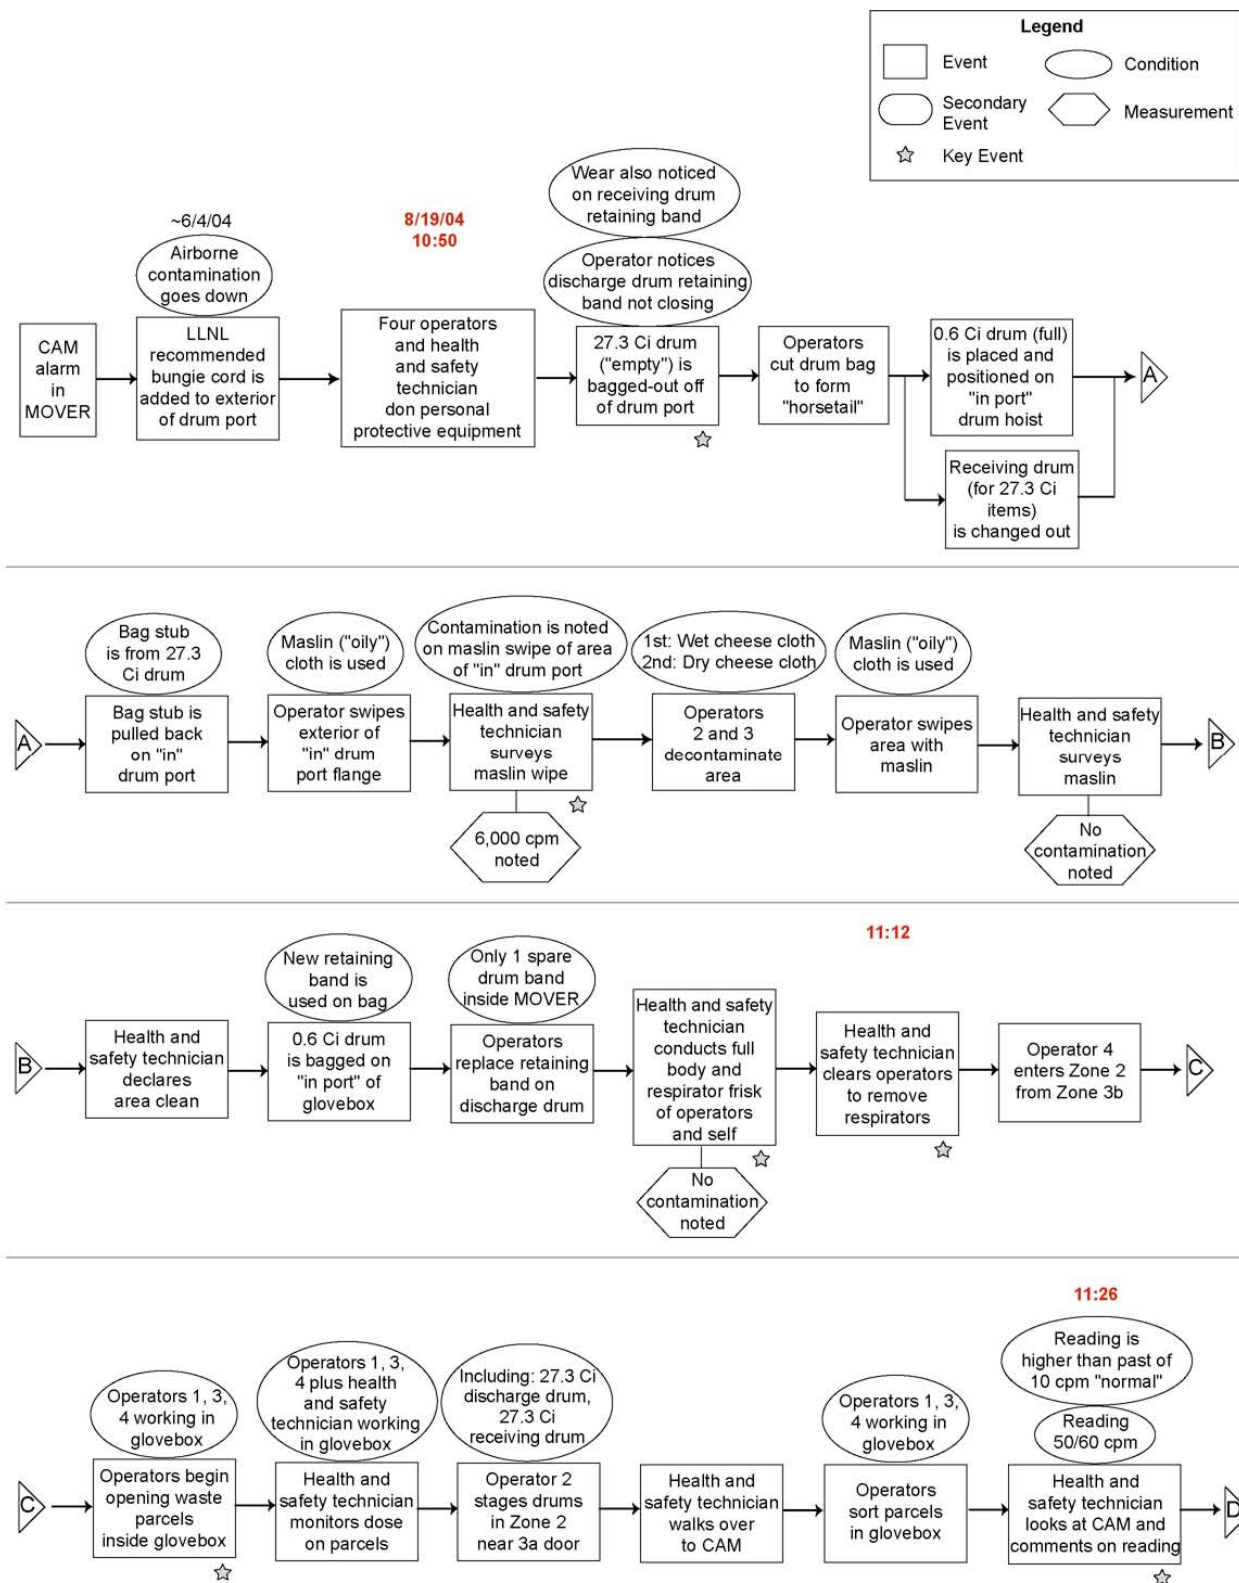
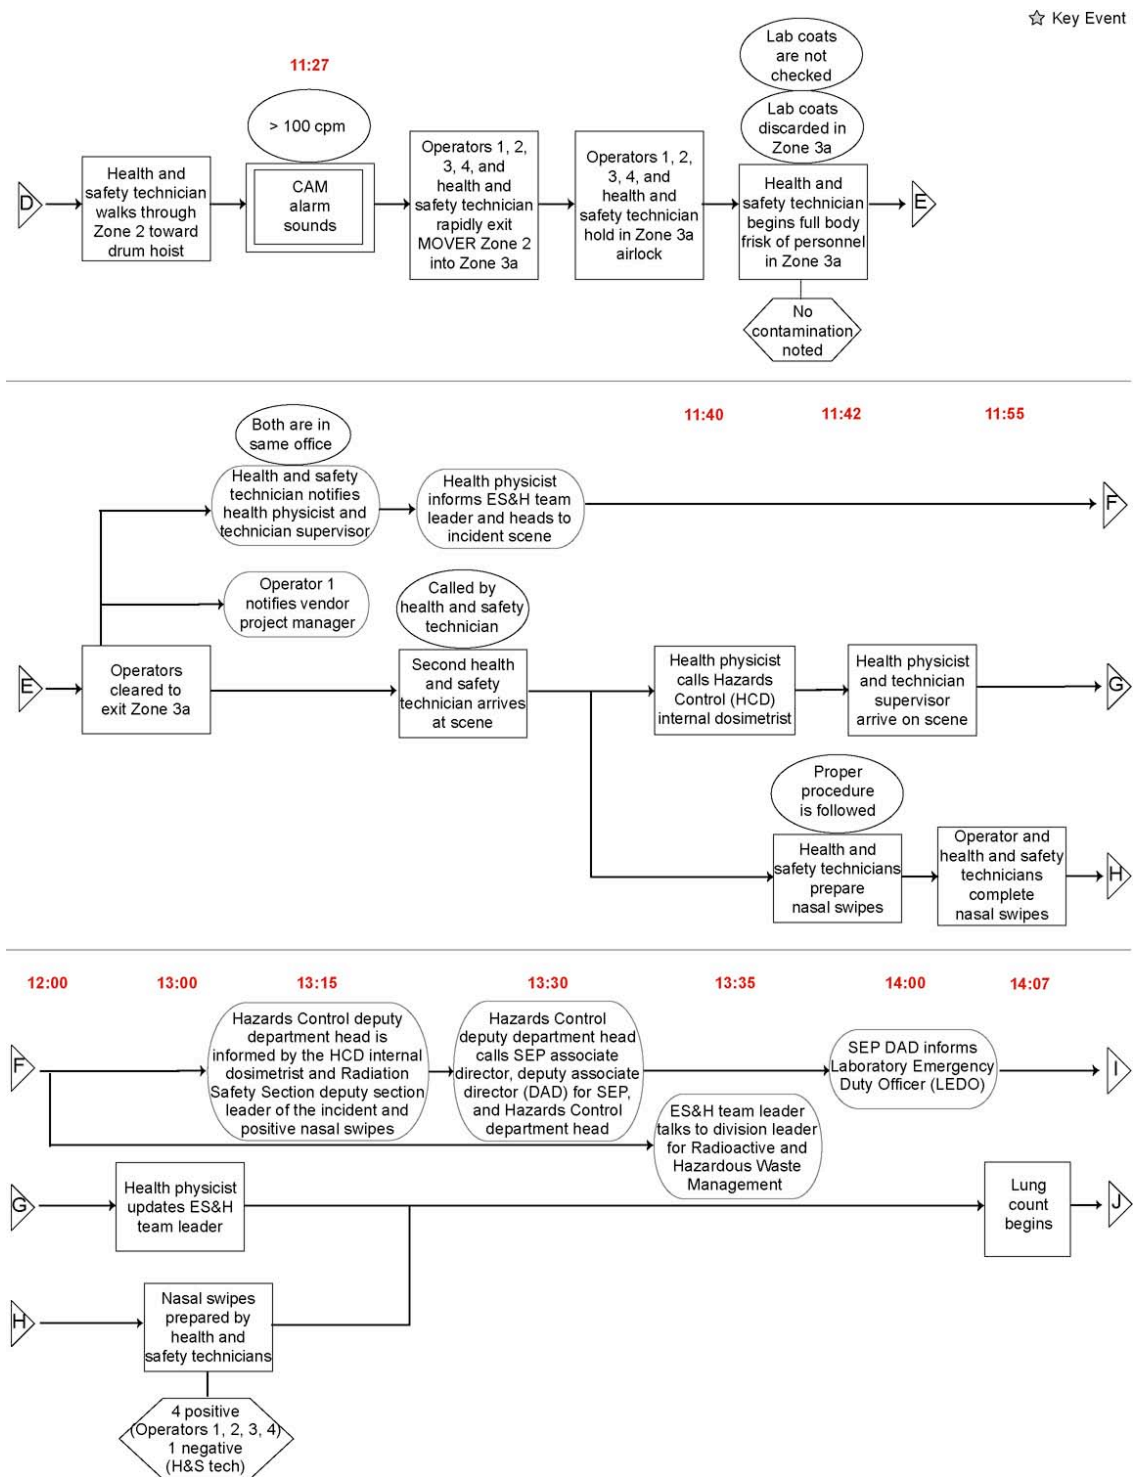
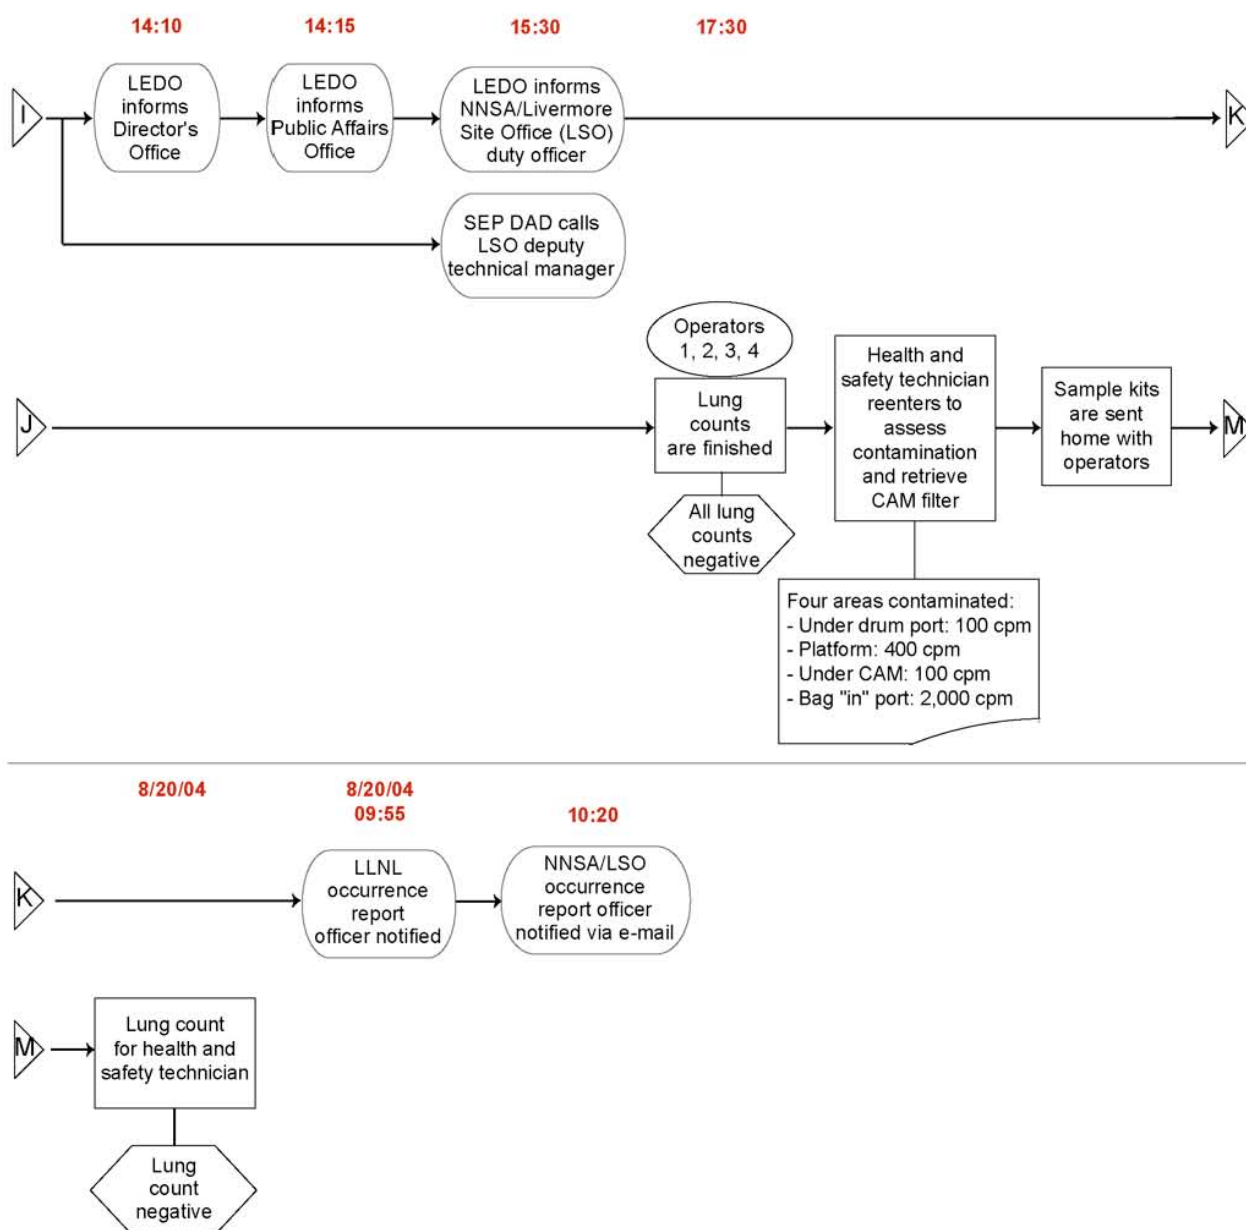
Figure 4. Event timeline.

Figure 4 shows the MOVER event timeline in detail. Refer to this figure for an overview of the sequence of events. At approximately 1055 hrs on August 19, 2004, three qualified MOVER operators and one H&ST donned respirators and personal protective equipment (PPE) and began work in the MOVER, Zone 2. The operators started the bag-out of a 27.3-PE Ci drum in accordance with CCP Procedure CCP-TP-042 and LLNL IWS 11359. Work was monitored by the H&ST, who is a certified Radiological Control Technician. During the bag-out process, the operators noticed that the metal retaining band that surrounded the bag over the discharge (“in”) drum port on the glovebox was not closing as tightly as normal. They also checked the band on the receiving drum port and noted wear on it. The operators continued with bag-out of the 27.3-PE Ci drum by moving it out of the drum port, with the bag still attached to the port. They proceeded to crimp, tape, and cut the bag to form “horsetails” of the newly separated bag segments. They also bagged out the drum located below the glovebox that received the checked contents from the 27.3-PE Ci discharge drum using the same procedural steps.

Post-event communication and notifications through the SEP and LLNL management chain were made as indicated in the Event Timeline (Figure 4). The notified personnel included three qualified LEDOs (the Deputy Department Head for HCD, Deputy Associate Director for SEP, and the on-duty LEDO). Although some judgment is necessary in making determinations as to

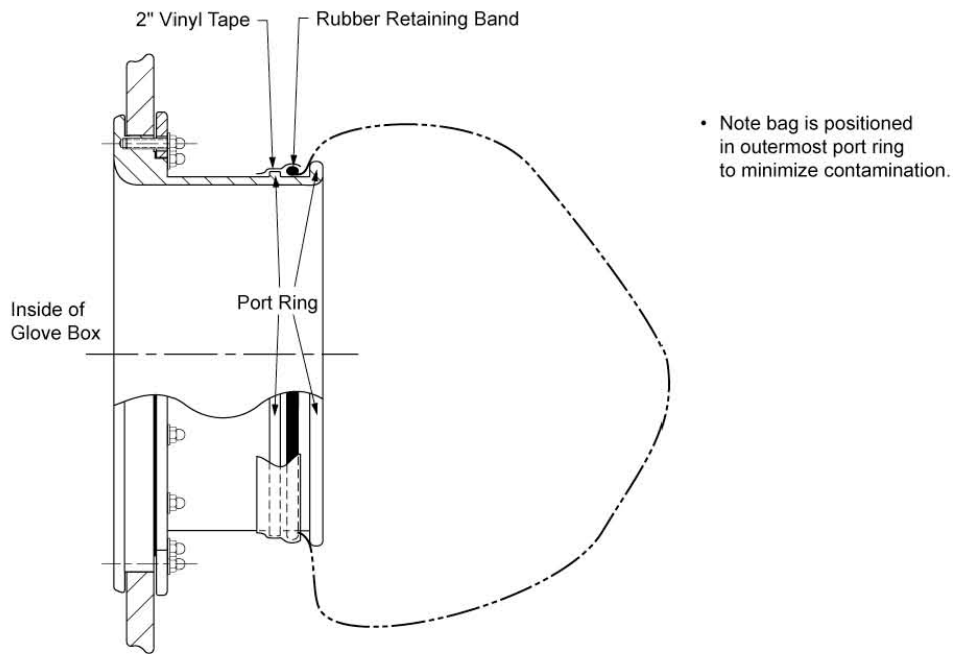
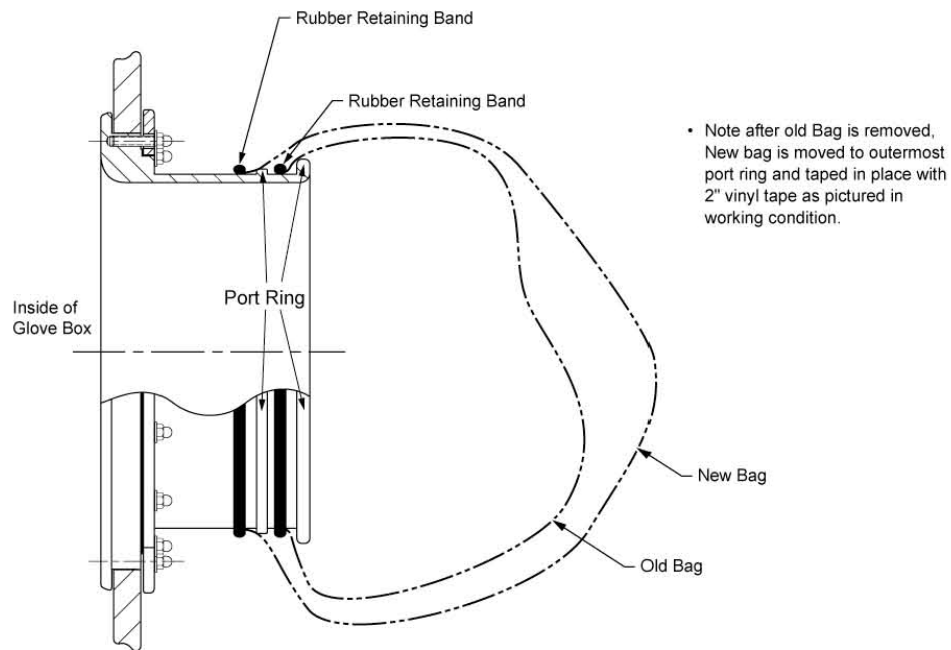
Figure 7. LLNL Plutonium Facility working configuration (top) and bag-change configuration (bottom).

Techniques used in the MOVER to secure the drum bag to bag port, as well as bag-changing techniques, are considerably different from the techniques used at the LLNL Plutonium Facility. The techniques used by CCP provided an opportunity for contamination on the bag port when changing a drum bag. Figures 6 and 7 compare the techniques used at the MOVER to those used at the LLNL Plutonium Facility.
