Annual Radioactive Waste Tank Inspection Program - 2011

Savannah River Remediation

R. S. Waltz, Jr.
W. R. West

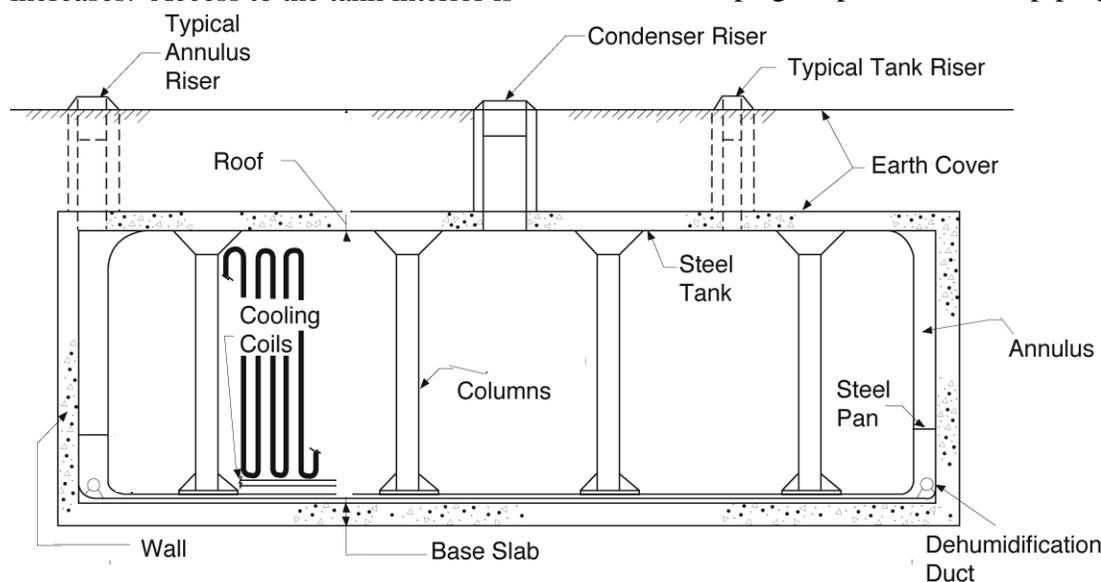
Figure 1. Cooled Waste Storage Tank, Type I (Original 750,000 Gallons).

The 12 original storage tanks constructed between 1951 and 1953 are designated Type I tanks. Tanks 1 through 8 are in F Area and Tanks 9 through 12 are in H Area. Each primary tank has a capacity of 750,000 gallons. Figure 1 shows the general features of Type I tanks, including the primary tank, the secondary pan, and the concrete support structure.

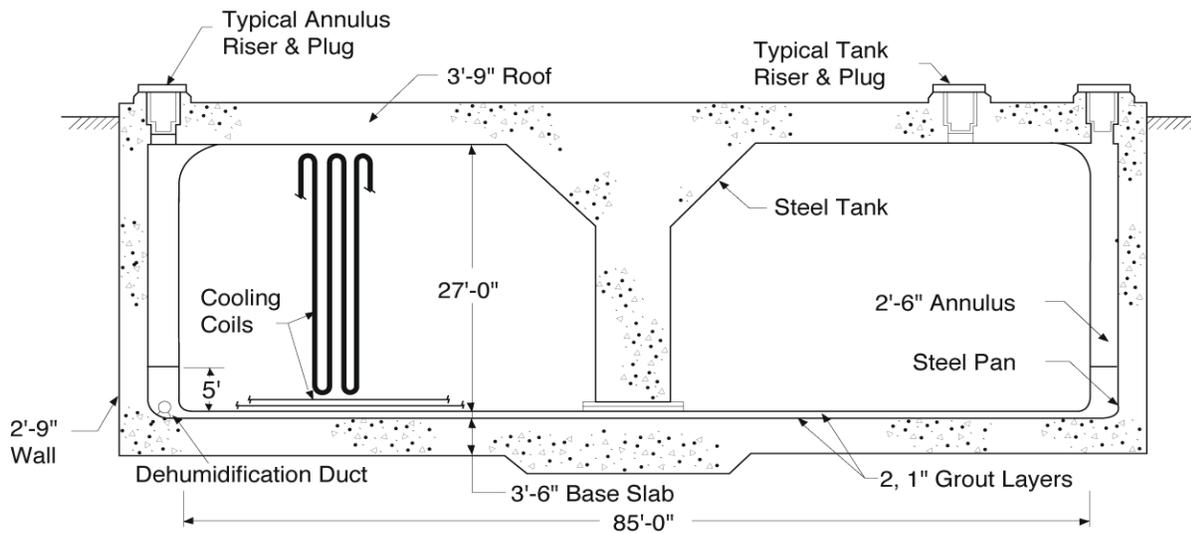
Figure 2. Cooled Waste Storage Tank, Type II (Original 1,030,000 Gallons).

Tanks 13 through 16, constructed in H Area in 1955 and 1956, are designated Type II tanks. Figure 2 is a cross section of this type of tank. Each primary tank has a capacity of 1,030,000 gallons.

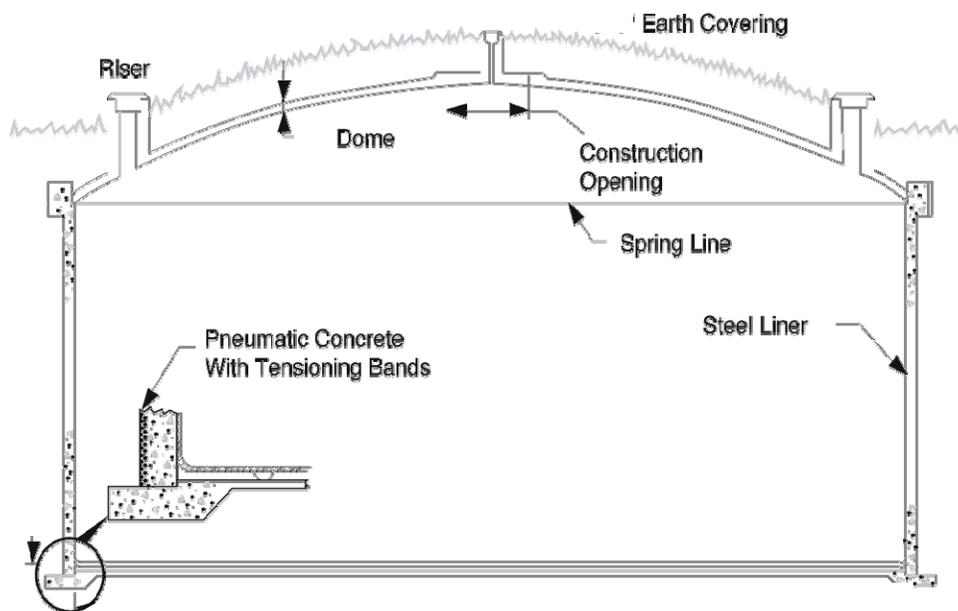
Figure 3. Uncooled Waste Storage Tank, Type IV (Prestressed Concrete Walls, 1,300,000 Gallons).

1,300,000 gallons. Figure 3 shows the general features of Type IV tanks. Each Type IV tank is basically a steel-lined, prestressed-concrete tank in the form of a vertical cylinder with a domed roof. Carbon steel plates were used to form the cylindrical sides and flat bottom portion of the steel liners. Concrete was built up around the steel vessel by the "shotcrete" technique.

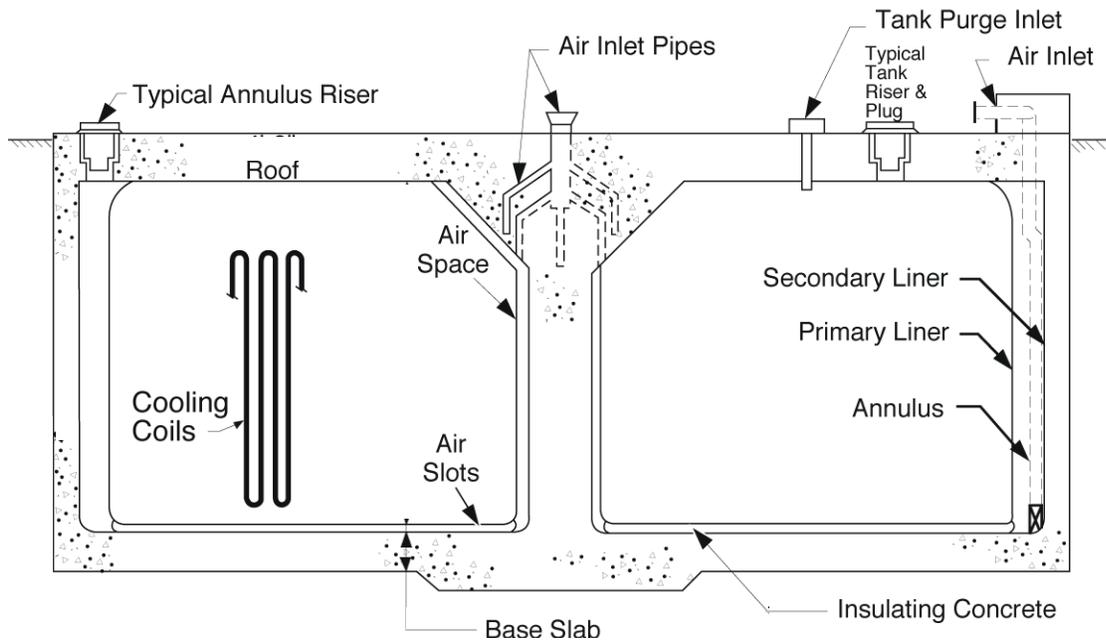
Figure 4. Cooled Waste Storage Tank, Type III (Stress Relieved Primary Liner, 1,300,000 Gallons).

The most recently constructed tanks are designated as Type III tanks (Figure 4). Twenty-seven tanks were built between 1966 and 1981. Figure 4 shows the general features of the Type III tanks. Type III tanks are designated as compliant. The Type III tank design was developed after an investigation into the causes of the leaks from the primary vessel of the Type I and Type II tanks. The study concluded that the leak-producing mechanism was nitrate-induced, stress-corrosion cracking at sites in or near the weld seams, and that stress relieving after fabrication should eliminate the cracking. For the Type III tanks, means were provided for heating each finished tank to relieve the stresses generated during fabrication. In addition, some stress patterns were avoided, or minimized, by mounting the roof supporting column on the foundation pad rather than on the bottom of
