A Novel Approach to Spent Fuel Pool Decommissioning

R. L. Demmer

April 2011

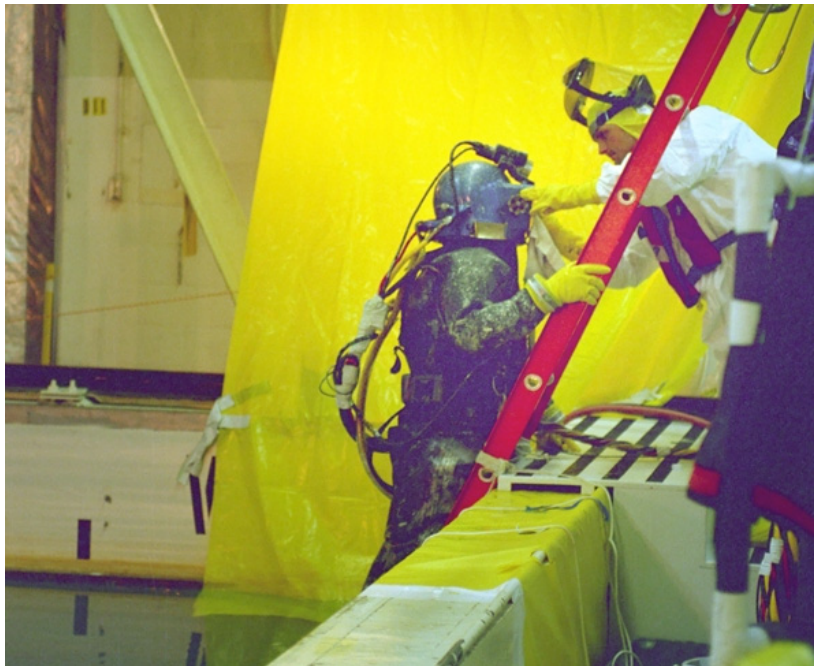
Figure 1, Diver at INL completing entry into basin for underwater cleaning and coating.

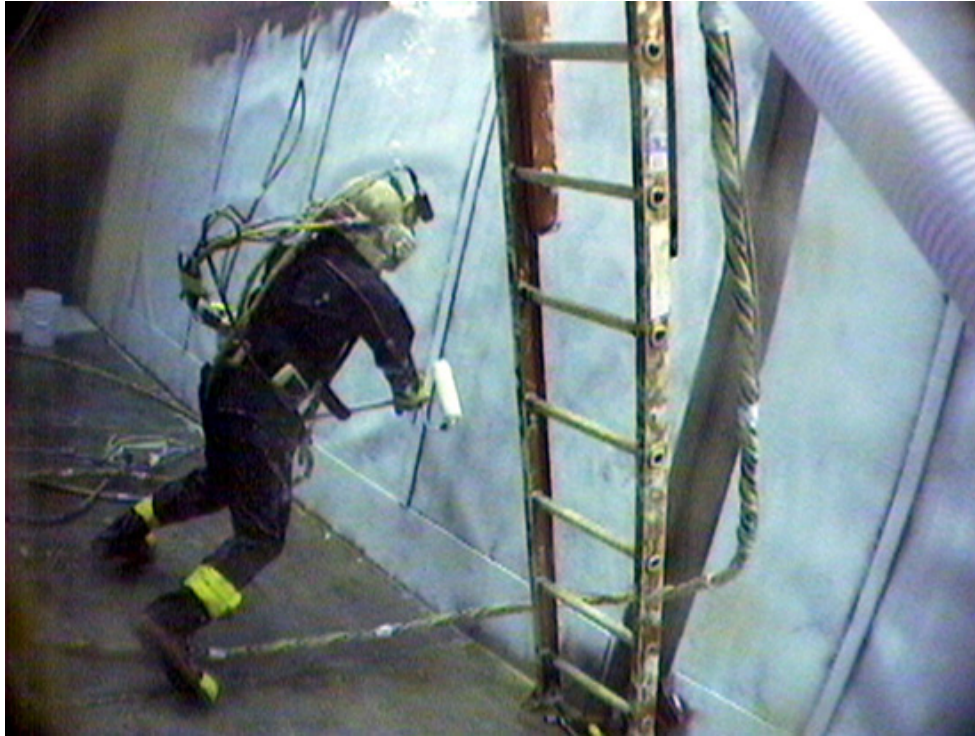
Figure 2, Special two hose roller system used for wall coating at the MTR pool.

A special type of paint roller system was used for underwater application of the epoxy coating, which is shown being applied underwater in Figure 2. The system had two separate pumps for the epoxy resin and hardener, which were pumped through separate hoses to a mixing manifold about 1.5 m from the roller. The roller/extruder system was flexible up to that point, and like a solid wand from there to the roller head.

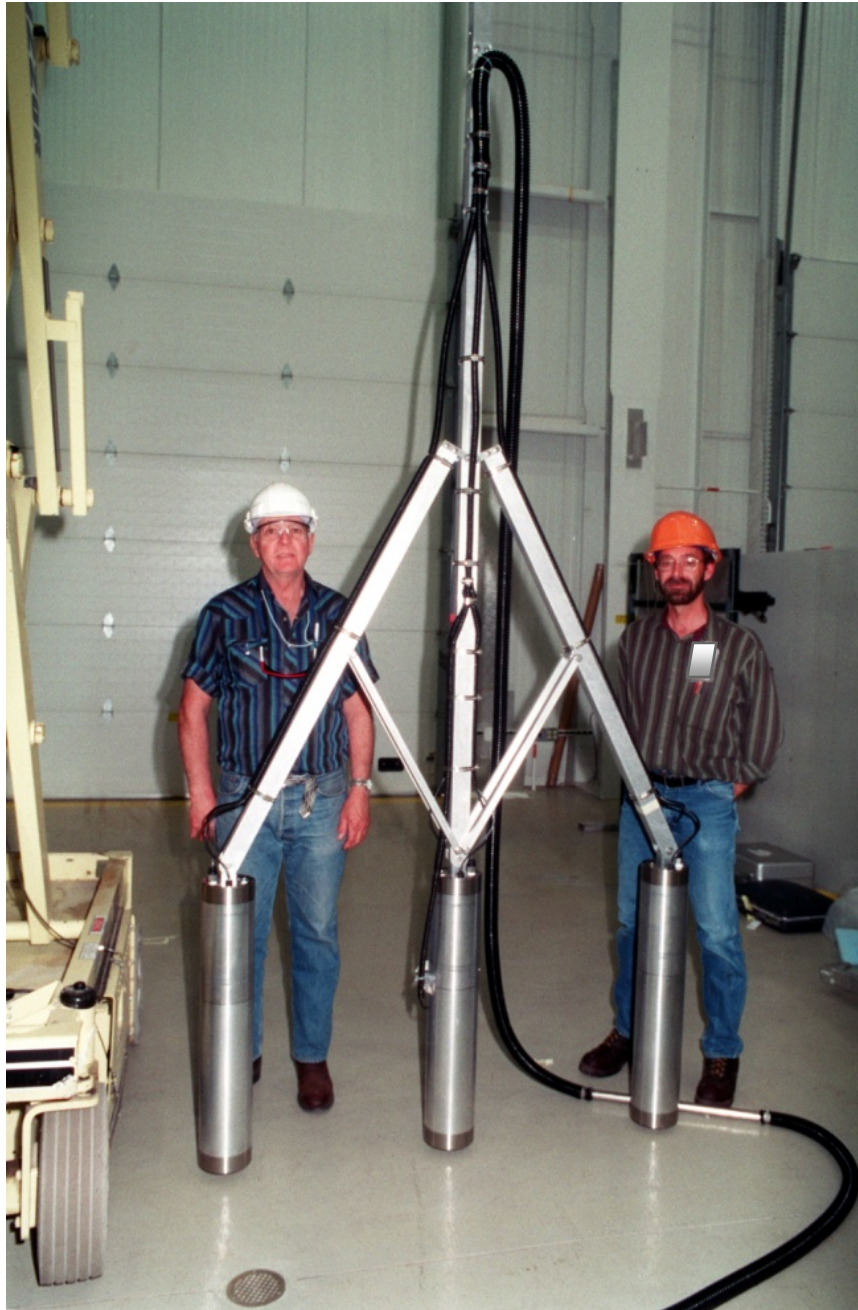
Figure 3, Multi Detector Basin Scanning Array for INTEC-603.

The validation phase during the INTEC-603 pool project occurred in parallel with some portions of the cleanout phase. After the racks and equipment were removed, an extensive examination using very sophisticated gamma scanning equipment was employed to map the location and character of the sludge at INTEC-603. In previous INL pools the diver approach simply surveyed the work area using a remotely reporting instrument prior to starting work each shift. At the Dresden project, the small Remote Underwater Characterization System (RUCS) assisted in the validation role prior to diver entry and cleanup. At the INTEC pool the Multi Detector Basin Scanning Array (Figure 3) was employed as the survey tool. This scanning array is composed of three sections containing gamma detection instruments and is specifically designed to be used with the INTEC-603 crane system and to traverse channels in the pool floor. Since the overall residual cleanout is not complete until the sludge is removed, the validation phase was performed after equipment removal but prior to sludge removal.

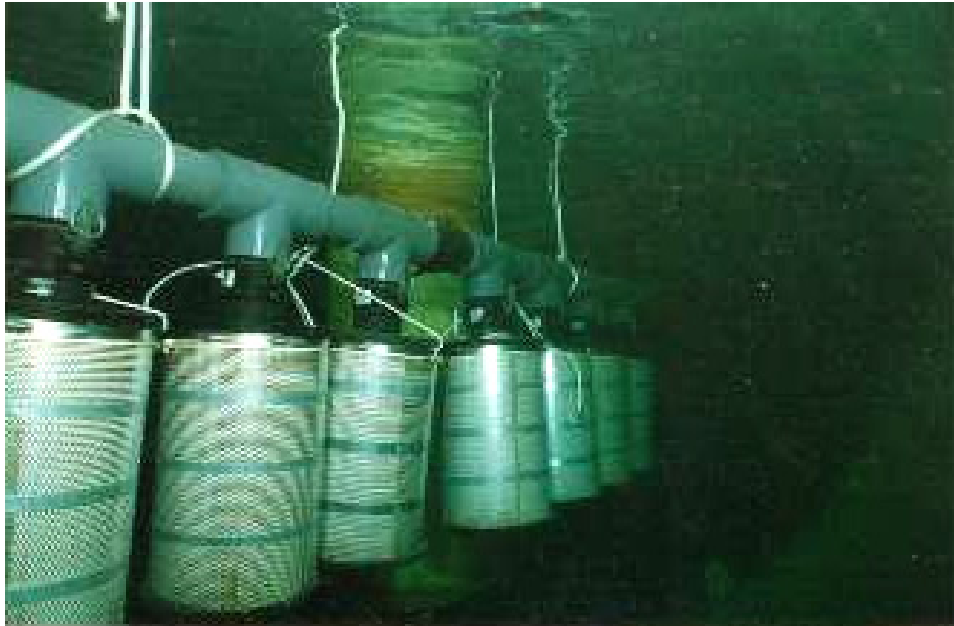
Figure 4, UCC vacuuming filtration system underwater manifold.

A system known as the UFV-100 "Tri-Nuc" Filter System, manufactured by Tri-Nuclear Corporation, was placed in the pool to maintain long-term water quality. The Tri-Nuc is a canister-type, shielded filter about 0.8 m. long and 18 cm in diameter. It is an easily-maintained, self-contained system with a submersible pump. After the peroxide injection and three weeks of Tri-Nuc filter operation, the pool water became clear and maintained clarity throughout the project. Over the course of the project, 50 of the Tri-Nuc filters were used. A skimmer system was added to the Tri-Nuc to clear floating algae debris. The underwater diving contractor provided a separate vacuum/filtering system consisting of a pump and eight 38 cm filters on a manifold (see Figure 3). Though this system helped to maintain water clarity, its primary purpose was to contain the paint chips and floor debris. A "rock catcher" screen was used on the UCC system to prevent larger particles from going
