# A NEW METHODOLOGY FOR BREAKWATER DAMAGE ASSESSMENT AND ITS IMPLEMENTATION ON A WEBGIS

In this paper a new methodology for breakwater damage assessment was developed to reflect the advances in monitoring techniques and to overcome some limitations in this process. The proposed methodology was implemented on a WebGIS called SIMOM - Monitoring System for Maritime Works. This system and the proposed methodology are presented using the Ericeira North breakwater (Portugal).

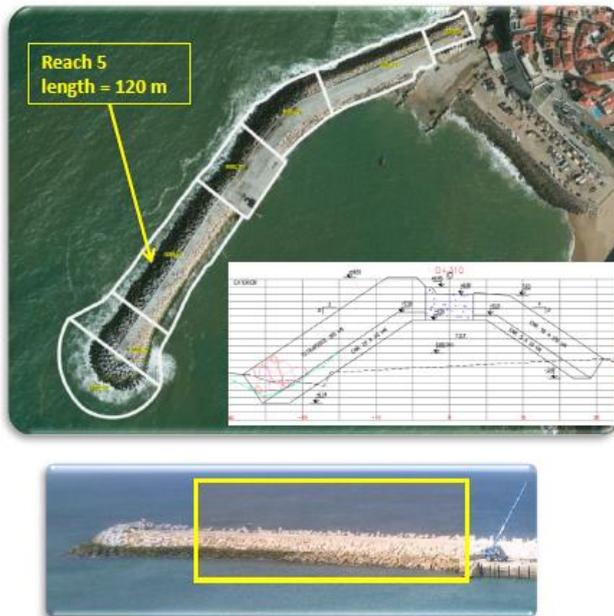
Structural Characterization – Reaches

Figure 5. Reach division (left) and QGIS plugin with the associated metadata highlighted (right).

In design, cross sections were represented every 10 m (44 total cross sections) and, at the breakwater head, 3 radial profiles ( $45^\circ$ ,  $90^\circ$  and  $135^\circ$ ), respectively. These sections were used both to determine the number of reaches, the structural elements and as cross sectional profiles to assess damage based on surveys obtained during the monitoring process. Based on those cross sections the structure was divided into 7 reaches represented in Figure 5. These reaches include rubble mound with superstructure, horizontal composite and transition reaches. The criteria used to define reaches were the structure function and structural homogeneity. Continuous transition areas were considered where homogeneity is not verified.

In Figures 5, 6 and 7 the QGIS plugin is shown to illustrate some of the details such as the name, length, weights, etc. It should also be noted that sensitivity analysis was performed, subjected to the practicability restrictions. It was found that this division assures maximum flexibility as well as maintains the number of reaches and subreaches within practical intervals for inspections and condition assessment purposed.

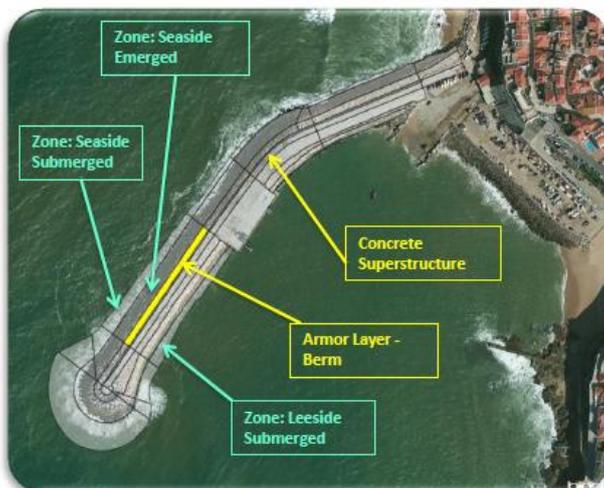
Structural Characterization – Elements/Zones

Figure 6. Division of the structure in elements and zones (left) and QGIS plugin with the associated metadata highlighted (right).

Once the structure was divided into reaches it was further divided into structural elements. These are represented in Figure 6 and include: armor layer berm and slope both imerged and submerged, crown wall, crest massif, pavement and quay.

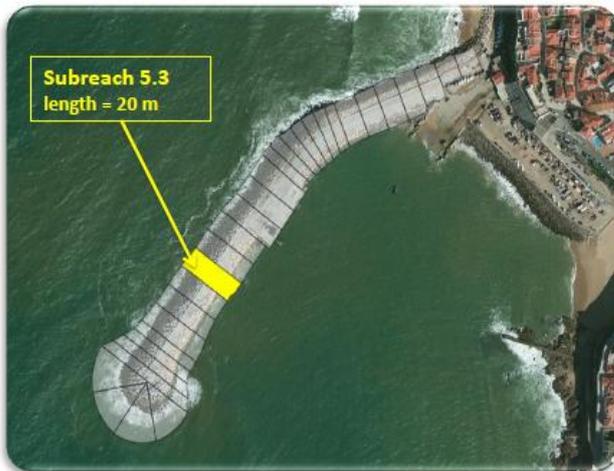
### Reach Subdivision in Subreaches

Figure 7. Division of the structure in subreaches (left) and QGIS plugin with the associated metadata highlighted (right).

After the structural elements were identified, each reach was divided into subreaches to facilitate the monitoring process. The reach length ranges between 10 and 20 m since the subreach length should be a submultiple of the reach length. Therefore the structure comprises 31 subreaches which are presented in Figure 7.
