Title: **“Improved Miscible Nitrogen Flood Performance Utilizing Advanced Reservoir Characterization and Horizontal Laterals in a Class I Reservoir – East Binger (Marchand) Unit”**

Type of Report: **Quarterly Technical Progress (Report No. 15121R05)**

Report Date: **August 10, 2001**

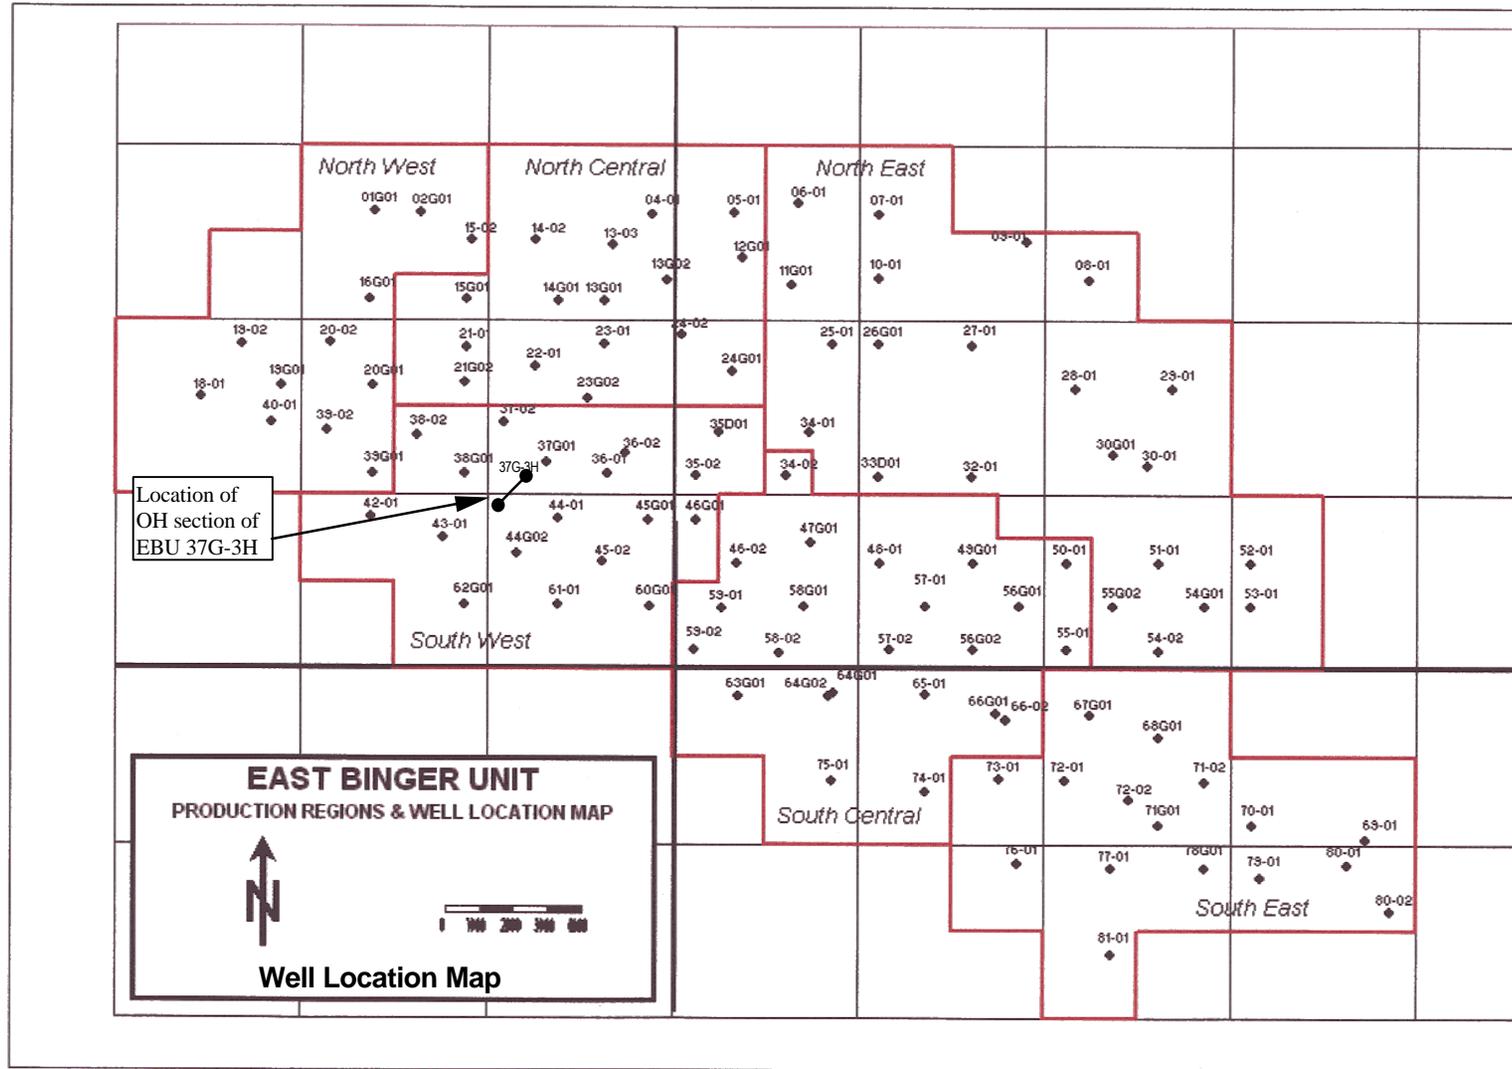
Figure 1. East Binger Unit map showing well locations, including the new horizontal well EBU 37G-3H. The well's surface location is adjacent to EBU 37G01, which was plugged due to casing problems.

One of the major items planned within this task was the drilling of two horizontal wells for the purpose of calibrating horizontal performance in the reservoir simulation models to actual field performance. The first of these wells, EBU 37G-3H, was spud during the second quarter of 2001, but had not been completed at the end of the reporting period. Significant problems and cost overruns were encountered during the drilling operations. This has forced Binger Operations to re-evaluate the cost/benefit relationship of a second well. After consulting with IRT, it was decided to forego the second well for the time being. EBU 37G-3H, originally planned as an injection well, will now be completed as a producer. Estimation of horizontal injectivity for the simulation work will be based on horizontal productivity. Figure 1 shows the location of the horizontal open hole.

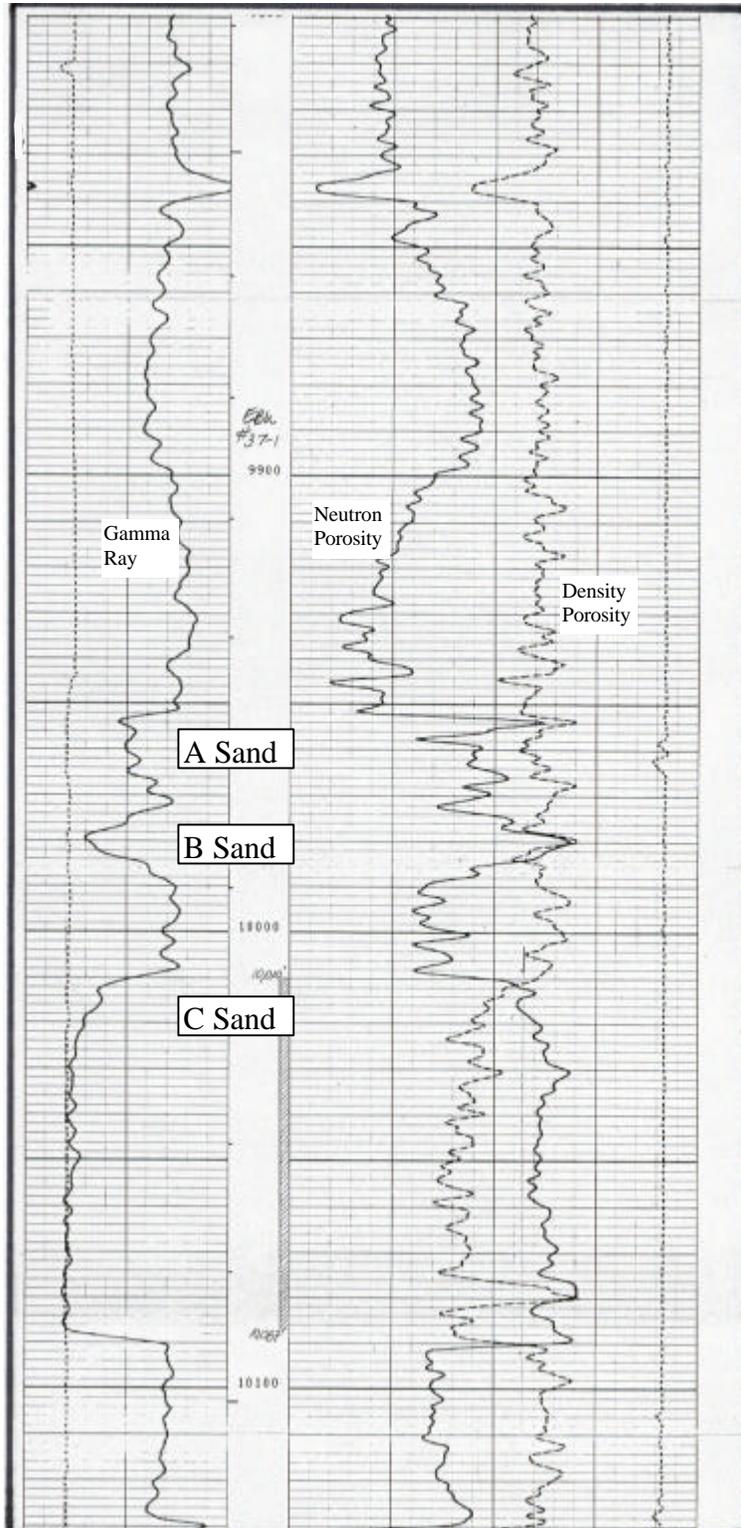
Figure 2. Open hole log from EBU 37G01 (Note - neutron porosity is based on a limestone matrix; density porosity is calculated using a grain density of 2.71 g/cc). Horizontal well EBU 37G-3H was drilled from the same surface location.

It is believed that the hole problems resulted from very water-sensitive shales just above the Marchand A Sand and between the Marchand A, B, and C Sands. Figure 2 is an open hole log from well EBU 37-1. Note the change in the shale line of the gamma ray curve that occurs at about 9900'. The change to an oil base mud was made to prevent further problems with these shales. For added insurance, a mud weight of 9.5 ppg or higher was maintained throughout the curve and horizontal section. Future horizontal wells in the Marchand will likely require oil base mud through the curve section, though the mud weight could possibly be reduced such the well could still be drilled underbalanced.

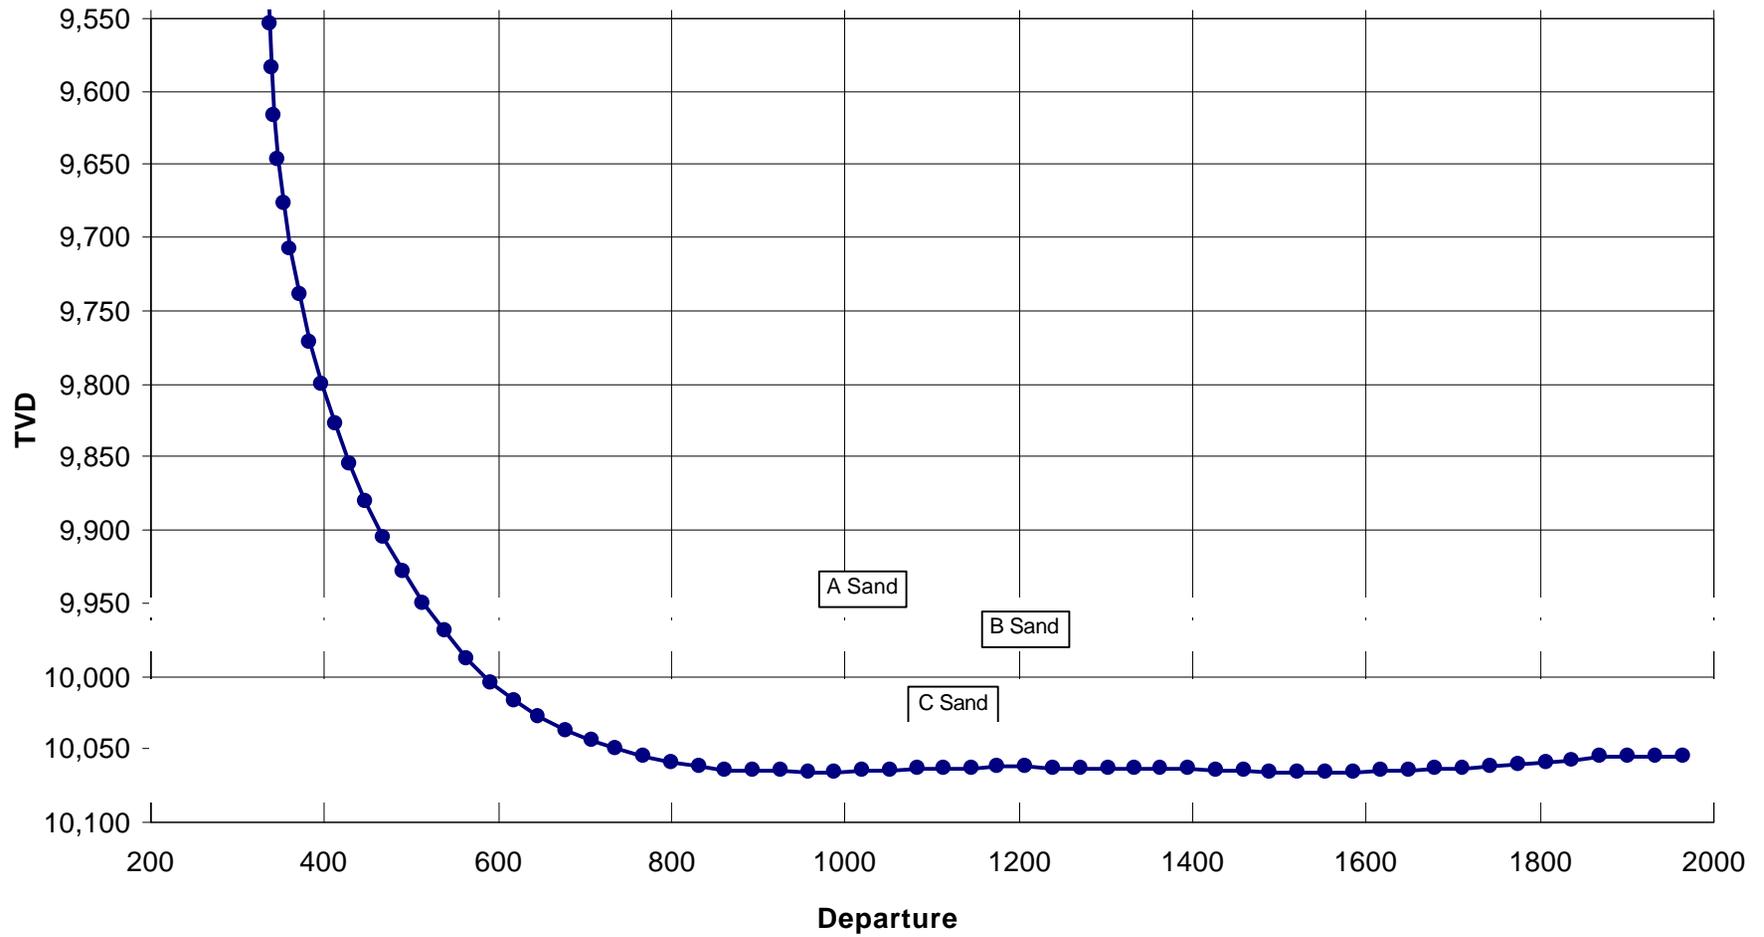
EBU 37G-3H Directional Data

Figure 3. Path of EBU 37G-3H wellbore

One other drilling problem occurred at the end of the horizontal section. After drilling about 1300' of horizontal section, the bottom of the drilling assembly got stuck in the hole. The tool string was backed off above the stuck point and the bottom 185' of the drilling assembly was left at the end of the horizontal open hole. Figure 3 is a plot of the path of the wellbore within the C Sand; the bit actually reached an additional 60' beyond the last point measured. Toward the end of the drilled section, the wellbore was drifting up in the section, despite efforts to keep it level and then turn it back down.
