Occupational Safety Review Of High Technology Facilities

L. C. Cadwallader

January 2005

**OCCUPATIONAL SAFETY REVIEW
OF HIGH TECHNOLOGY FACILITIES**

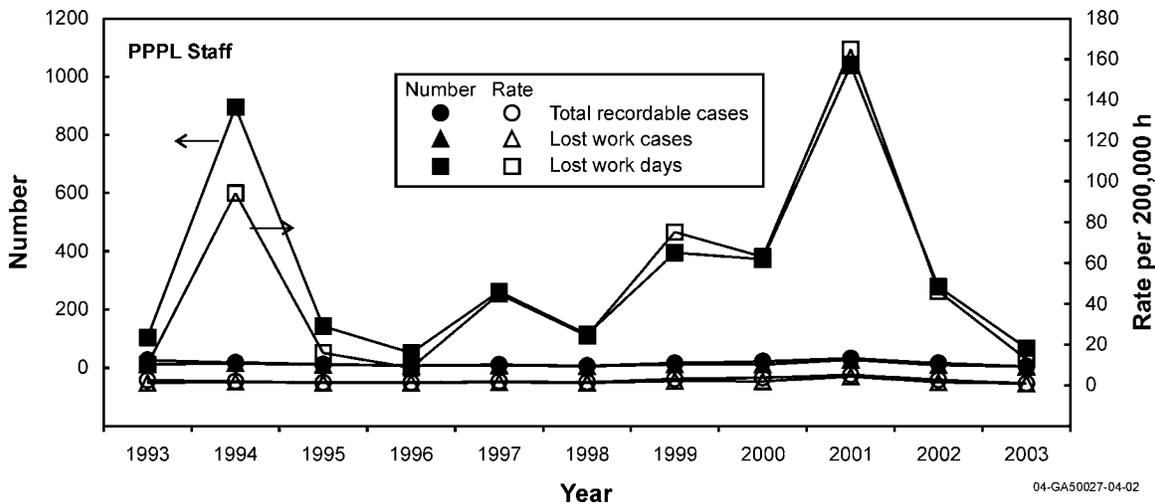
Figure 1. Plots of PPPL Industrial Safety Performance from 1993-2003.

The industrial safety performance of the PPPL staff over the last decade has been obtained from the DOE Computerized Accident/Incident Reporting System (CAIRS) and plotted in Figures 1 and 2. Overall, the data in Figure 1 show a positive trend of decreasing the lost work days, which means PPPL is working on reducing the number and severity of accidents. This is positive since the PPPL values are higher than the overall R&D values presented later this report. The PPPL peak values in 1994, 1997, and 1999-2002 are explained by the activities under way at the lab during those years. In 1994, the PBX-M was shut down and was placed into safe, cold shut down mode. In 1997, the TFTR ceased its D-T operations and entered a safe shut down mode, which entailed a great deal of work with all the tokamak subsystems. In 1999, the NSTX machine began operations, but, more importantly, the TFTR began decontamination and decommissioning (D&D). That was a significant task, demanding large efforts from the staff in tasks that they were not as familiar with as operations. The PLT and PBX-M machines were dismantled and removed from their test cell building in the same time

note: The DOE data have shown that no staff or other workers have suffered a work-related fatality while working at PPPL.

Figure 9 gives the DOE safety performance data for all research and development facilities from 1993-2003. Comparisons of these overall rate data to Figures 1, 3, 5, and 7 show that for staff members, PPPL varies between being equal to the yearly ‘all DOE research’ values and having much higher rate values, SLAC varies between being equal to the ‘all DOE research’ values and having about double the rate values, FNAL is about the same as the ‘all DOE research’ values, and CEBAF/Jlab is usually slightly below the ‘all DOE research’ values for lost work day rates. For services subcontractors, SLAC and FNAL were much higher than the ‘all DOE research’ values, CEBAF was lower, and PPPL did not list services separately. For construction, SLAC had rates generally higher by factors of 2 to 3, FNAL was slightly lower than the DOE values (except for a few peak years), and CEBAF was generally lower than the DOE rates except for one spike

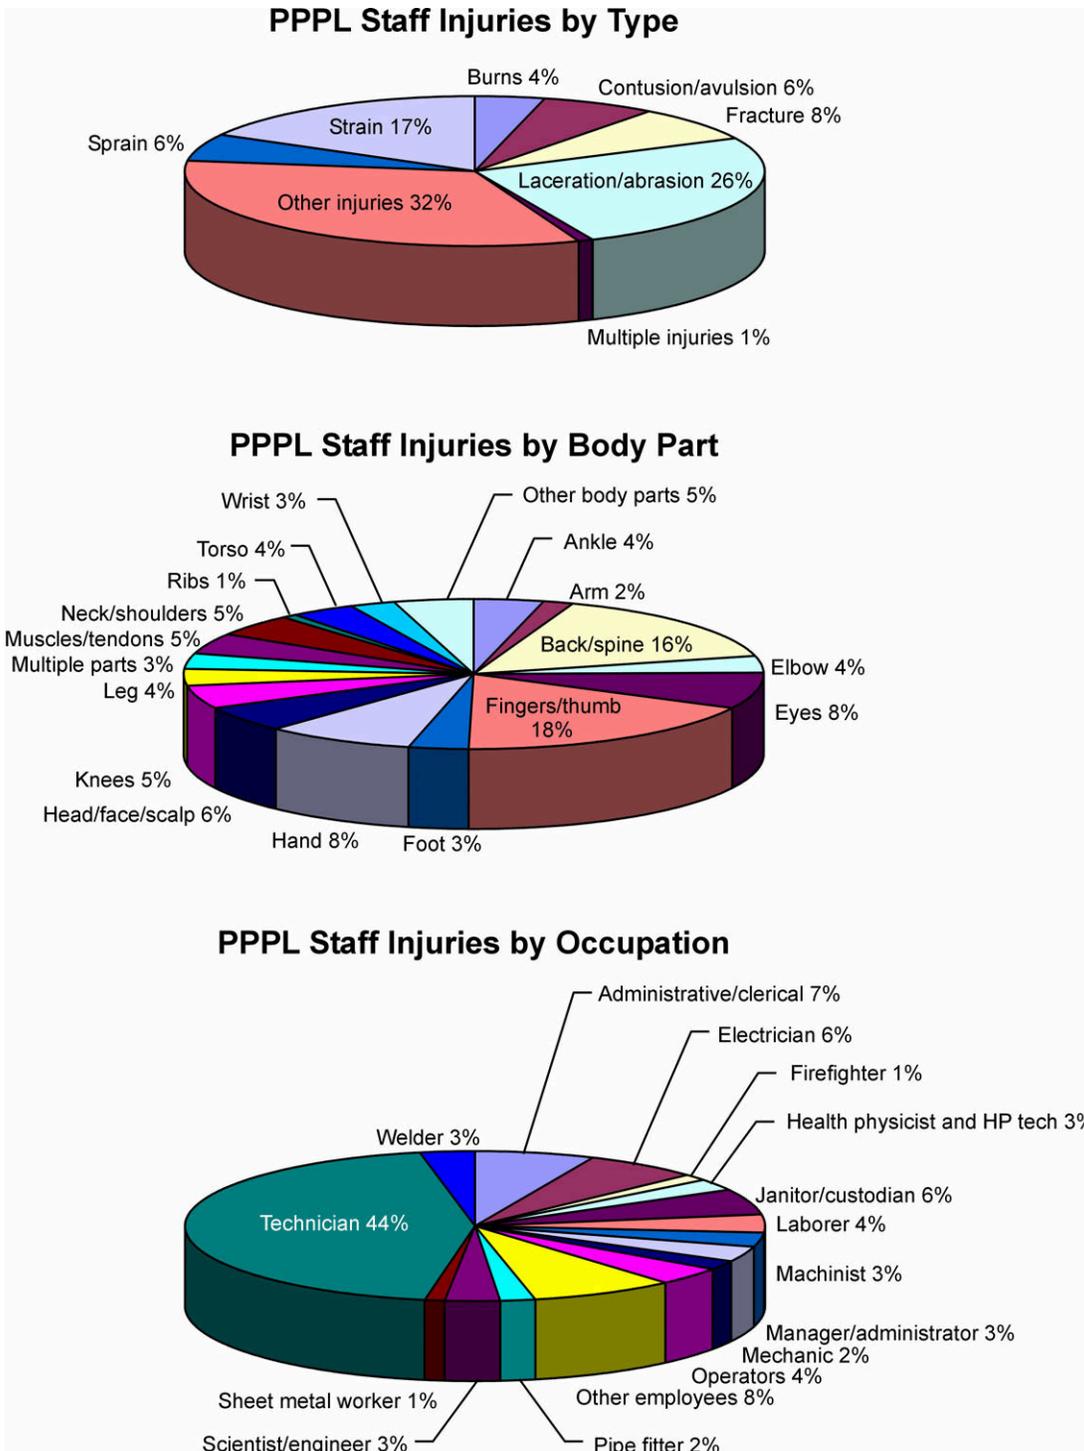
Figure 2. PPPL Industrial Injury Distributions from 1981-2003.

period as TFTR D&D. Their removal made way for the NCSX device, which is currently under construction. The NCSX will use neutral beam, vacuum pumping, and water cooling systems from the PBX-M, and power supplies from the TFTR. The occupational injury distribution results are presented in Figure 2. The first chart shows that lacerations are frequent. The ‘other injuries’ category includes punctures, dislocations, cumulative trauma, dermatitis, eye injuries, insect bites, hernia, injuries “not otherwise classified”, and other types of injuries that individually were small in number but summed together comprise almost a third of all reported injuries. The second chart in Figure 2 shows that finger injuries are the most common, which is to be expected with the large amount of hands-on work involved with tokamak maintenance. The third chart shows that technicians have the highest number of injuries incurred in their work, this is because the technicians are continually closest to the tokamak systems and perform the majority of the hands-on tasks. The data plotted in Figure 1 can be compared to the research facility totals that will be presented later in this report (see Figure 9). The charts from Figure 2 can be compared to the similar charts given for accelerator facilities. Note that PPPL did not report construction contractor or services subcontractor injuries. Some sites report their construction contractor and services (electricians, technicians, custodians, etc.) injuries, especially when the contracts involve significant amounts of manpower.

Unfortunately, the fission plant occupational safety data resolution does not allow estimation of the accident or fatality risk for individual occupations (e.g., welder, mechanic, electrician, etc.) or operation in the plant, such as maintenance, surveillance, or inspection tasks, operations evolutions, or other tasks. Only the yearly totals have been reported by INPO and WANO. These data apply only to the utility personnel, that is, the people who are permanently assigned to the power plant, not subcontractors who are hired for special tasks. Subcontractors were not included in these estimates. The data can only serve as bounding values for overall yearly safety estimates for fusion workers. From previous chapters, there have not been any occupational fatalities in operation of the fusion experiments or accelerators, so there is no fatality rate. Lost work case rates for PPPL, SLAC, FNAL and CEBAF, from Figures 1, 3, 5, and 7, have been compared to the accident rates given for fission plants and were very comparable in past decades, but now the fusion and accelerator rates are in the 0.02/worker-year range and the fission plants have reduced their accident rate to the 0.002/worker-year range. However, the severity of the accidents is usually quite low for the technology facilities (as seen in Figures 2, 4, 6, and 8) while the accident severity for the power plants is not known.

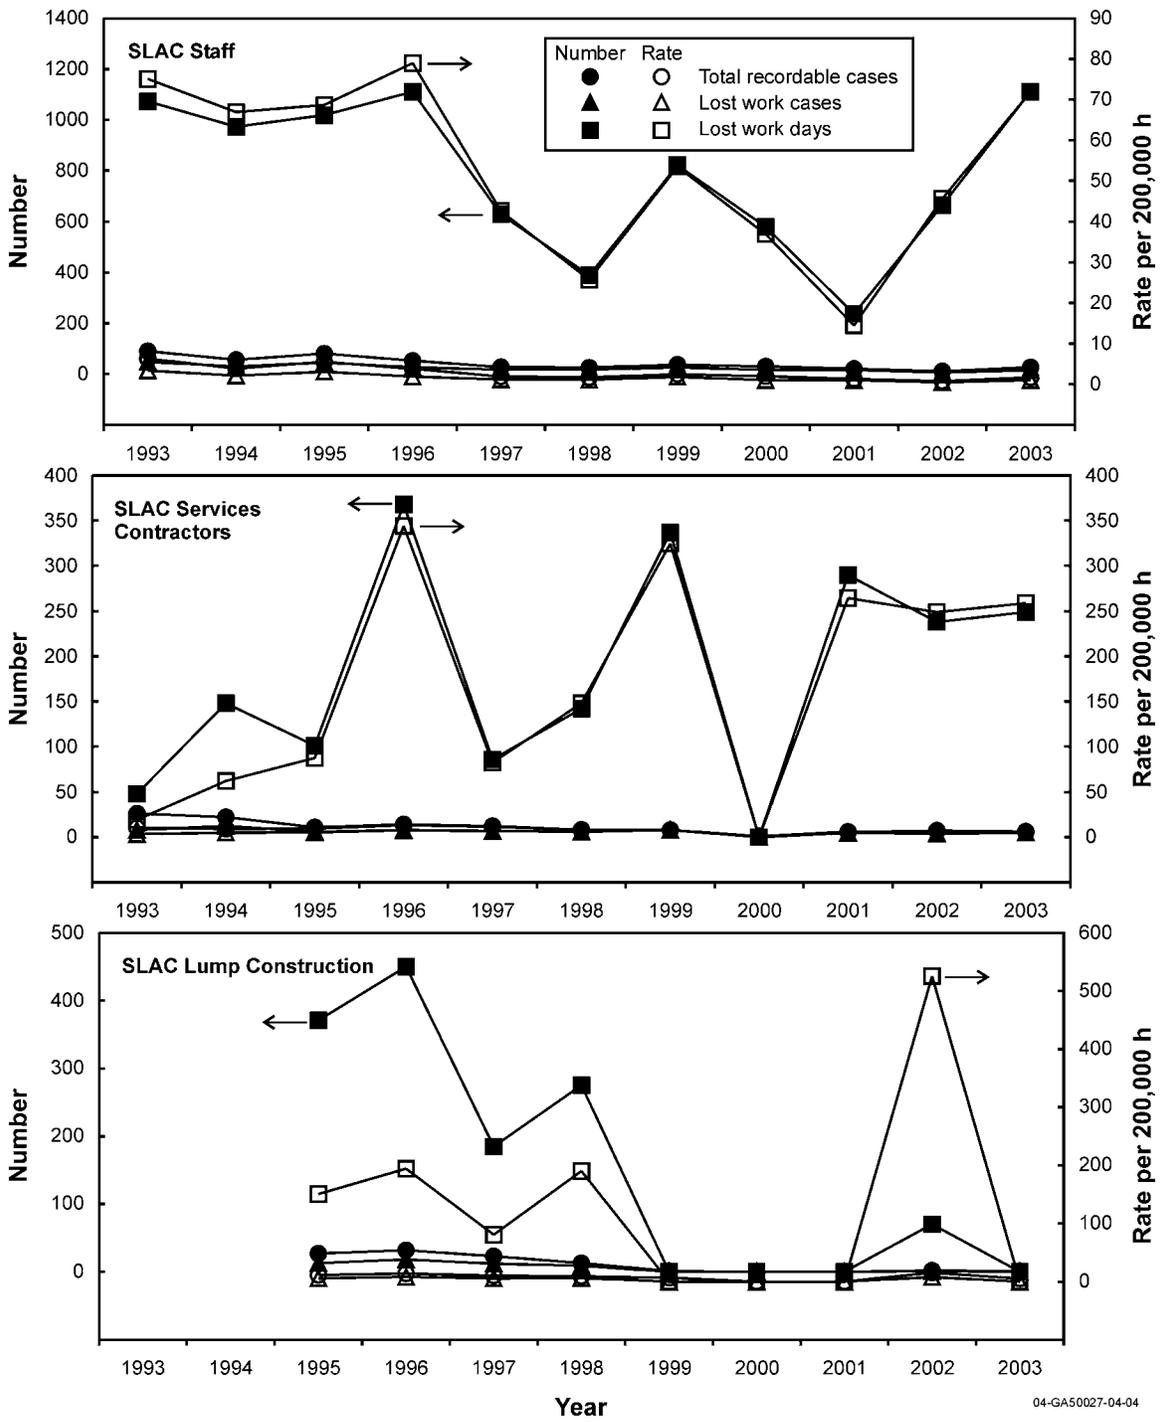
Figure 3. Plots of SLAC Industrial Safety Performance from 1993-2003.

The earliest entry into the Department of Energy Computerized Accident/Incident Reporting System (CAIRS) was March 1977. The initial report was a cryptic description of a chemical explosion that did not injure any employees but did result in \$5k damage to the facility. The other data in CAIRS is summarized in the lost work day and lost work case plots given in Figure 3, and the injuries are summarized in Figure 4. In Figure 3, lump construction is construction contracted on a lump sum fee basis. The construction work is the same regardless of the type of construction contract. Service contractors can be support services, such as technicians, computer support, custodians, laundry, food

note: There were no fatalities at SLAC in the 1993-2003 time frame.

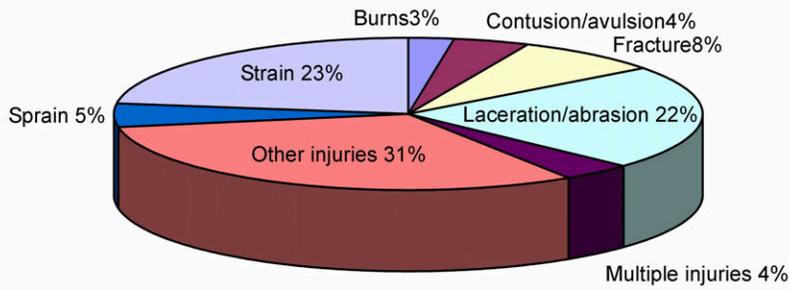
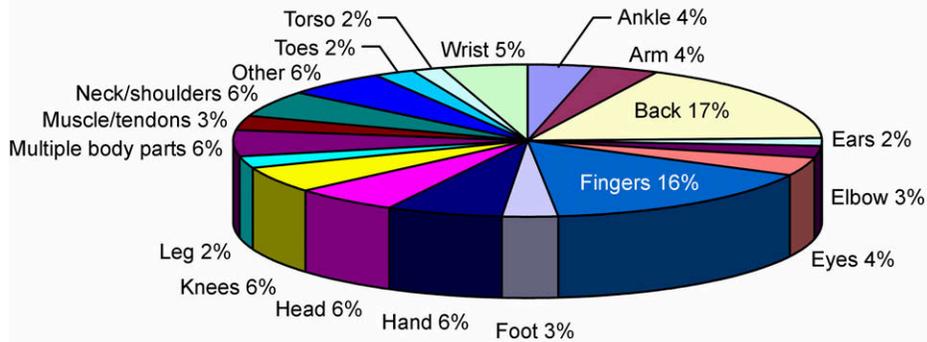
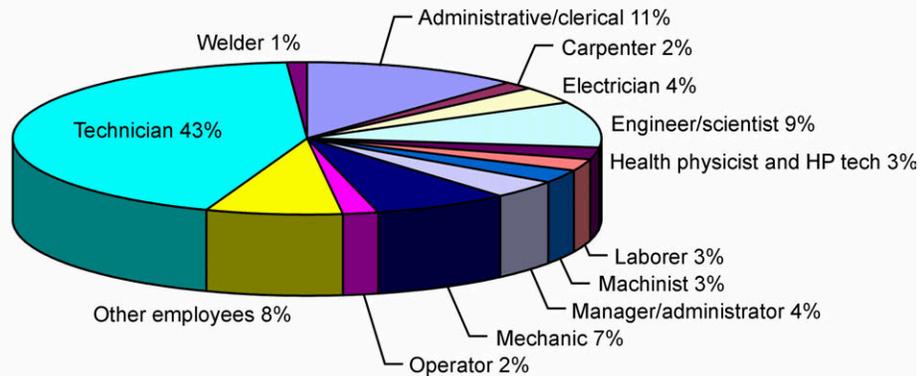
Figure 4. SLAC Industrial Injury Distributions from 1981-2003.

SLAC Staff Injuries by Type

SLAC Staff Injuries by Body Part

SLAC Staff Injuries by Occupation

services, laborers, and other workers. The results show a cyclic trend of decreases and then increases. Reasons for these varying results are not known. Figure 4 shows that the 'other injuries' category is large; it includes issues such as skin irritation, insect bites, puncture wounds to fingers, carpal tunnel syndrome, dermatitis, mental illness, and "injuries not otherwise specified". As seen with PPPL, the SLAC technicians suffer the highest number of injuries, which indicates that again, the technicians are the people who interface most directly with the machine and its subsystems, the work is similar between the two types of facilities. A surprising result is the high number of injuries among the other occupational groups, mainly the administrative staff and the engineers/scientists. The injuries were typically not severe, generally they were small lacerations, falls to the same level (i.e., slipping and tripping), and carpal tunnel syndrome. Nonetheless, the numbers of injuries appeared to be high for the administrative people in traditionally low hazard office occupations. The scientists and engineers probably are injured due to spending time working with the machine and its diagnostics rather than designing, analyzing data, etc. Data similar to that presented in Figures 3 and 4 were prepared for SLAC for the 1985-1990 time period (Lyon, 1991); the earlier data very comparable.

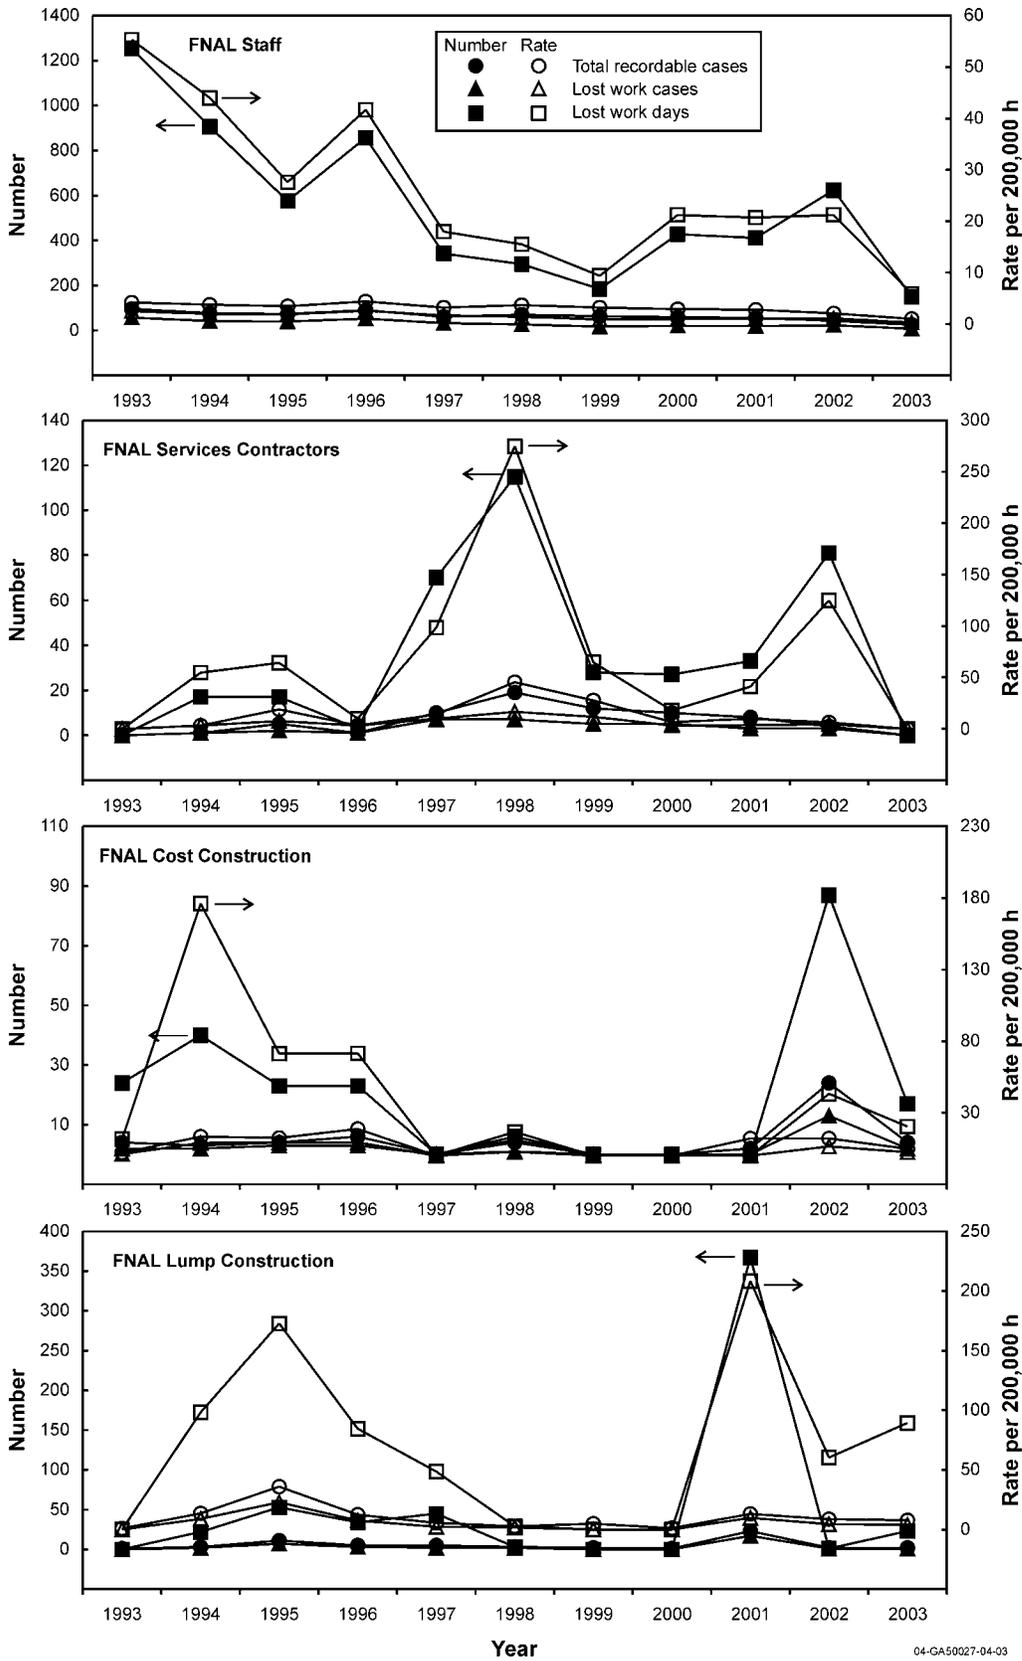
Figure 5. Plots of FNAL Industrial Safety Performance from 1993-2003.

FNAL was searched in the DOE CAIRS and ORPS databases. The data in CAIRS is summarized in the lost work day and lost work case plots given in Figure 5 and injury graphs in Figure 6. In Figure 5, lump construction is construction work contracted on a lump sum fee basis, and cost construction is contracted on an actual cost-plus award fee basis. The actual construction work is the same for either type of contract. The 1990's peaks in construction work were likely due to initiation of the Main Injector construction task. The reason for the peak in the 2000's is probably the construction work for additions to the Main Injector. The FNAL permanent staff graph shows an overall downward trend over the time period. Reasons for service contractor peaks in 1998 and 2002 are not known. Service personnel can be technicians, computer support, custodians, laundry, food services, laborers, and other workers. It is possible that the construction work required more on-site support services. The total for all scientific research in the DOE is presented later in this chapter and comparisons show that FNAL has modest or

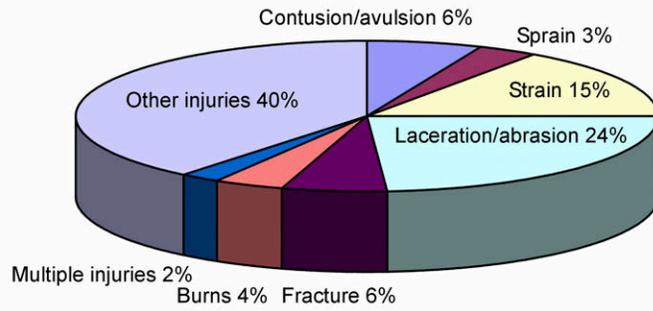
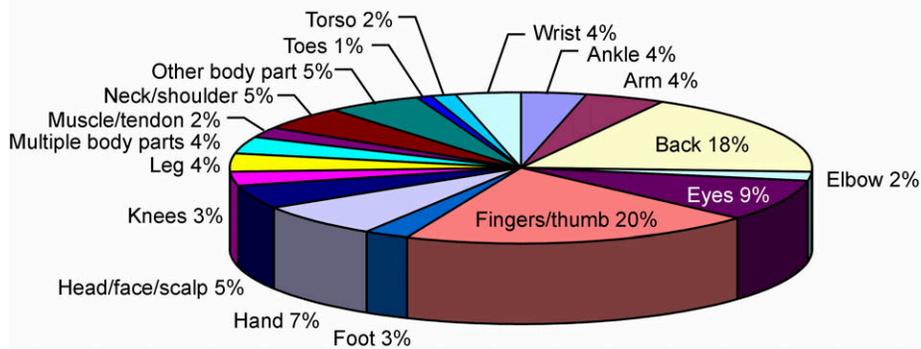
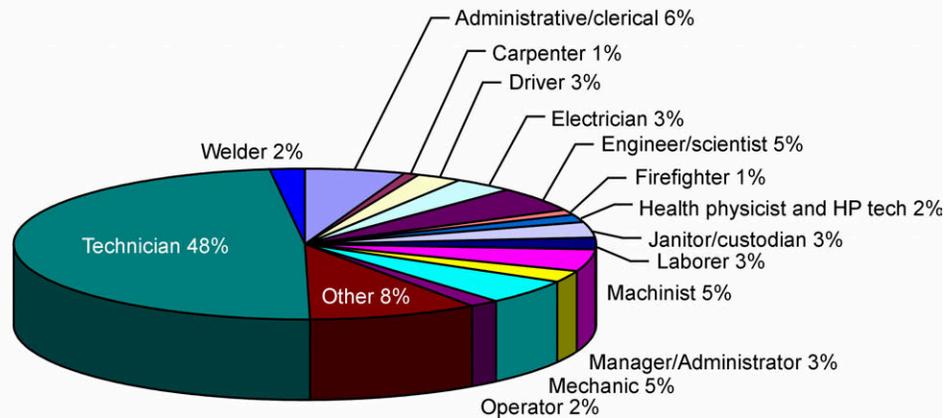
Figure 6. FNAL Industrial Injury Distributions from 1981-2003.

FNAL Staff Injuries by Type

FNAL Staff Injuries by Body Part

FNAL Staff Injuries by Occupation

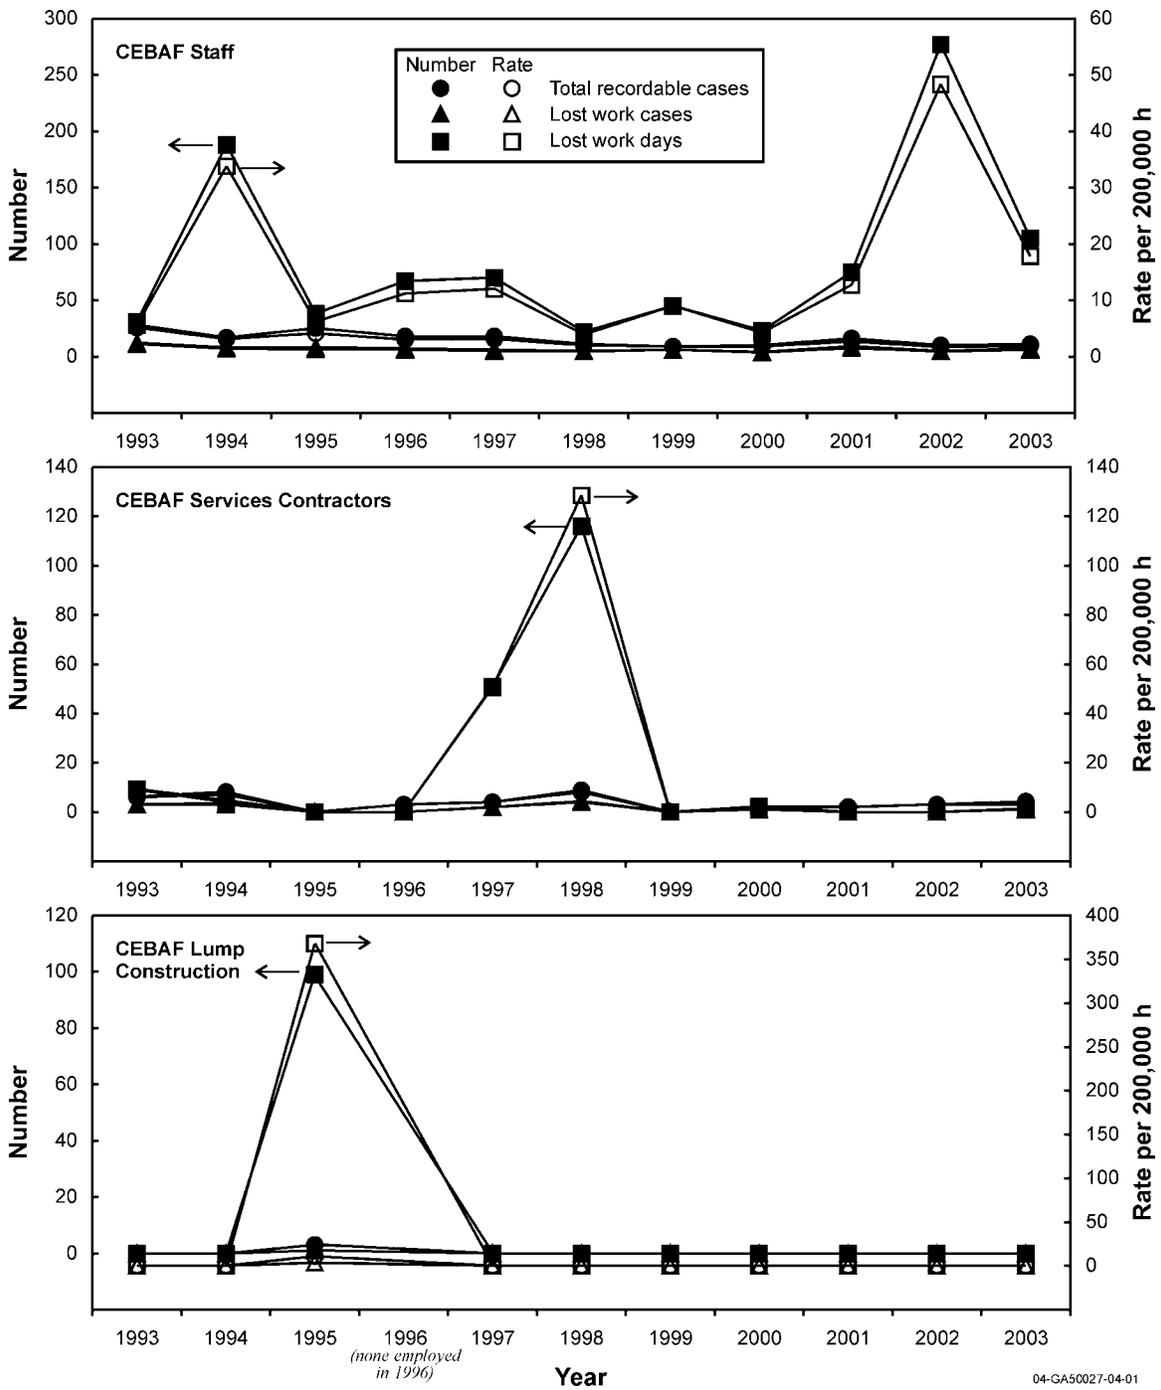
Figure 7. Plots of CEBAF Industrial Safety Performance from 1993-2003.

The Jlab occupational safety data are presented in Figures 7 and 8. These data are similar to the other facilities already presented. The Jlab plot annual values are below the DOE research and development values. The staff peak in 1994 was probably due to experiment commissioning tests, and free electron laser upgrade in 2001-2002 may be responsible for the peaks in those years. The pie charts in Figure 8 show that once again, technicians are the leading group for industrial injuries.

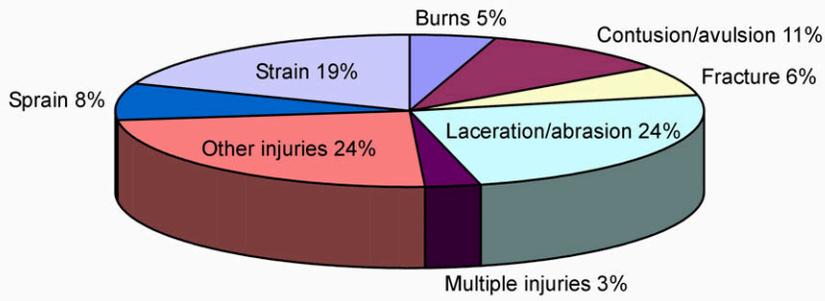
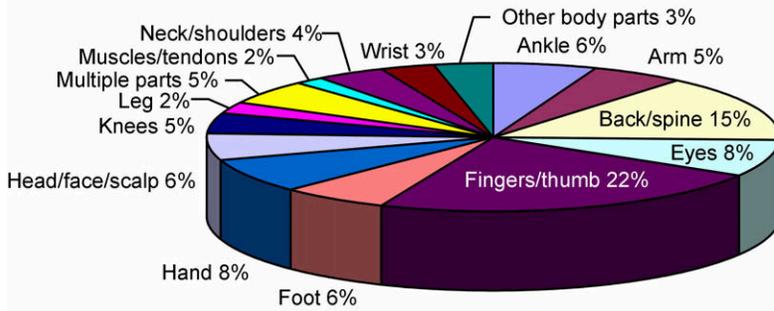
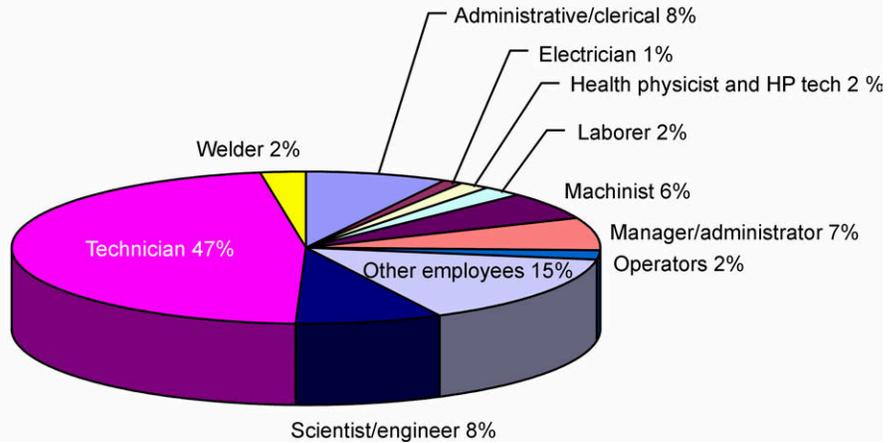
Figure 8. CEBAF Industrial Injury Distributions from 1988-2003.

CEBAF Staff Injuries by Type

CEBAF Staff Injuries by Body Part

CEBAF Staff Injuries by Occupation
