## Mechanical Devices Readiness FY04.0402.3

**KCP-613-8507**

Final Report

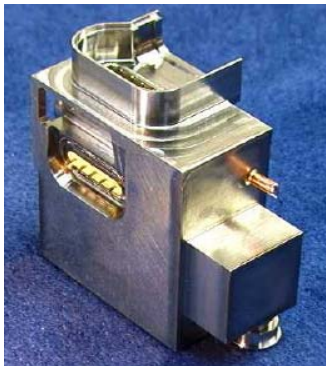
Figure 1. MC4710 ISL

The W76-1 LEP mechanical assemblies that this project supported are: the MC4710 Intent Stronglink (*see* Figure 1), the MC4711 Trajectory Stronglink (*see* Figure 2), the MC4713 Launch Accelerometer (*see* Figure 3), and the Forward Mount. Processes and tooling were improved and additional tooling was procured to support First Production Units (FPU), rate production, and schedule pull ups to support the new building (KCRIMS). All FPU schedules were successfully met for these components because of efforts supported by this project. Likewise, rate production schedules are also being supported.

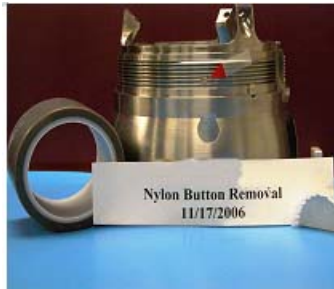
Figure 5. Button Removal

Removal of a nylon button in the W76 Forward Mount was a very time consuming and costly process. The previous process involved soaking one Forward Mount at a time in solvent vapor for 48 hours to remove the button (*see* Figure 5). A process was developed to use a solvent that would allow 19 parts to be run at once for 6 hours, resulting in a cost savings of \$699 per Forward Mount. This resulted in a FY07 savings of \$13,279. Discoloration was also a problem and a process was developed to remove the discoloration without causing damage to the part (*see* Figure 6).

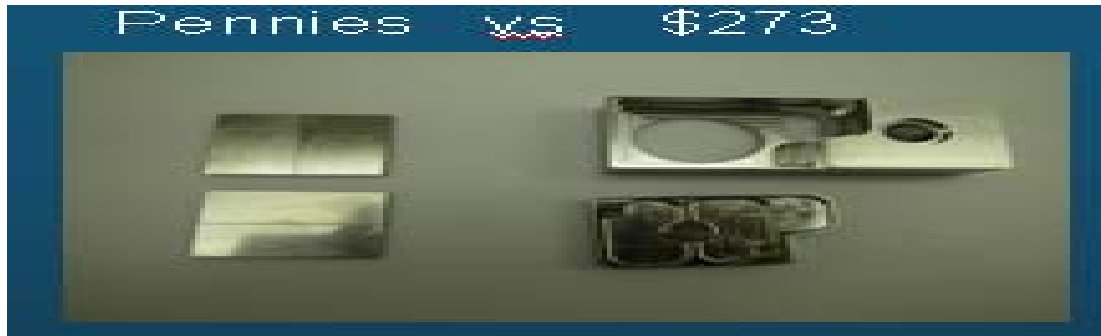
Figure 19. Snap Plates vs Simulated Samples

KCP developed snap plates and recommended changing from WR qualified parts or simulated WR qualified part weld samples to using snap plates for before and after shift weld samples (*see* Figure 19). This has been implemented on the W76 mechanisms by replacing approximately half of the WR qualified parts or simulated samples with snap plates. The snap plates allow real time evaluation of the welds by welding the joint between two snap plates and breaking them

apart to view the welds. Penetration can be determined without sending off expensive WR qualified parts or simulated part weld samples for metallurgical testing. This will save well over \$1M for the life of program.

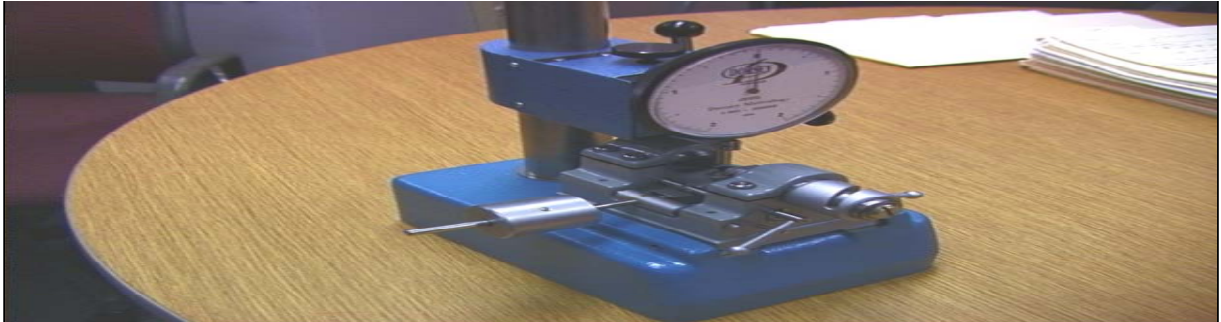
Figure 21. Bearing Push & Radial Fixture

Bearing push test and radial play fixturing and processes were developed, resulting in drawing changes to inspect bearings (*see* Figure 21). This eliminated the expensive and time consuming bearing disassembly and hardness testing procedure. There was also subjectivity due to hardness test variability where the vendor would accept and then KCP would reject parts.

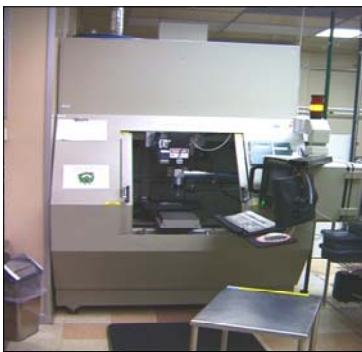
Figure 22. LaserDyne YAG

To ensure support of rate production, backup welding machines were qualified. The second of two LaserDyne YAG (*see* Figure 22) continuous weld machines has been qualified for the W76 mechanisms. A new pulsed YAG weld machine has been qualified to replace older machines that are not as well suited to smaller tack welds on newer mechanisms. A second copy of this machine will be procured and qualified in the future.
