## Damage assessment on frame structure with bolted joints based on experimental modal analysis

To cite this article: M H N Izham *et al* 2019 *IOP Conf. Ser.: Mater. Sci. Eng.* **469** 012102

# Damage assessment on frame structure with bolted joints based on experimental modal analysis

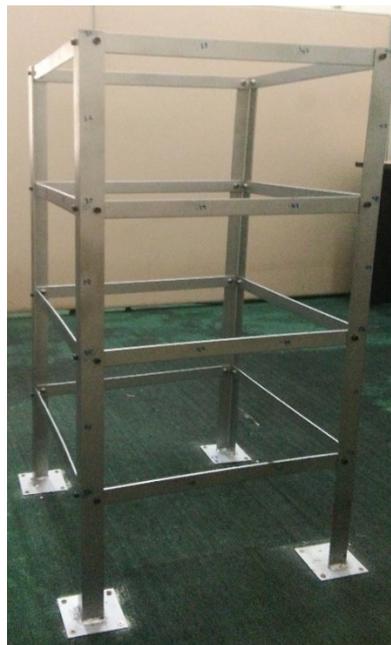
**Figure 1.** Frame structure with bolted joints.

Frame structure is a simplified model of a communication tower which involves bolted joints to connect two or more components. The structure consists of 4 L/angle bars, 4 metal plates and 16 flat bars with a 4mm thickness across all component. Image of frame structure is shown in Figure 1. Total of 32 pcs of M6 screw together with nuts to complete the frame structure with a control torque of 8-9 Nm on undamaged structure.

Table 1 shows the dimension of each component of frame structure. Stainless steel SUS 304L is selected as a frame structure and table 2 below is shows the material properties of frame structure. Boundary set as fixed-free boundary condition to replicate the actual model of communication tower which shown in Figure 1, with 4 plates is used to secure the structure to the ground.

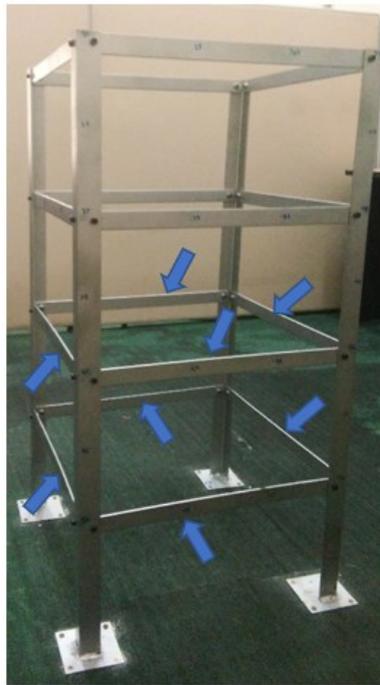
**Figure 4.** Damage condition of Frame structure.

In this study, damage is focused on the joint itself instead of structure. Bolted joint is intentionally being loosening to simulate the damage condition on the frame structure. Undamaged structure condition is defined as a flat bar is still intact on the structure with a tightening torque of 8-9Nm whereby damages explain about the structure with a loose bolted connection and no torque is set on this condition. Figure 4 represent the structure with flat bar selected to be loosen with an arrow pointing to the impacted components and Figure 5 shows the detail image of loose bolted joints to simulate the damage condition.

Total of 16 bars used in the frame structure, which a single bar consists of 2 screws with 2 nuts. 50% (16 out 32) of total screws is set to loosening to simulate the damage condition which this will makes total of 8 flat bars is loose.

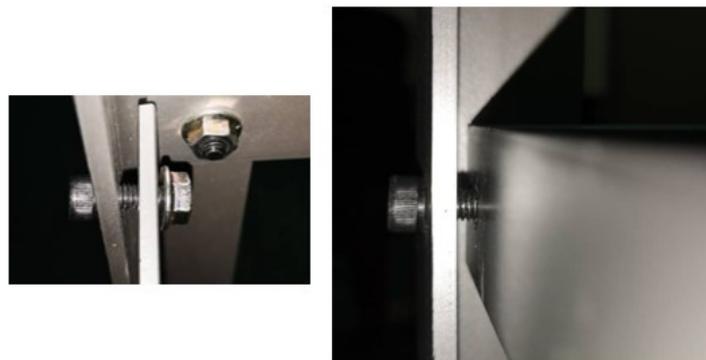
**Figure 5.** Detail image of damage condition on bolted joints.
