## Mechanical Properties Analysis of Patch Repaired Composite Structures with Debonding Flaw

To cite this article: Xia Guo *et al* 2019 *IOP Conf. Ser.: Mater. Sci. Eng.* **472** 012004

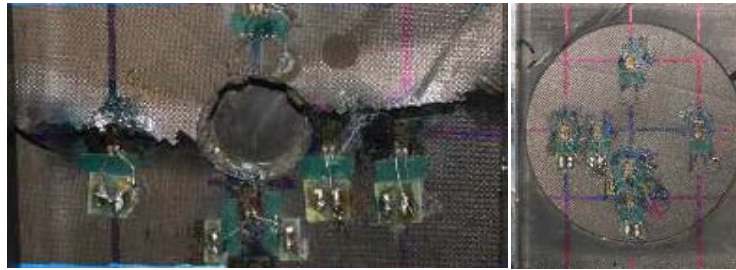
**Figure 4.** Failure modes.

The compression strength of patch repaired composite structures without flaws is 257.94MPa, and the dispersion coefficient is 6.02%. The failure modes are the repair patch peeled off, and first layer of the parent laminates stripped at first. Then the parent laminates crushed along the hole edge, as shown in figure 4.
