## Corrosion resistance of epoxy primer, polyurethane, and silyl acrylate anti-fouling on carbon steel

S Devanny<sup>1</sup> and R Riastuti<sup>1</sup>

<sup>1</sup>Department of Metallurgy and Materials Engineering, Faculty of Engineering,  
Universitas Indonesia, Depok, West Java, Indonesia

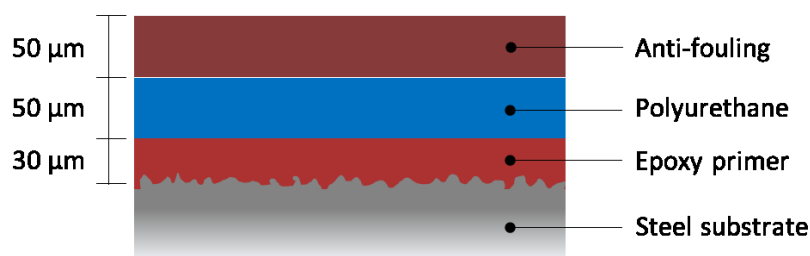
**Figure 1.** The three-layer paint.

A JIS SS400 carbon steel plate with dimensions of 15 cm x 10 cm x 0.2 cm was used as a metal substrate. Before being painted, the plates were sandblasted in accordance with the SSPC SP-10 standard to achieve a cleanliness level of 2½ Sa (an ISO 8501-1 standard). The multilayer paint was comprised of three types of commercial paint applied through manual spraying with dry film thickness (DFT) as shown on Figure 1. The drying process of each layer took approximately 4 hours followed by a final curing taking 7 days in an open space.

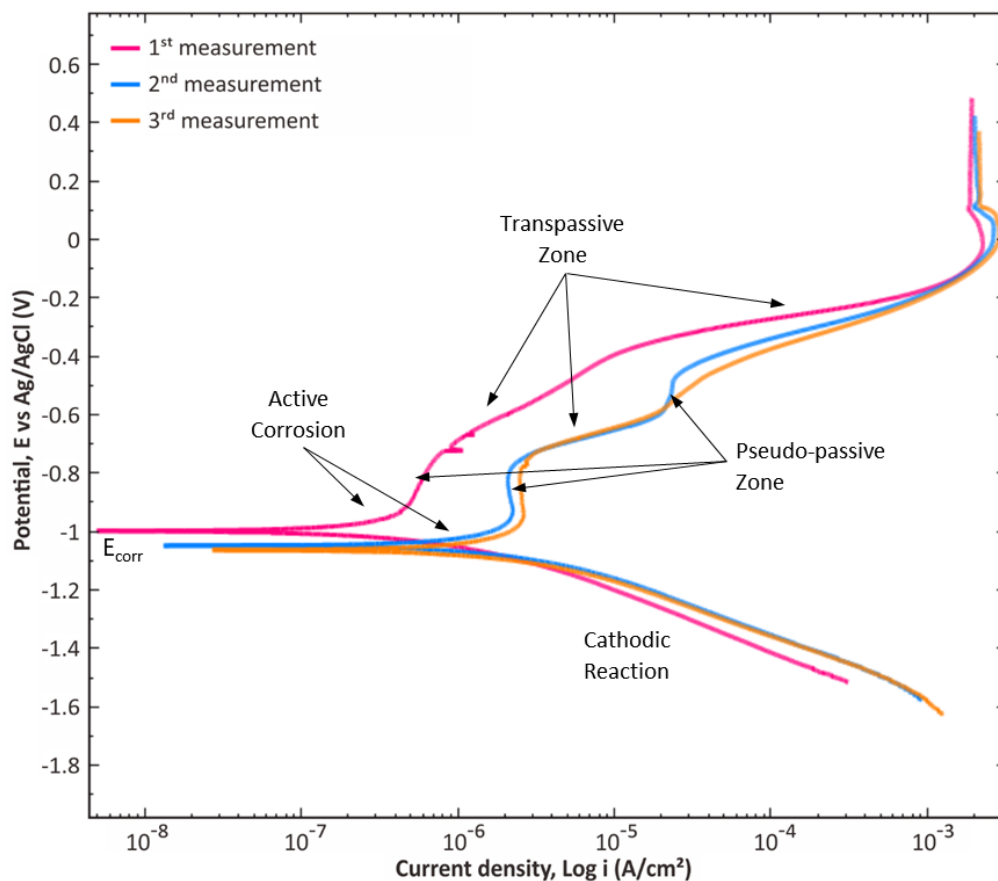
**Figure 2.** The polarization curve of specimens in 3.5% NaCl.

The polarization measurements, carried out 3 times on the same specimen, produce a potential curve  $E$  (V) and a current density  $i$  ( $\text{A}/\text{cm}^2$ ) as shown on Figure 2. This curve informs anodic and cathodic reactions, corrosion potential ( $E_{\text{corr}}$ ), and passive conditions that may occur in the system. On the other hand, the Tafel extrapolation of the curve shows the corrosion current density ( $i_{\text{corr}}$ ) to calculate the corrosion rate. The result of these polarization measurements shows that the layer is actively corroded after -0.9 and -1.05 V vs Ag/AgCl ( $E_{\text{corr}}$ ) potential while the current density is relatively constant or only increases slightly as the passivation potential rises. In the 1<sup>st</sup> measurement, passivation looks quite clear at a potential of about -0.92 V vs. Ag/AgCl. Whereas in the 2<sup>nd</sup> and 3<sup>rd</sup> measurements, the passivation curve is formed twice at the potential around -0.95 V and -0.60 V vs. Ag/AgCl.

This passivation is linked to zinc phosphate contents,  $\text{Zn}_3(\text{PO}_4)_2$ , as an anti-corrosion pigment in the epoxy primer paint. According to a study by Hao et al. [10], zinc phosphate pigment has an inhibitory mechanism in the form of a shielding effect combination of zinc phosphate and the formation of a passive phosphate layer consisting of  $\text{FePO}_4$ ,  $\text{Fe}_2\text{O}_3$ , and  $\text{FeO}$  on the metal surface that covers corrosion products and prevents further corrosion. However, the pseudo-passive behaviour of the system shows that the passive layer of phosphate formed at the steel paint-substrate interface is weak, unstable, and not tight.

Another factor that influences the occurrence of pseudo-passive condition is the characteristic of the anti-fouling paint materials that can start chemical hydrolysis with seawater, forming a thin leaching layer—which then eroded by the flow of seawater—and releasing the biocides. Silyl acrylate polymers are relatively difficult to be permeated so that the cycle of both formation and erosion of the leaching layer takes place at a relatively constant rate. In other words, passivation occurs when the leaching layer forms and erodes, leading to a decrease in the thickness of the paint. This also explains a bit more about the difference of the curve shape from the first run of polarization measurement with the next two, where during the initial immersion the paint is still intact or the process of forming and erosion of the leaching layer has not yet occurred. As the measurement took place and the specimen has been immersed for some time, the leaching layer is formed and eroded thus affects the passivation curves on subsequent measurements.

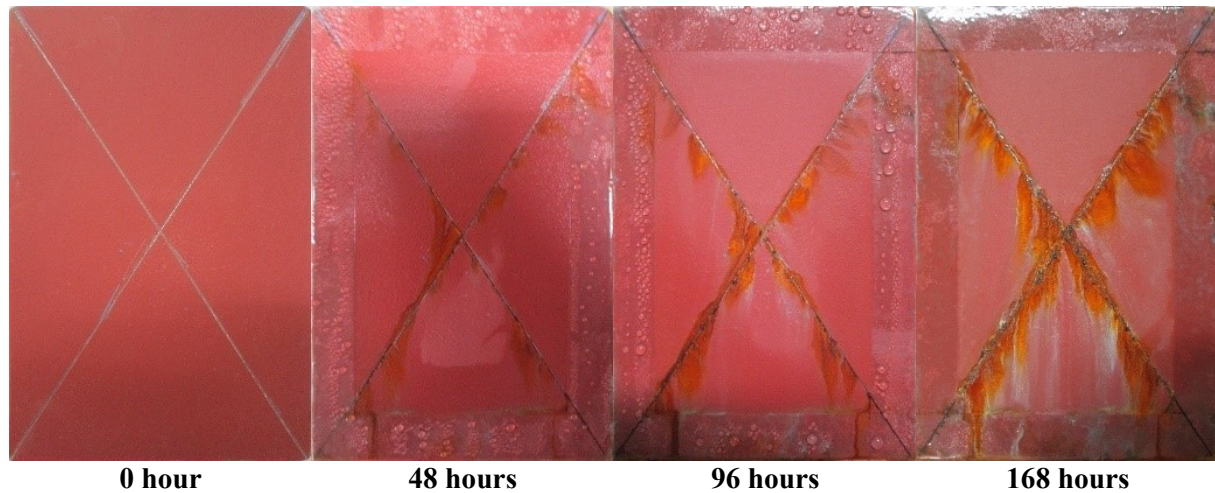
**Figure 3.** The condition of specimens before and after salt spray test.

Figure 3 shows the visual condition of the specimens before and after salt spray test. All the specimens suffer a severe damage to the scribes and the formation of rust has clearly been visible from the 48-hour test period. Most of the corrosion products are brown-orange-reddish and black which are the characteristics of iron oxide rust. The iron rust seems to decay until it comes out of the scribed areas, leaving rust-brown stain on the specimen surface. In addition, there are also white patches

around the scribes which are salt deposits from NaCl solution that dissolve in the anti-fouling paint and then dry.

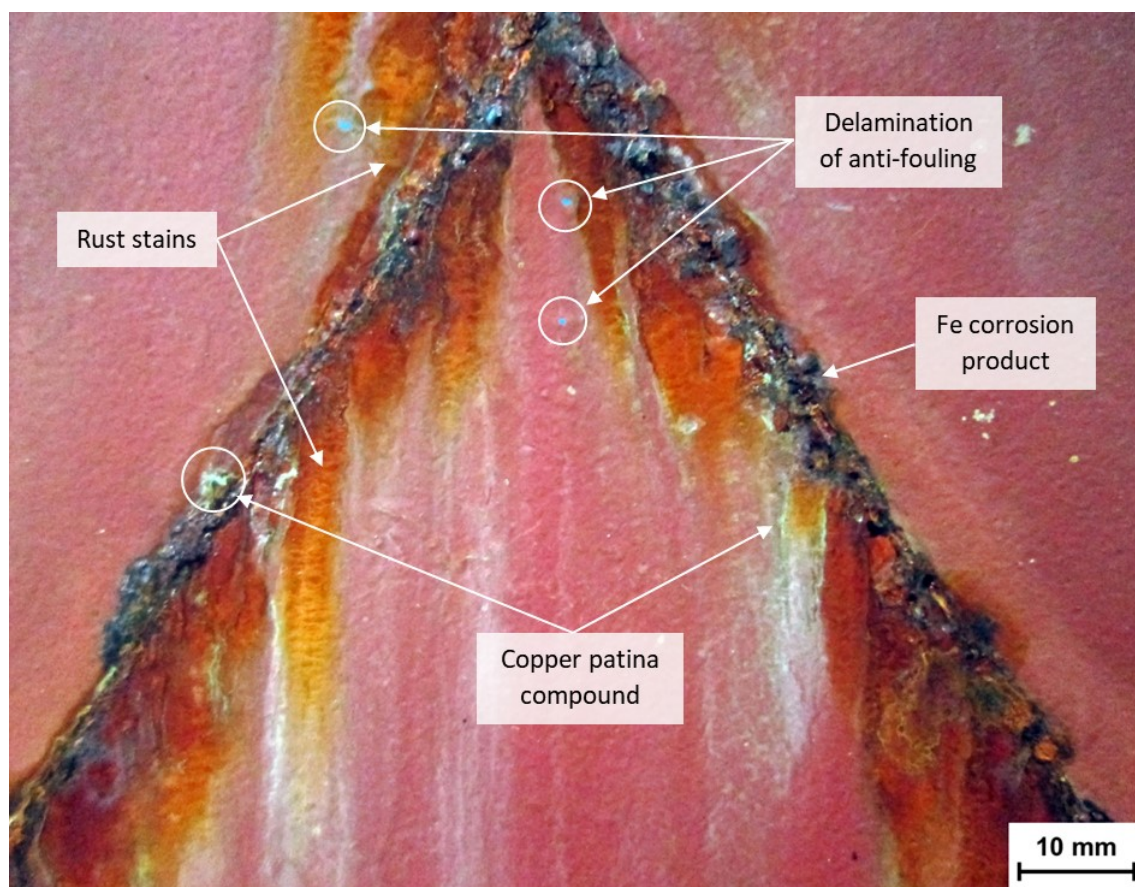
**Figure 4.** The detailed rust in the middle of scribe.

A number of greenish products appear in several locations around the scribes, which are suspected as copper hydroxy chloride compounds. If the paint is in its actual service condition, which is
