## Effect of Local Corrosion Caused by Inclusions and Surface Scratches of Steel in High Temperature and Pressure Flue Gas Environment

To cite this article: Dong Wang *et al* 2019 *IOP Conf. Ser.: Mater. Sci. Eng.* **542** 012083

**Abstract.** By simulating the high temperature and high pressure flue gas environment in heavy oil thermal recovery, the influence of two kinds of surface defects, steel inclusions and surface scratches, on local corrosion of steel was studied. And the mechanism of local corrosion caused by inclusions and surface scratches was analysed steel #20 and 26CrMo4 were used as experimental materials, and reacted in a 9 MPa flue gas environment for 24h. The reaction temperatures were 120 °C and 250 °C. The results show that the non-metallic inclusions in the steel are weak parts of the passivation film on the surface of the sample and are easily corroded by corrosive media. The scratched area is more likely to cause aggregation of corrosive media than other parts of the steel surface, and the iron elements in the metal in this area are more likely to reach the surface and react with the corrosive medium.

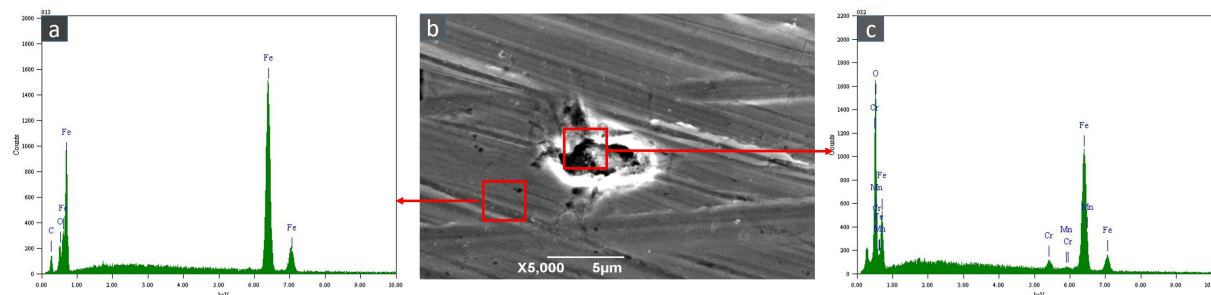
**Figure 1.** SEM and EDS images of steel #20 for 24h at 9MPa and 120°C:(a) EDS images of uncorroded area, (b)SEM images of sample surface,(c) EDS images of corroded area.

Sulfide inclusions are the most sensitive locations for initiation pitting of carbon steel and low alloy steel. In carbon steel, there are usually mixed Fe-Mn sulfides. The manganese-rich sulfide is easily corroded by corrosive medium, and a manganese-rich sulfide is easily attacked by a corrosive medium. Cracks are often formed around manganese-rich sulfides, and inclusions and matrix are eroded. The steel #20 and 26CrMo4 used in this experiment all contain a certain proportion of impurity elements such as Mn, S and P. This is unavoidable in the iron and steel smelting process. These materials are trapped inside the material during the formation of the metal, forming defects in the crystal. If some of these impurities are exposed during the polishing process, local defects will occur. These defects are active sites where corrosion preferentially occurs, resulting in corrosion pits. The observation of the morphology after the corrosion test did show some local corrosion aggravation behavior caused by inclusion defects. However, through the observation of the morphology after the corrosion test, it is true that some localized corrosion behaviors caused by inclusion defects exist on the surface of the sample. Figure 1 and figure 2 shows the morphology of the inclusions due to localized corrosion of inclusions in the experimental samples.

There are two explanations for the mechanism of steel corrosion caused by inclusions. One is that pitting occurs and developed in the micro-voids on the boundary between sulfide and metal, and the other is pitting caused by the dissolution of sulfide itself. In particular, certain composite sulfide-oxide inclusions establish a disordered state in the region immediately adjacent to them, therefore affecting the protective properties of the passivation film. At the same time, the locally disordered film is thick but often defective. The adhesion of the film is generally poor, and the physical and chemical resistance is low.

It is worth noting that the occurrence of localized corrosion caused by inclusions has little to do with the temperature, pressure and corrosion time of the experiment. The position of inclusions in the sample block cannot be predicted. The morphology of the inclusions is exactly in a certain area of the observed surface, and the surface is not covered by a thicker corrosion layer.

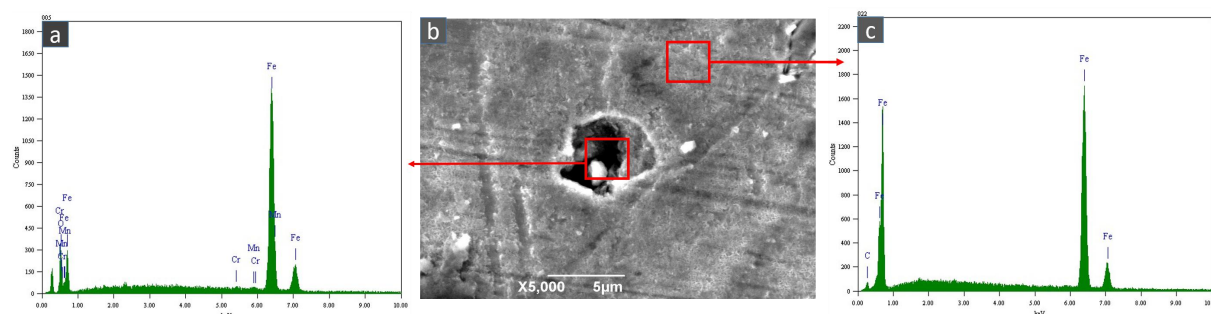
**Figure2.** SEM and EDS images of 26CrMo4 for 24h at 9MPa and 120°C:(a) EDS images of uncorroded area, (b)SEM images of sample surface,(c) EDS images of corroded area.

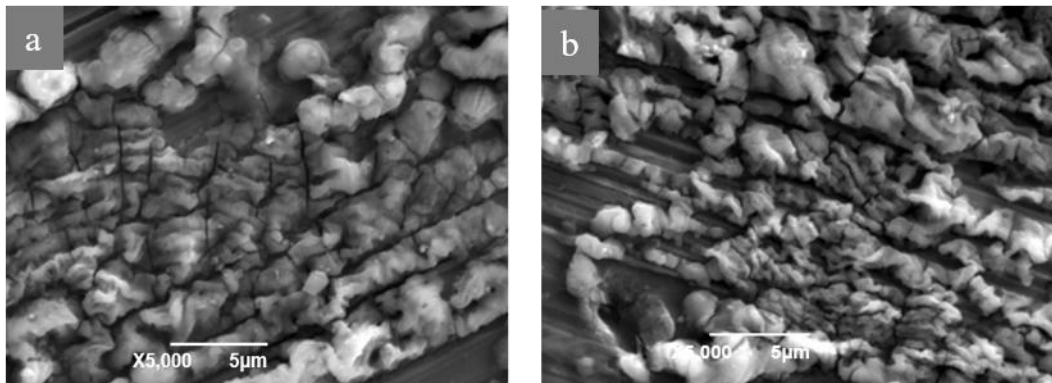
**Figure 3.** SEM images of corrosion for 24h at 9MPa and 250°C:(a) steel #20, (b)26CrMo4.

In this experiment, the sample was carried out under high temperature environment of corrosion of 9MPa and 250 ° C. As shown in figure 3, such corrosion product particles grown along the scratch were observed. After 24h reaction time, there were three different morphologies on the surface of steel #20 and 26CrMo4 samples, which were flat surface, scratches and corrosion product particles growing along the scratches. At the same time, the energy analysis shows that the corrosion product is iron oxide.

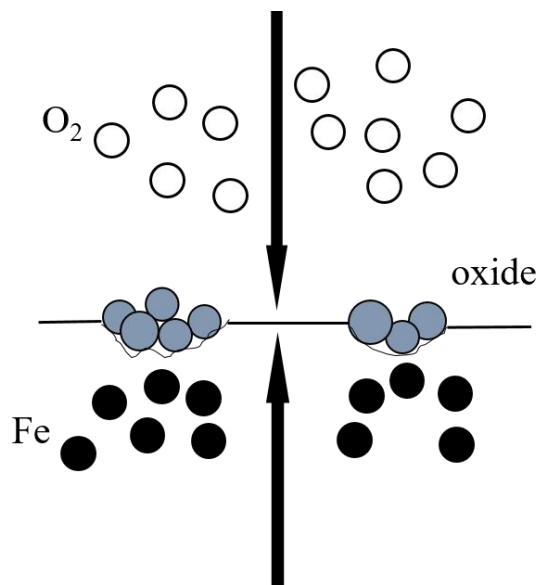
**Figure 4.** Schematic diagram of corrosion mechanism at scratch.

The local corrosion mechanism caused by scratches on the surface of steel is shown in figure 4. Scratched depressions provide a natural enrichment site for the enrichment of corrosive media. Since

the sunken region is closer to the substrate, the iron ions diffused outward from the substrate are first brought into contact with oxygen ions adsorbed on the metal surface in these regions and undergo oxidation reaction to form a corroded particle product. The diffusion path of iron element in the matrix includes two channels, the grain boundary and the inner part of the crystal, wherein the diffusion speed at the grain boundary is higher than the diffusion speed inside the crystal. And a large number of scratches appearing on the surface during polishing can become a diffused short-circuit path. The high temperature environment helps to increase the diffusion rate and the size of product particles. This process should be more obvious in high temperature environment and occurs in the early stage of corrosion. As the corrosion progresses, the scratches will gradually be covered and the oxide growth advantage in the scratch direction will no longer exist.
