The fire characteristics of the Municipal noise absorbing screen

Z Mašková¹ and O Bret¹

¹ Czech Technical University in Prague, Faculty of Civil Engineering, Department of Railway Structures, Czech Republic

Abstract. This article deals with the fire resistance of an innovative noise protection – so called the *Municipal noise absorbing screen* and its resistance in other dangerous situations with the occurrence of fire. The article briefly describes the characteristics of the noise absorbing screen's element which is made mostly of the cemented rubber granulate. Due to its geometrical, spatial and material solution the Municipal noise absorbing screen innovatively extends technical opportunities in the field of noise reduction from the rail transport, especially in the urbanized areas. This article also covers the problems of possible causes of fire considering the real installation of the element into the tramway track. The main focus of the article lies in the selection of possible dangerous fire situations. In connection with this, within the experimental part there were carried out reaction to fire tests according to the arranged fire scenarios. There were realized three bas

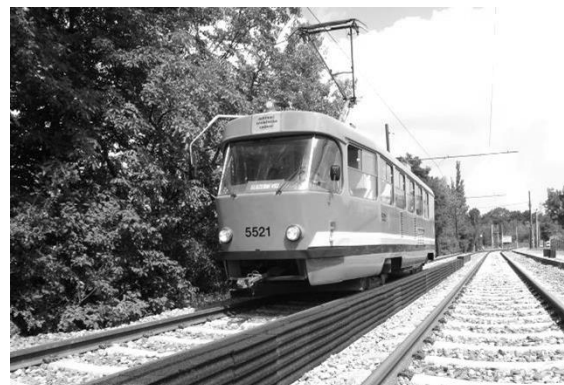
Figure 2. The Municipal noise absorbing screen in Prague – Braník.

The main material component of the Municipal noise absorbing screen is a cemented rubber granulate emerging from recycling of eliminated tyres. Within the recycling process the tyres are freed from bead wires, other metals and textile. [1] [4] The final product – granulate of a given grain size is then bonded with high-molecular-weight polyurethane adhesive and placed into individual manufacturing forms. These forms are adjustable so various surface finishes can be achieved (e.g. waves, pyramids, etc.). These surface finishes help to a better acoustic absorption of the screen. [4] Figure 2 shows the design used in the test section in Prague – Hloubětín which was realized in 2018.

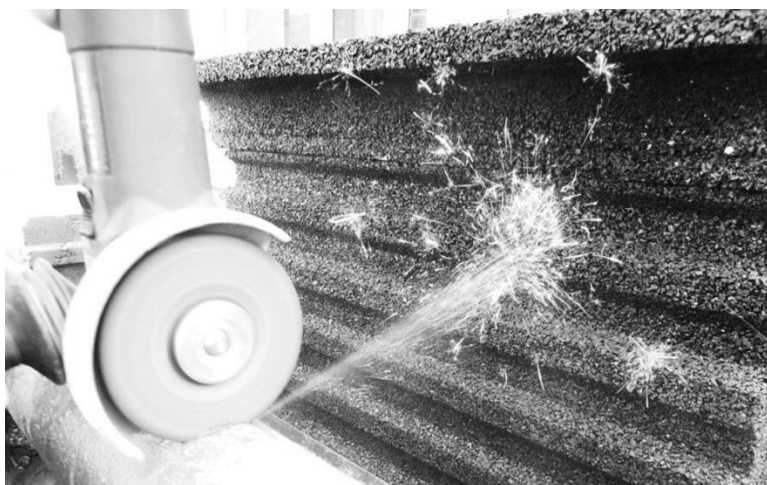
3.2.1. Test 1 – Effect of fly away sparks simulating rail grinding. The aim of this test was a determination of segment's reaction on effect of sparks as a simulation of rail grinding. There were two takes within this test where a tube from cast iron was placed on a metal frame in two different distances from the segment. The first distance represented the actual distance from the screen's face to the track, or more precisely to the outer rail. The second configuration should provide bigger amount of fly away sparks coming to a more concentrated area on the face of the screen. The entire construction was secured against shifting. The tube was cut with an angle grinder so that the sparks flew away to the face of the screen (Figure 3). These sparks should simulate the state during rail grinding. In both cases, the segment was exposed to the sparks for 30 s. Results from this test can be seen in Table 1.

Figure 3. Test 1 - simulating rail grinding.

Conclusion: The risk of a flare from the fly away sparks is negligible. The effect of the fly away sparks caused a local increase of temperature by approximately 10°C. During rail grinding the screen is under supervision when the workers can immediately intervene in the case of potentially problematic situation (e.g. occurrence of fire or its expansion).
