Diagnostics and repair of centrifugal oil transfer pump rotor shaft

Abstract. Materials on methods for diagnostics and repair of centrifugal oil transfer pump rotor shaft are considered. Results of research on reconditioning worn-out pump shaft journals are presented with provision of surface low roughness by a method of mechanical and ultrasound surface ruggedizing final finish. Analysis of the results attained by the ultrasound ruggedizing finish of a pump shaft and inspection of the superficial layer quality has shown the method, when applied, to considerably increase equipment availability, reliability, and serviceability.

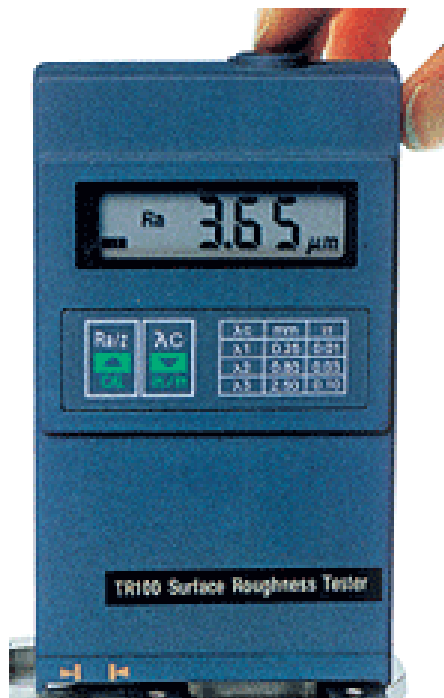
Surface roughness inspection after mechanical and ultrasound treatment was performed with TR-100 profilograph.

Figure 3. Small-sized TR-100 profilograph. After cutting and turning pump shaft journals, roughness was - Ra 3.2.
