Characteristics of Non-Cohesive Embankment Failure

Z M Yusof¹, A K A Wahab¹, Z Ismail¹ and S Amerudin.²

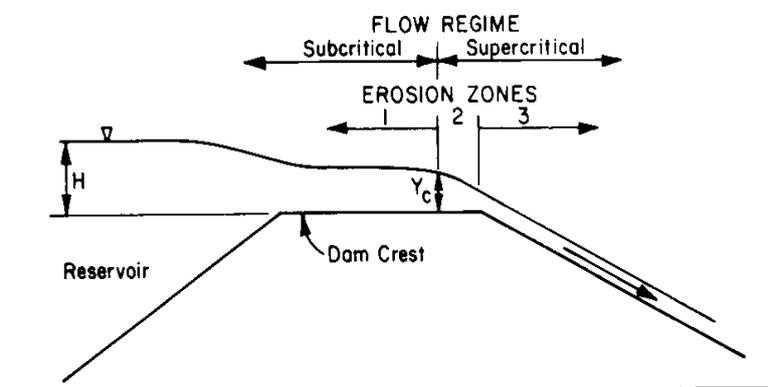
There are three hydraulic flow regimes and erosion zones for flow overtopping an embankment, as shown in Figure 1 [5]. A highly erodible zone occurs when the subcritical flow happens on the dam crest. At this stage, the energy slopes, velocities, and tractive stresses are relatively low and cause the embankment crest to erode, followed by a transition to supercritical flow on the downstream portion of the crest. As a result, the energy slopes and tractive stresses are higher in this region and erosion is sometimes observed at the knick point at the downstream edge of the crest. When the crest is paved, uplift of the paving materials is also possible if the pavement is underlain by permeable materials. The 3rd zone of erosion is the downstream face of the dam where the flow accelerates at supercritical depths until reaching uniform flow conditions.

Figure 1. Classification of flow regimes and erosion zones in an embankment overtopping [5]

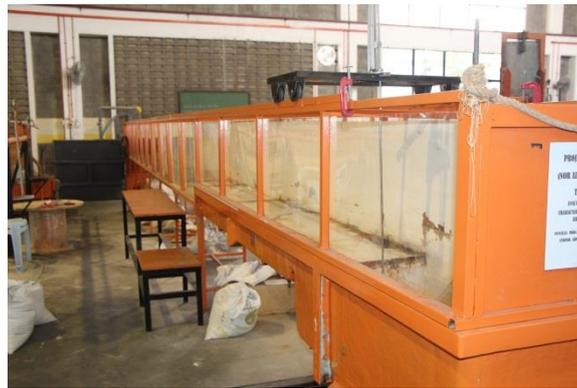
The breaching test for the embankment sand took place at the Hydraulics and Hydrology Laboratory, Department of Hydraulics and Hydrology, Faculty of Civil Engineering, UTM. The test was conducted in a 11 m long \times 0.6 m deep \times 0.5 m wide flume (Figure 2). Non-cohesive soil is used to construct the 0.1 m high embankment. The width of the embankment crest is 0.1 m as well. The face slope of the embankment is fixed at 1V:3H, as shown in Figure 3. The breaching test uses a constant inflow rate of $0.8 \times 10^{-3} \text{ m}^3/\text{s}$. The inflow is kept constant until the overtopping process started and the water then flows through the notch above the dam crest, as shown in Figure 4. The flow rate from upstream to downstream area passes through the embankment dam, which is located at the middle of the channel.

Figure 2. A 11 m long \times 0.6 m deep \times 0.5 m wide flume

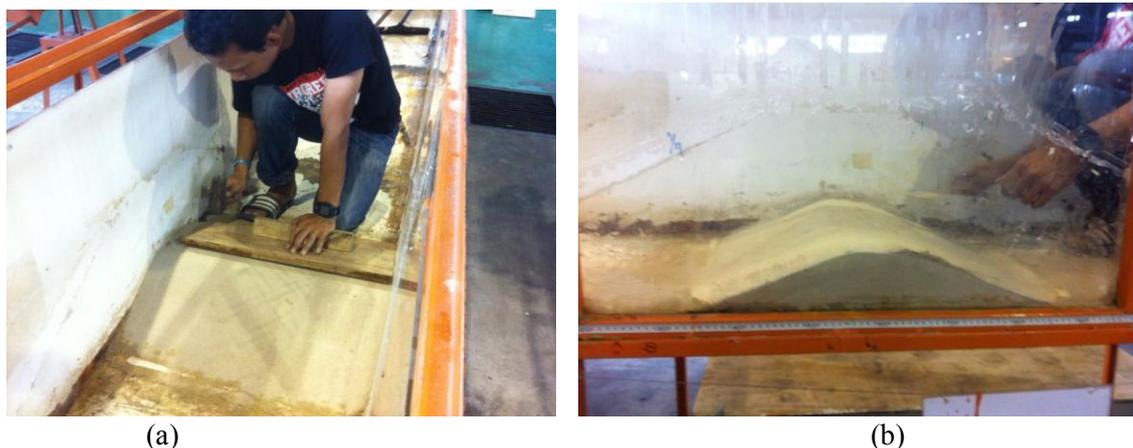
The initial step in the testing procedure was sieving the material of non-cohesive soil, which is in range between 600μ and 250μ . Material sieved was compacted layer by layer in the middle of flume, as shown in Figure 3.

Figure 3. Compacting the embankment; (a) compaction method, (b) final shape of the embankment

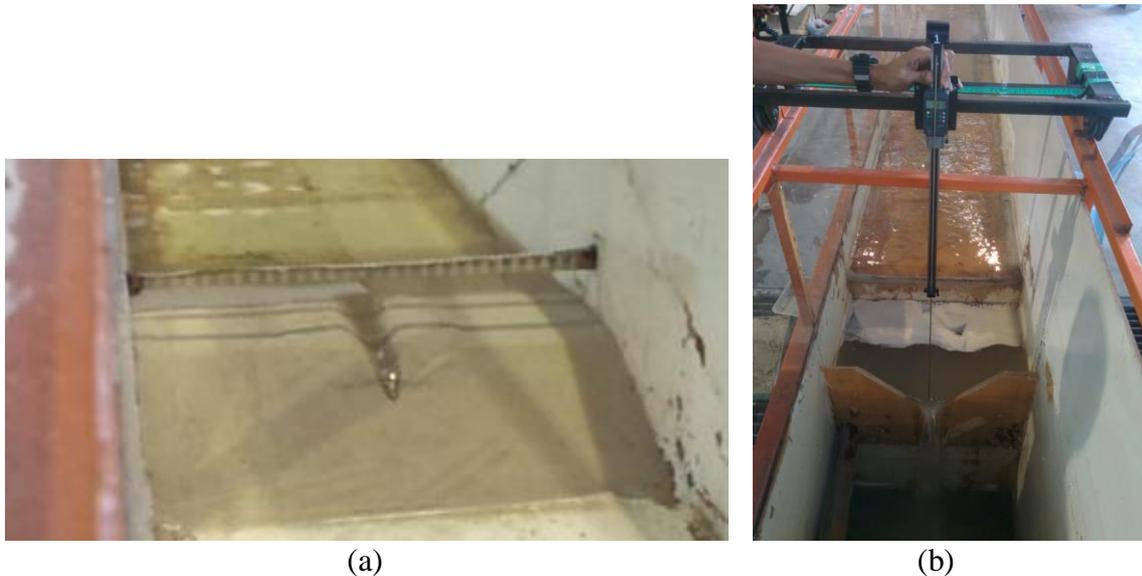
Figure 4. Model setup; (a) a handmade notch (b) a V-notch to measure discharge

During the experiment, video cameras were used to record the temporal progression of breaching patterns. The discharge is then measured using a V-notch with a 90^0 angle, located at the outlet of the flume. The discharge is calculated using the formulae,

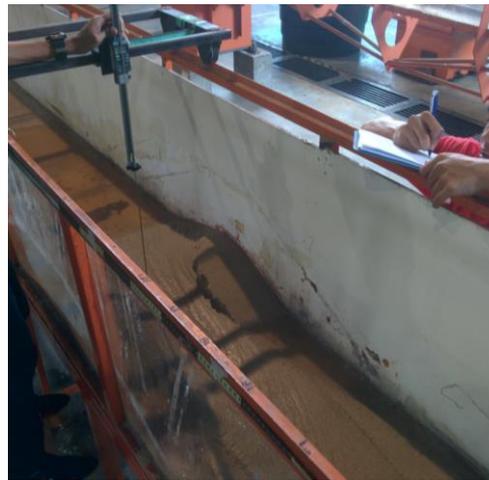
The breaching process starts when the flow enters into notch as the result of overtopping flow. This is due to the fact that the water forces the embankment material to become eroded. Also, the effect of hydrostatic force behind the embankment triggers the embankment material to be transported away due to instability, causing further failure to embankment. After breaching process is complete, sediment transported by the stream will form bed lock as shown in Figure 5. The formation of sediment transports were varied from each test because of uncertainties in the experiment.

Figure 5: A plan view of a breached embankment

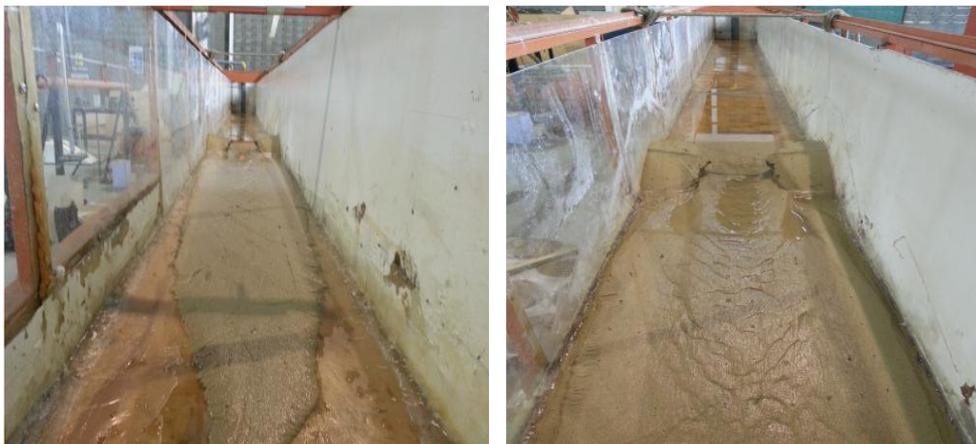
When the embankment starts to breach, it continues to erode parts of the embankment. The process was initiated by the weakness of the sediment. In this study, the final shape of the breached embankment was almost symmetrical between both sides, which is similar to a result found in [9]. Additionally, the study has found that only half of the embankment width eroded when using lower inflow rate, which has similar outcome as [8]. Figure 6 shows the sediment deposited pattern at downstream after the embankment has completely breached.

Figure 6. Failure and sediment pattern at downstream after completely breached

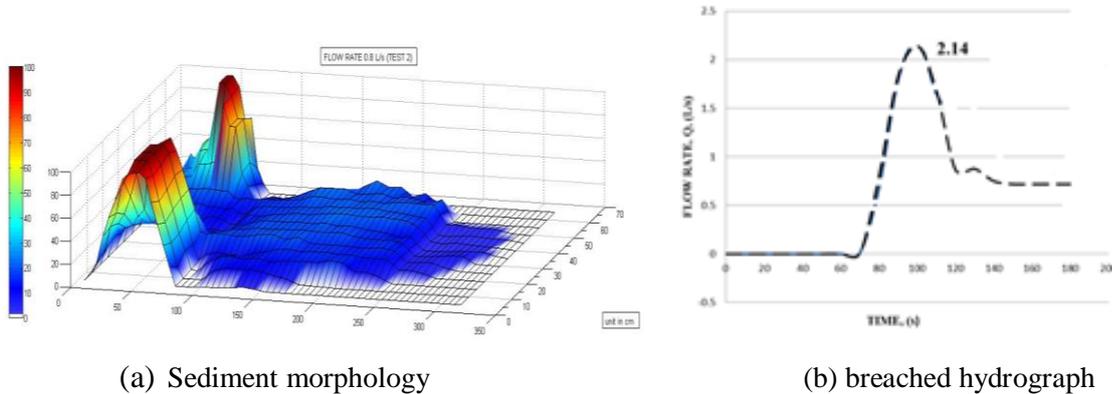
Figures 7 and 8 show a plot of breached morphology and breached hydrographs after the embankment has completely breached for medium and coarser embankments. The heights of sediment were recorded and plotted in MATLAB. The length and height of sediment transported downstream are measured at 5 second interval. The result of peak flow rate obtained was approximately at 2.14 m^3/s at 95 s for the medium embankment, while for the coarser embankment, the peak flow was recorded at 3.36 m^3/s . The morphology of breached sediment occurred at the middle and is shaped like a trapezoidal from front view. This might be due to the initial shape of v-notch built at the crest of the embankment to trigger the erosion. The water started to flow through the initial v-notch to erode at the middle of the notch until the embankment fails.

Figure 7. A breached morphology and a hydrograph of a medium embankment after the failure

Findings from both experiments showed that sediment morphology patterns were various and inconsistent because of the implementation of different inflow rates and embankment sizes. From the morphology plotted, it could be concluded that the higher the flow through the embankment, the more sediment will be transported to downstream. This occurs due to higher flow rates that affect the time taken for the embankment to fail.

Sediment deposited at the middle failure showed that the surface of the sediment transport was more even as compared to the surface of the deposition at the upper downstream of the channel. The width of the sediment deposition also became narrower as compared to the upstream that transported too wide towards the wall of the channel. As a result, sediment deposition towards the downstream tends to form tapered shape. The results showed a similar trend of hydrographs but the profile of sediment morphology was different. It can be concluded that the pattern of sediment transport is depending on factors such as material, degree of compaction, flow rates, embankment size and slope. Even though the results have shown the similar pattern of hydrographs, the morphology profiles could not give the similar results.

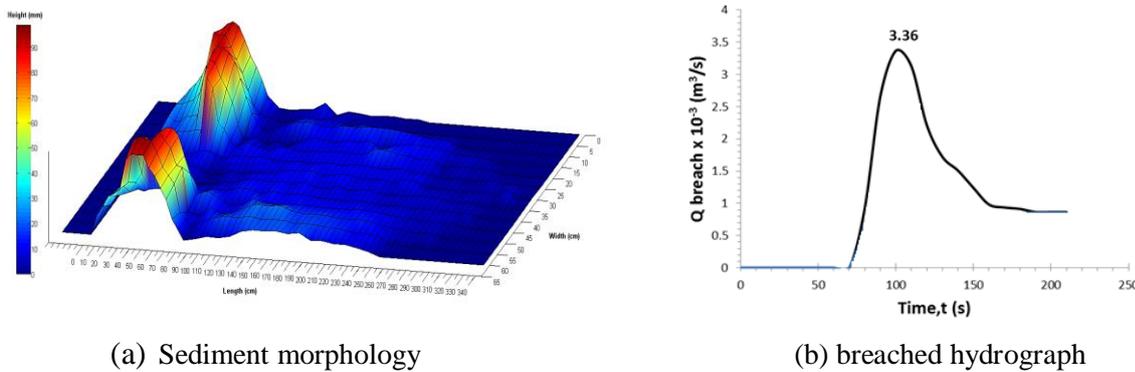
Figure 8. A breached morphology and a hydrograph of a coarser embankment after the failure
