# Infrared thermography and ultrasonics to evaluate composite materials for aeronautical applications

S. Boccardi, N.D. Boffa, G.M. Carlomagno, L. Maio, C. Meola<sup>1</sup>, F. Ricci

Department of Industrial Engineering - Aerospace Division, University of Naples Federico II, Via Claudio, 21, 80125 Napoli, Italy

**Abstract.** The attention of this paper is focused on the suitability of two techniques: infrared thermography and ultrasonics to evaluate impact damaged carbon/epoxy specimens. The obtained results are compared by highlighting advantages and disadvantages of each technique, as well their limits in view of an integrated use. In this context, a crucial task may be to assess the extension of delamination caused by an impact event, which may ask one to guess between sound and damaged materials at the edge of the instrument background noise. To help fixing this problem, results obtained with either lock-in thermography, or an ultrasonic phased array system, are analysed with the aid of thermographic data collected during impact tests.

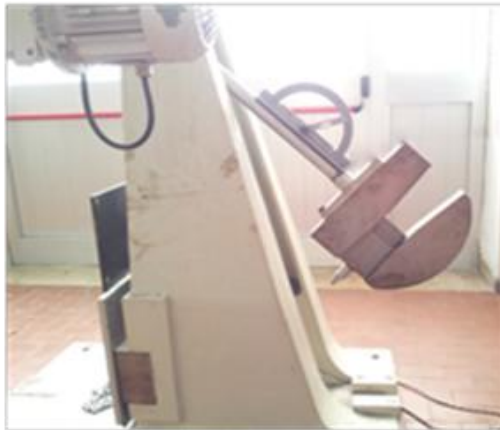
a) Charpy pendulum

Impact tests are carried out with a modified Charpy pendulum (Figure 1a), which allows enough room for positioning of the infrared camera (Figure 1b) to view the rear specimen surface (i.e., opposite to that struck by the hammer). The test setup is similar to that described in [6], the only difference regards the specimen's lodge which now includes two larger plates with a window 15 cm x 7.5 cm to allow for the contact with the hammer from one side and optical view (by the infrared camera) from the other side. The hammer has hemispherical nose 12.7 mm in diameter. The impact energy  $E$  is in the range 50-70 J, chosen to produce only barely visible damage of the panel without perforation and is set by suitably adjusting the falling height of the Charpy arm.

**Figure 1.** Setup for impact tests
