# Monitoring fatigue damage of an adhesive joint using fiber optics sensors

**Abstract.** Adhesive joining has many merits over traditional joining techniques. However, adhesive joints are susceptible to damage and degradation caused by service loading. If such degradation went undetected, serious structural failures and catastrophic outcome might follow. It is difficult and economically unviable to carry out regular examination on the joint integrity using conventional non-destructive evaluation techniques, especially in the case of practical structures with large scale adhesive joining. In this work, optical fibers with Bragg grating (FBG) sensors embedded in single lap joints has been demonstrated to be able to detect internal damage caused by monotonic and cyclic loading. FBG sensor works by reflecting specific wavelengths from a broad spectrum incident light. The wavelengths reflected depend on the strain on the FBG. Internal damages will perturb the strain field in the joint and thus change the shape of the reflected FBG spectrum. With embedded FBG sensors, it is possible to achieve on-line monitoring of the joint integrity in an economical way.

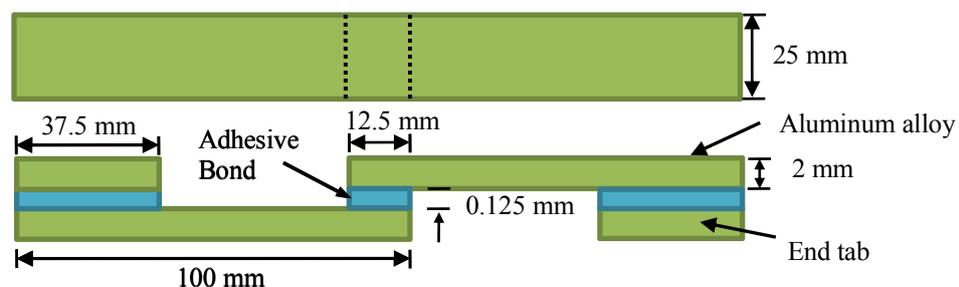
6061-T6 aluminum strips were glued together with Loctite E-30CL structural epoxy adhesive to forms single lap joint specimens (Fig.1). Optical fibers with FBG are embedded at either  $0^\circ$  (parallel to loading direction),  $45^\circ$  or  $90^\circ$  in the lap joint as shown schematically in Fig.2. The sensor designation

Fig.1 Dimensions of the single lap joint specimen.

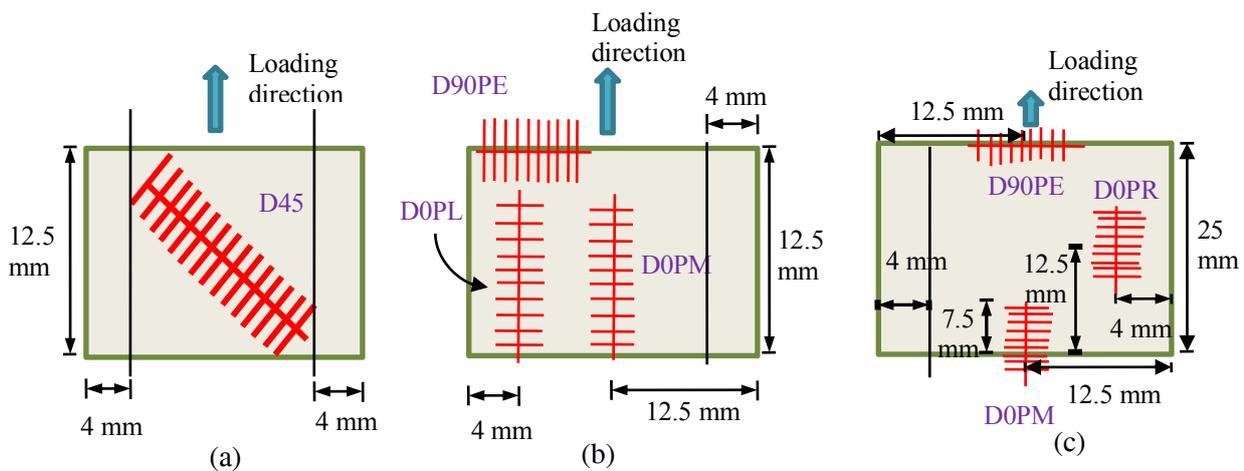
is in the form  $DnPx$ , where  $n$  represents the orientation angle and  $x$  denotes the location.  $x$  may take the letter E (edge), L(left), M(middle) or R(right). The relative positions of these locations are indicated in Fig.2. The bond line is approximately as thick as the diameter of the optical fiber, i.e. 125  $\mu\text{m}$ . The specimens were subjected to tensile or cyclic loading. Testings were interrupted periodically to allow the reflected light spectra from the FBGs to be recorded at the instantaneous loading and at 0 N. These spectra were compared with the respective original spectra before testing. The recorded spectra covered a span of 10 nm to ensure the characteristic FBG wavelength was totally included. For each set of testing conditions, the tests have been repeated at least three times to ensure the results are consistently reproducible.

Fig.2 Different layouts of the FBG sensors in the adhesive bond.

**3.1.2. Effect of of FBG locations on sensitivities in response to damage.** It is known that stress concentration occurs near the edges where the adhesive bond lines end in the loading direction. Since the sensing length of the FBG employed was about 10mm and there was likely a  $\pm 1$ mm deviation in positioning it in the bond, the  $0^\circ$  FBGs in configuration depicted in Fig.2b may or may not touch the ending edges of the bond. To investigate the difference in sensing sensitivity when the  $0^\circ$  FBG covers the edge of the bond or well clear of it, a joint overlapping length of 25mm instead of 12.5mm was used. The D0PM FBG was deliberately placed across one edge so that 2.5mm of it was outside the bond. On the other hand, the D0PL FBG was placed in the center of the bond so that it was about 7.5mm from either bond edges. As results above suggest that damages may start earlier in the middle, a  $90^\circ$  FBG (D90PE) was also included and was placed very close to the edge and centered in the middle instead of on the left. The complete lay out is shown schematically in Fig.2c.

In these tests, the lap joints were 12.5mm in length. FBG layout was similar to Fig.2b except that the  $90^\circ$  FBG was changed to  $0^\circ$  and was placed 4mm from the right side. Also the center of the FBGs were positioned at the transverse center line of the bond as far as possible so that their ends were within 1.5mm from either ending edge of the bond. The specimens were cycled between 0.156kN and 1.56kN at a frequency of 5Hz. The minimum and maximum loads corresponds to 4% and 40% of the average tensile failure load. The resulting average fatigue life was 144860 cycles.

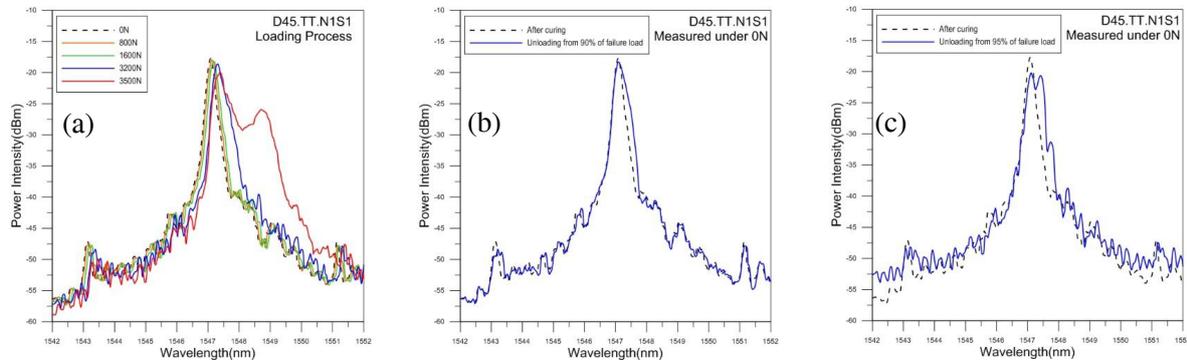
*3.1.1. Sensitivities of different FBG orientations in response to damage under tensile tests.* Fig.3 shows the spectrum from the 45° FBG configuration (Fig.2a) under different loading. As the applied tensile loading on the specimen increased, the FBG spectra initial shifted to the longer wavelength and eventually chirped and changed shape significantly. The reflected wavelengths from an FBG are affected by the strain acting on the FBG. The presence of internal damages will perturb the strain field in the joint and thus change the shape of the reflected FBG spectrum. On the other hand, loading the specimen will stress the joint and cause a wavelength shift of the spectrum. Non-uniform strain induced by stress concentration near the edges of the joint will chirp or even split the spectrum. To differentiate spectrum change caused by damage from the latter effects, spectra were recorded with the specimens fully unloaded after loading to different levels.

On unloading from 90% of failure load, the FBG spectrum started to show slight change in shape (Fig.3b), suggesting the existence of internal damages in the adhesive bond at this load level. Damage became more intensive on loading up to 95% of failure load and thus induced a more significant change in the FBG spectrum on unloading (Fig.3c).

Fig.3 Spectrum measured from the  $45^\circ$  FBG under various loading.

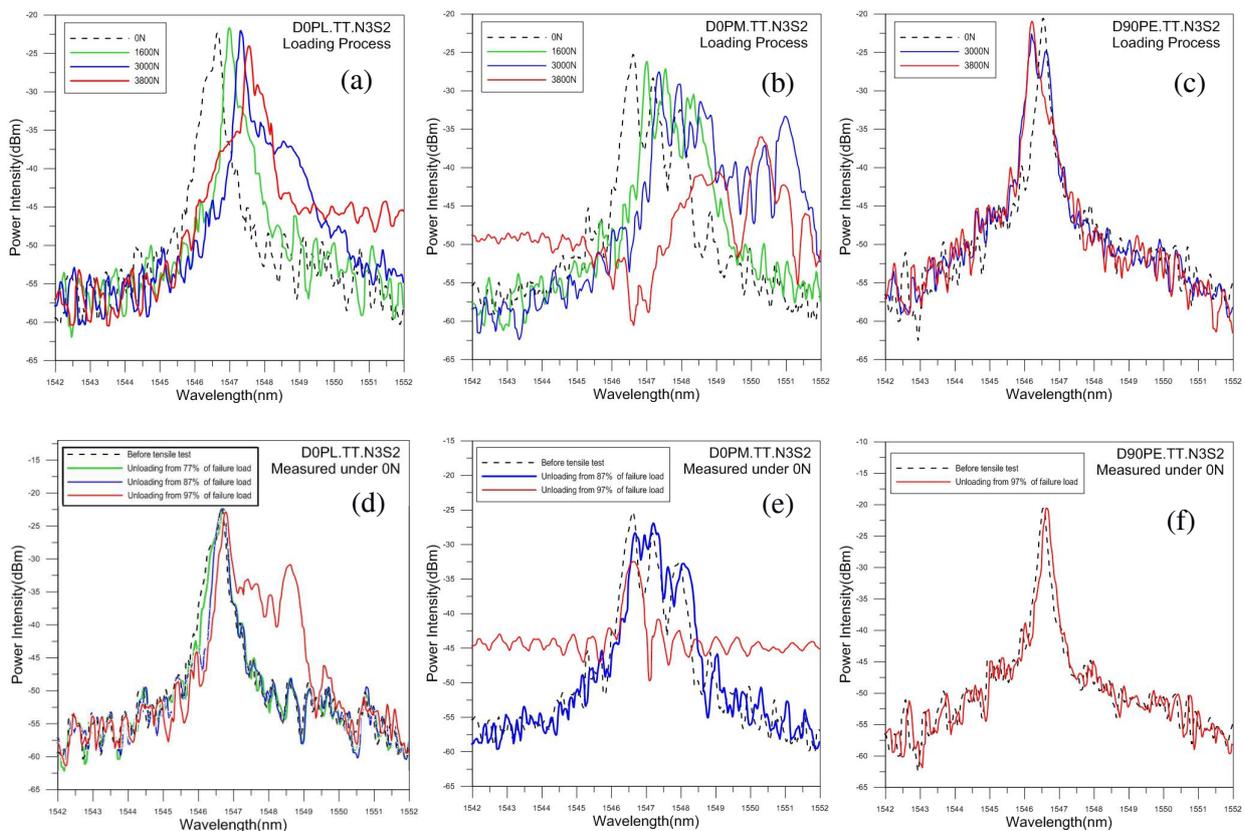
Fig. 4 shows the spectrum from the 0° and 90° FBG configurations (Fig.2b) under different loading. For the 0° FBGs, the spectra changed shapes much more heavily (Figs. 4a & b) than the 45° FBG under similar loading. On the other hand, spectra from the 90° FBG changed very little shape even near failure (Fig. 4c). The same trends occur in the unloading spectra (Figs. 4d-f). As a result, it may

be concluded that the  $0^\circ$  FBG is the most sensitive to damage inside the bond and the  $90^\circ$  FBG is the least sensitive while the sensitivity of the  $45^\circ$  FBG lies in between.

Fig.4 Spectra measured from the  $0^\circ$  and  $90^\circ$  FBGs under various loading.

The D0PM unloading spectrum from 87% of failure load (Fig. 4e) showed slightly more well-defined changes than that from D0PL. Results from two other specimens tested under the same conditions also exhibited the same phenomenon. This suggests that the  $0^\circ$  FBG located in the middle of the bond (D0PM) is slightly more sensitive than the one located on the left (D0PL). This may be due to damages started to occur earlier in the middle.

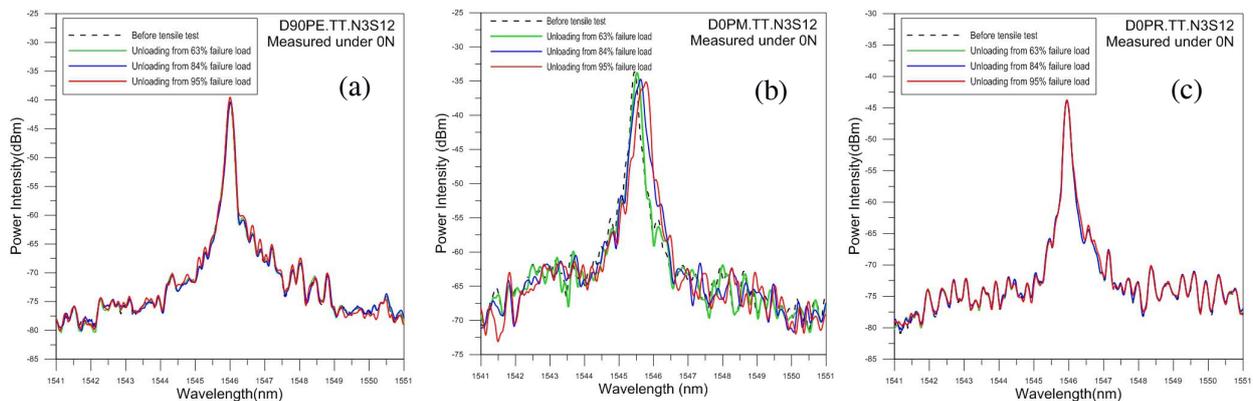
Fig.5 shows the unloading spectra from each FBG after loading up to various loads. The unloading spectra from the  $90^\circ$  FBG and the  $0^\circ$  FBG well inside the bond showed virtually no change up to 95% of the failure load. The one straddling one bond edge (D0PM) started to show marked change in the unloading spectra at 84% of the failure load. This shows clearly  $0^\circ$  FBGs in the vicinity of the ending edges of an adhesive bond has much greater sensitivity than FBG well clear of the edge.

Fig.5 Unloading spectra measured from the  $0^\circ$  and  $90^\circ$  FBGs using the configuration in Fig.2(c).

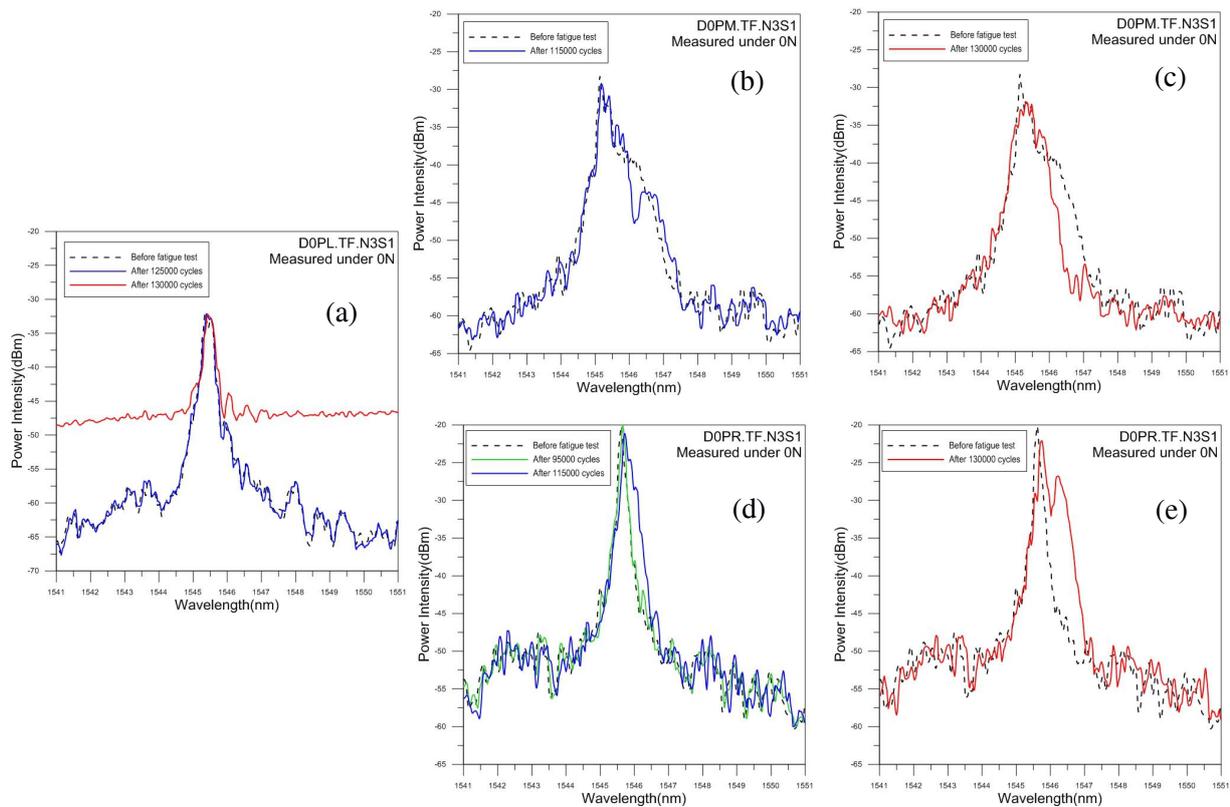
**3.2.1. Virgin specimens fatigue testing.** Fig.6 shows the unloading spectra from the three FBGs near the end of fatigue life. For the D0PL FBG, no marked change in the shape of the spectrum occurred up to 125000 cycles (95% life). At 130000 cycles (98% life), a prominent rise in background intensity was observed (Fig.6a). The D0PM spectra started to show discernible change at 115000 cycles, or 87% life (Fig.6b). The spectra continued to evolve and at 130000 cycles, it differed quite significantly from the initial spectrum (Fig.6c). The D0PR spectra started to show slight change at 95000 cycles (72% life). The change became quite marked at 115000 cycles (Fig.6d) and 130000 cycles (Fig.6e).

Fatigue damage is a highly localized and stochastic in nature. After damage initiated, it develops slowly under the small cyclic loading and may only affect the FBG in its vicinity. This explains why some FBG showed spectrum change much earlier and more significantly than the others.

Fig.6 Unloading spectra from the three  $0^\circ$  FBGs near the end of fatigue life.

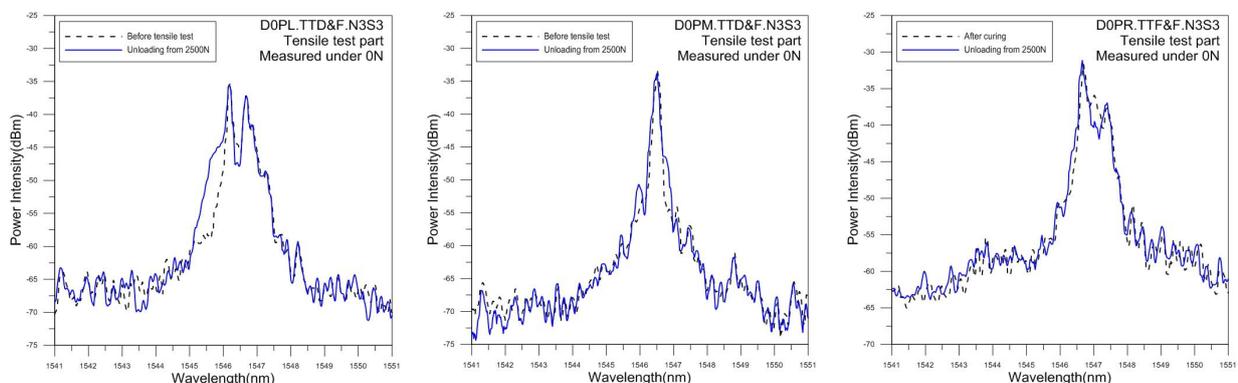
**3.2.2. Pre-tensioned specimens fatigue testing.** Tensile loading was applied to two batches of specimens. In the first batch, applied loading was increased stepwise until the unloading spectra of all three  $0^\circ$  FBG started to show discernible changes. In the second batch, stepwise increase of the applied loading was just stopped short of causing discernible change in the unloading spectra. Fig.7 shows the spectra of one specimen in the first batch unloaded from a maximum load of 2500 N, which corresponds to about 63% of the average tensile failure loading. On fatigue cycled between 0.156kN and 1.56kN, it got a life of 34600 cycles, significantly shorter than the average life of 144860 cycles.

Fig.7 Unloading spectra from the three  $0^\circ$  FBGs which just started to show discernible changes.

A specimen in the second batch was loaded to 2000N, which corresponded to about 50% of the average tensile failure loading and was higher than the maximum cyclic loading of 1560N. The unloading spectra from all three  $0^\circ$  FBG showed no discernible changes. Follow up fatigue test gave a life of 137250 cycles, which is within the scatter of the virgin specimen fatigue life.
