Repair of filament wound composite pipes

Abstract. Filament wound pipes are used in a wide variety of industries, due to the advantages composites have over metal pipes, such as a high strength to weight ratio, and resistance against frost, corrosion and heat. Composite pipes require minimal maintenance to ensure they are safe. Any damage occurring in composite pipes could lead to failure; therefore all damage should be assessed through NDT. If it is decided that the damage makes the pipe unsafe then a decision needs to be made whether to repair or replace the pipe. Repairing a composite pipe can be quicker, easier and cheaper than replacing it and can restore the strength of the pipe effectively. This investigation looks at the repair process and the parameters involved in determining the strength of the pipe following repair through the use of over 150 models in FEA software, Abaqus. Parameters considered include the pipe diameter and thickness, damage removal size and wrap width and thickness. It was found that if the pipe is thin-walled then it can be assumed that the pipe's thickness has no effect on the FOS following repair. Formulas were created to predict the FOS following

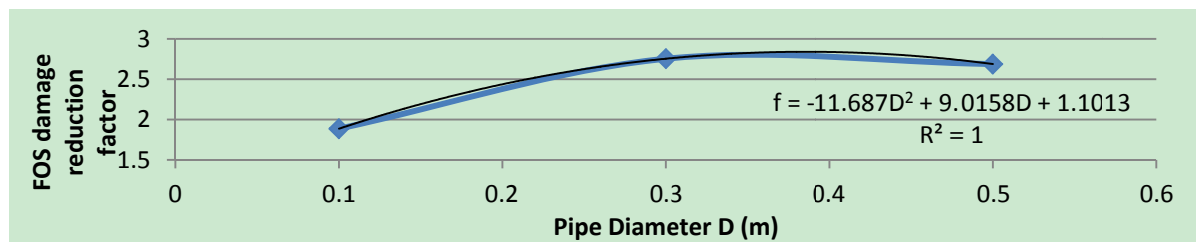
Pipe diameter varies dramatically with applications therefore it is important to understand how pipe diameter affects effective pipe repair. In this investigation the FOS of the pipes prior and following damage and following repair are considered to obtain an understanding of the effect of removing damage and repairing a pipe for different size pipes: 0.1 m, 0.3 m and 0.5 m. This was done through the use of 9 initial FEA models. First to be considered was the effect of pipe diameter on the damage removal FOS, with the results shown in Figure 3, where FOS reduction factor is as defined in equation (1). These results were then used to create equation (2).

Figure 3. FOS damage reduction factor for varying pipe diameters.

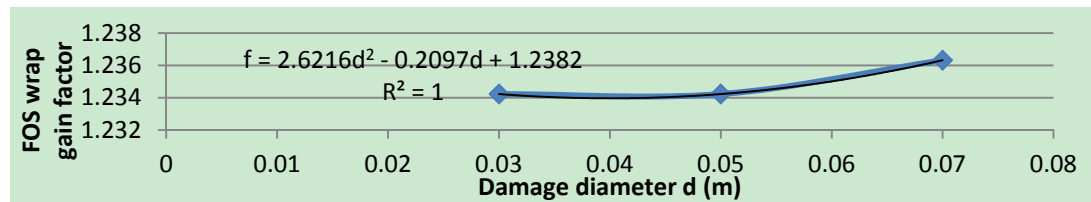
From all the results collected the overall gain or loss of strength can be considered, by looking at before damage and after repair. From these results were used to obtain Figure 5 and equation (10). It was noticed that the overall FOS gain factor varies very little for different damage diameters.

Figure 5. FOS overall gain factor.

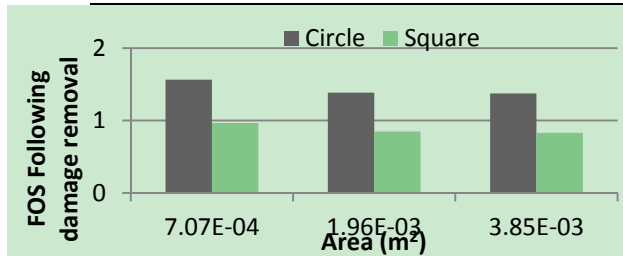
Figure 6. FOS following damage removal with varying cut out shapes.

It is not always possible to remove damage with a circular hole, due to the geometry and the size of the damage and component. In these cases, a square cut out with rounded corners should be used instead. From a previous study the worst case scenario of a square cut out was considered and it was found that the best angle to remove damage is at 45° [11]. Therefore, an investigation was carried out to determine the difference in using a square cut out at 45° with a circular cut out. To make the shapes comparable the area between the cut out shapes were kept constant, as shown in Table 2, and the FOS following damage removal. Figure 6 and Figure 7 shows the results obtained. As expected as the damaged area increases, the FOS decreases. By using a square cut out the FOS is dramatically less than using a circular cut out. For each scenario it was found that the FOS following damage removal is 60% less if a square cut out rather than a circular cut out. It can be seen that the FOS following repair is approximately the same whether a circle or square is used to remove damage, with the square cut out FOS being only 0.5% less than the circular cut out. Therefore it can be stated that as long as a suitable wrap is used then it does not matter what shape is used to remove the damage.

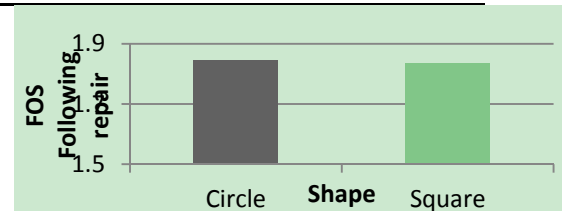
Figure 7. FOS following repair for varying cut out shapes.

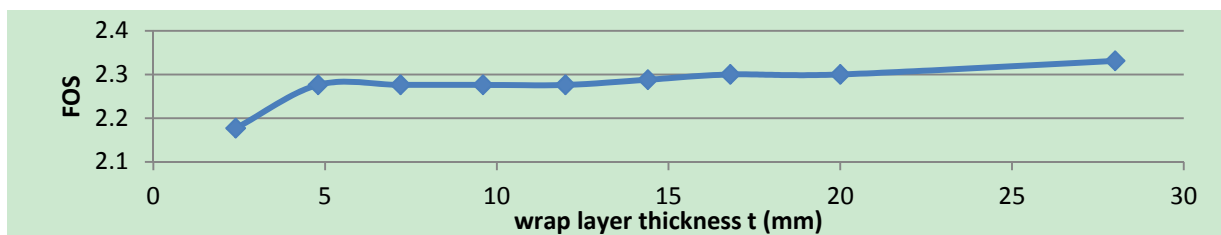
Figure 8. As expected as the thickness of the wrap increases the FOS also increases. There is a large

jump in the FOS between 2.4 and 4.8 mm, therefore a minimum thickness of 4.8 mm is suggested in this scenario.

Figure 8. Wrap thickness investigation FOS.

An investigation was carried out into the effect of varying the wrap thickness between 0.3 mm and 3.5 mm. A total of 9 models were considered and analysed using FEA software and from the results the minimum FOS was noted for each wrap thickness and used to create

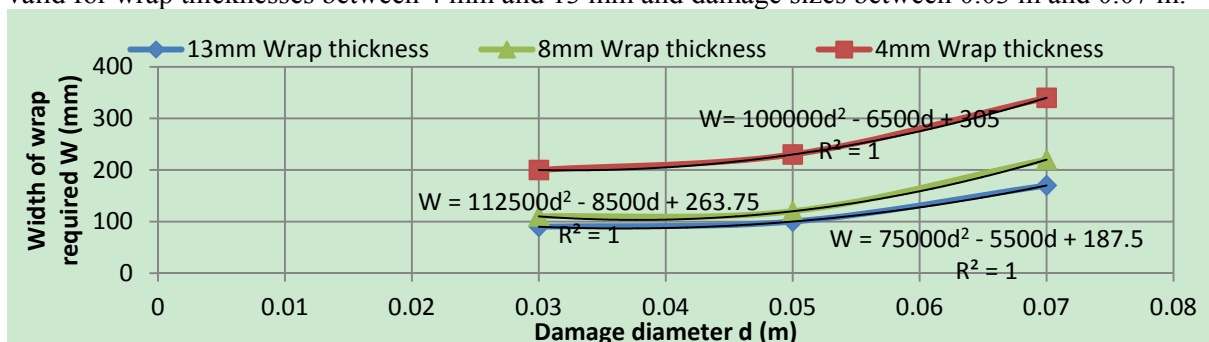
Wrap manufacturers recommend at least 51mm of wrap either side of the damage, their standard wrap width is 292 mm. This section looks at whether this much wrap is actually needed either side of the damage. If the wrap is too short then it's possible that the wrap will not be able to deal with the stress concentrations caused by the hole and risk failure. But a wrap width of too much will waste material, money and time. Therefore three wrap thicknesses (13 mm, 8 mm, and 4 mm) and three damage sizes (30 mm, 50 mm and 70 mm) were considered in an extensive trial and error method of 70 models to determine the optimum wrap width for each scenario. The results can be seen in Figure 9, which is valid for wrap thicknesses between 4 mm and 13 mm and damage sizes between 0.03 m and 0.07 m.

Figure 9. Wrap width investigation- Wrap width against damage size for varying wrap thicknesses.

The wrap was then investigated by looking at thickness and width. As expected it was found that as the wrap thickness increased the FOS following repair increased. An extensive trial and error method was used to investigate the wrap width for nine scenarios with varying damage sizes and wrap thicknesses. From this equations were created to predict the FOS before and after repair with an accuracy of 98%. It was also found that if T/D is constant then the wrap width required is the same length.
